Heritage on Fire – Complexities, Potential Solutions and Current Regulations: An Exploratory Study

Report 5641, Lund 2021

Master Thesis in Fire Safety Engineering

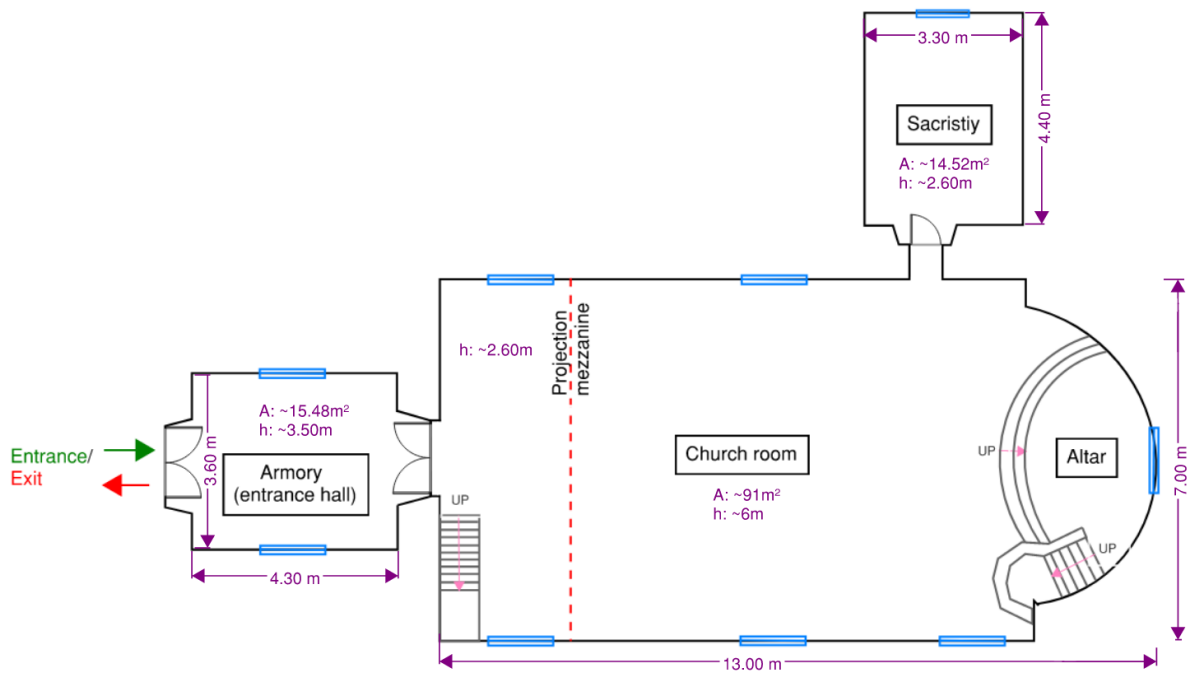
Figure 11 Sketch of Härlövs church layout based on its original floor plan provided in Brandskyddslaget's report (redrawn by Bianca Coutinho and adapted with authorization from Staffan Bengtson, here representing Brandskyddslaget).

The church building consists of three compartments: a large nave (the “Church room”), an entrance hall, also named as “Armory” in the church layout, and the “Sacristy”. The church room has a ceiling height of approx. 6 m and the total area of around 90 m². Since the actual dimensions of the church and the area of the other compartments were not provided, they will be estimated.

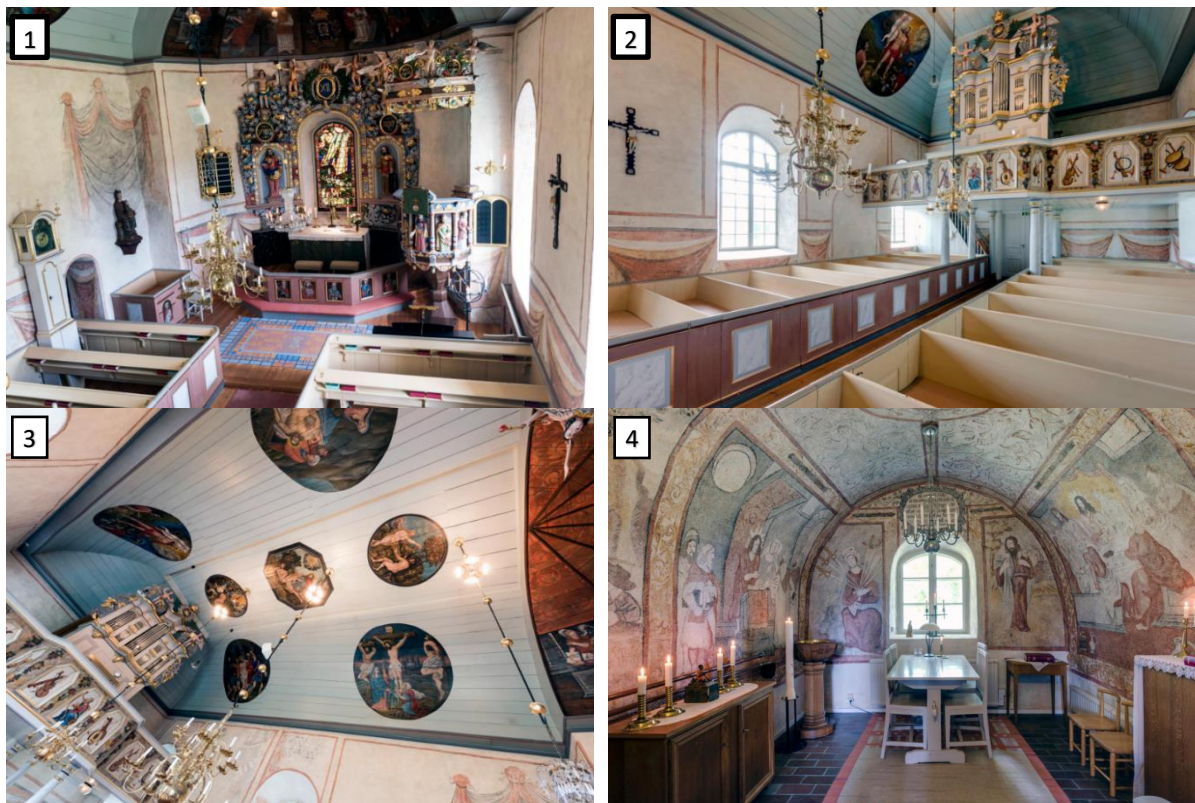
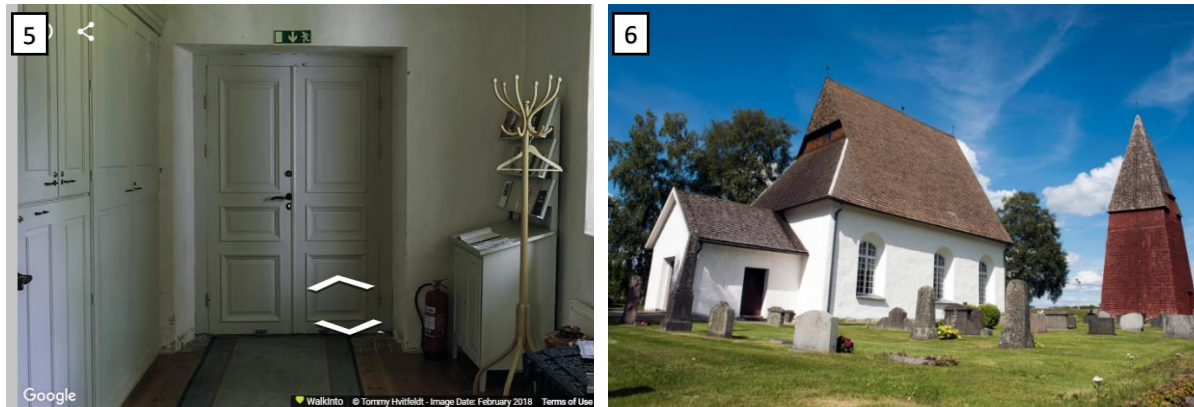
Figure 12 Härlöv's church interior and exterior architecture. 1. View to the altar; 2. View of the church room and the mezzanine with the organ; 3. Ornamental ceiling in the church room; 4. View of the sacristy; 5. View of the entrance hall (Armory); and 6. External view of the building and neighboring construction. Retrieved from Alvesta's parish website: <https://www.svenskakyrkan.se/alvesta/harlovs-kyrka>. Reproduced with the permission of Elisabet Cárcamo Storm, Vicar.

In addition, it is considered that the existing church has already an automatic fire detection and alarm system designed according to SBF 110:8 (Swedish standard) with spoken evacuation alarm. The church is also provided with adequate signage on the top of the exit doors (see Figure 12Figure 12.5).

The church’s interior design carries the Baroque style with exuberant paintings, sculptures, highly ornaments with enriched details like curves and deep colors transmitting movement, contrast and depth. Such characteristics combined with the uncertainty of the materials composition make it difficult to estimate a credible fire load. Figure 12 below displays images of the interior of the church, retrieved from the Alvesta parish’s website, with permission.
