Water Penetration in Solid Clay Brick Masonry and its Mitigation by Repointing

Kahangi, Mohammad

2024

DOCTORAL DISSERTATION

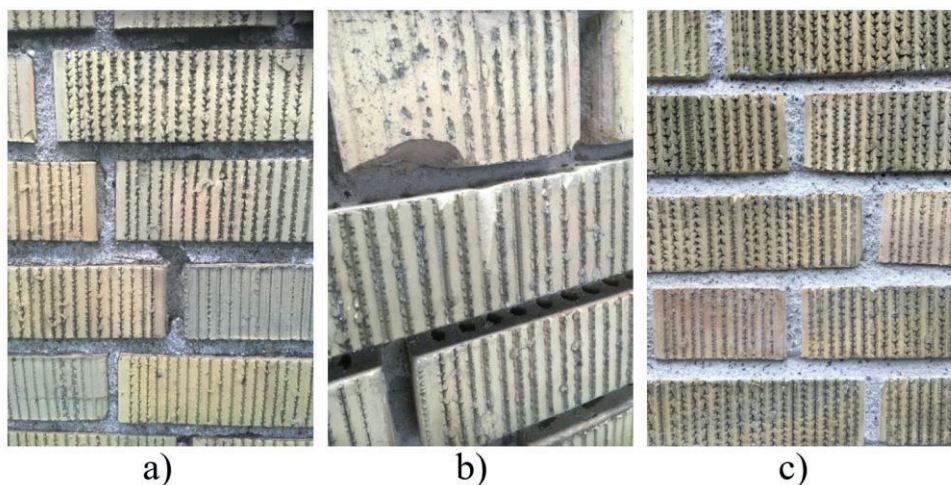
Figure 2. A clay brick masonry façade, before and after repointing, a) the initial state with eroded mortar joints; b) mortar joints raked out up to the depth of 25 mm; c) newly pointed mortar joints

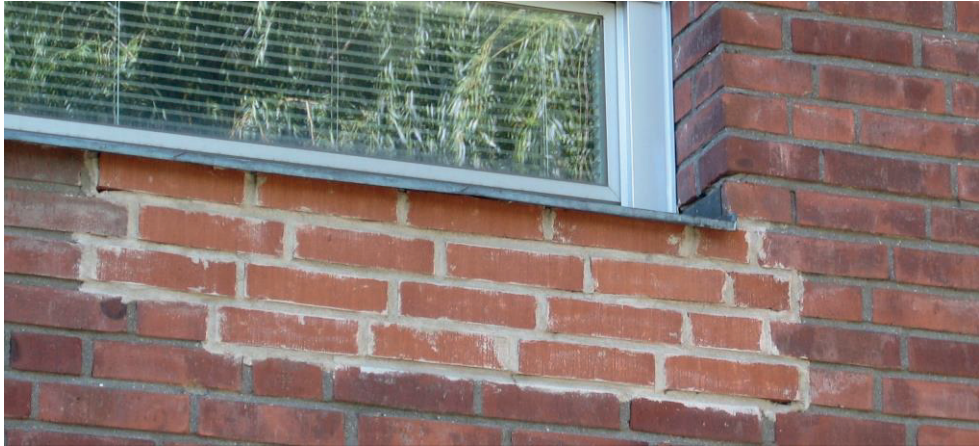
Figure 3. An example of the adverse effects of selecting unsuitable mortar and shoddy workmanship during the replacement of bricks due to frost damage

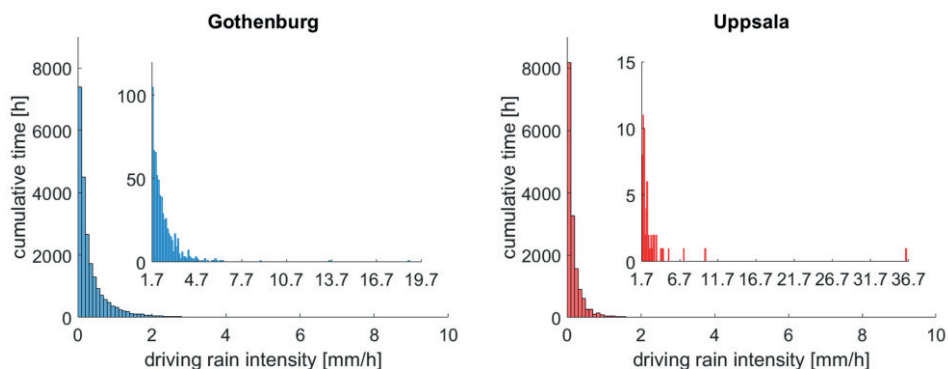
Figure 6. Driving rain intensities from 1995 to 2020 for the building considered in this section are a) Gothenburg and b) Uppsala – Calculations according to the ISO Standard [86]

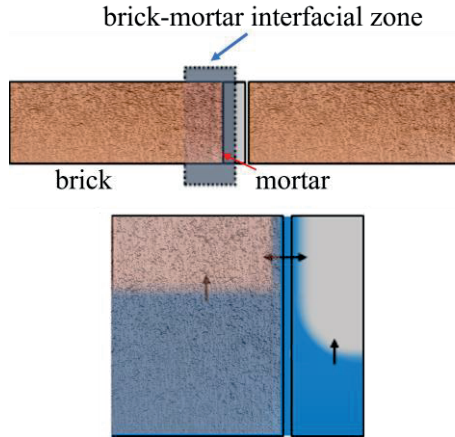
Figure 9. Moisture transport through a brick-mortar interfacial zone; high conductivity pathway - water transport parallel to the interface

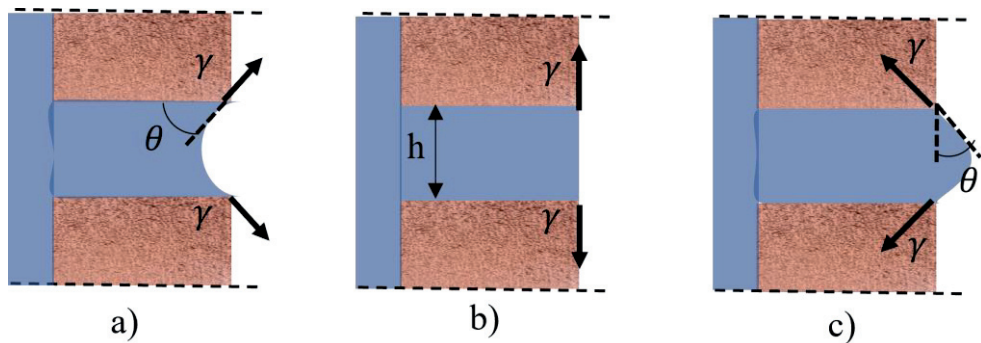
Figure 11. (a) Initially, water is drawn into the opening as a result of capillary action, (b) On the backside side of the opening, the meniscus takes on a flat shape with the surface tension preventing water penetration, and (c) The hydrostatic pressure increases, causing the contact angle of the meniscus to rise. This increase in the contact angle is countered by surface tension, as adapted from [21]

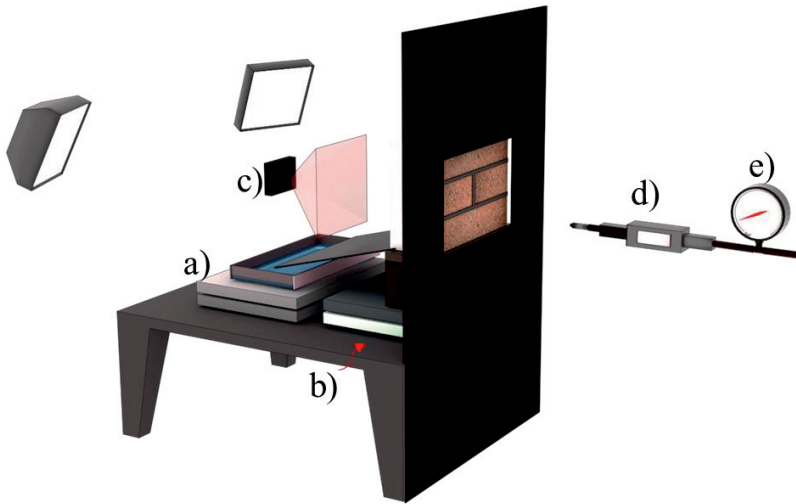
Figure 12. Schematic of the developed test setup: a) scale measuring water penetration, b) scale measuring water absorption, c) digital camera, d) water flow meter, and e) water pressure regulator

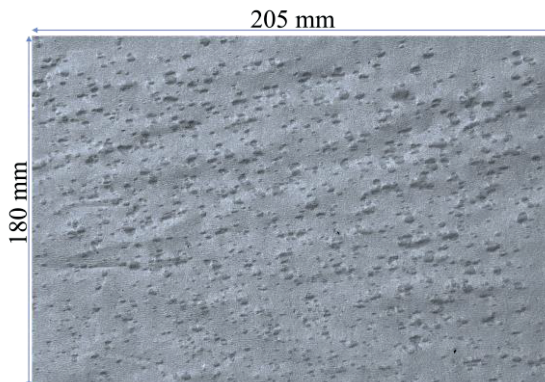
Figure 13. Wet dots on a paper sheet exposed to water spray for 1–2 seconds

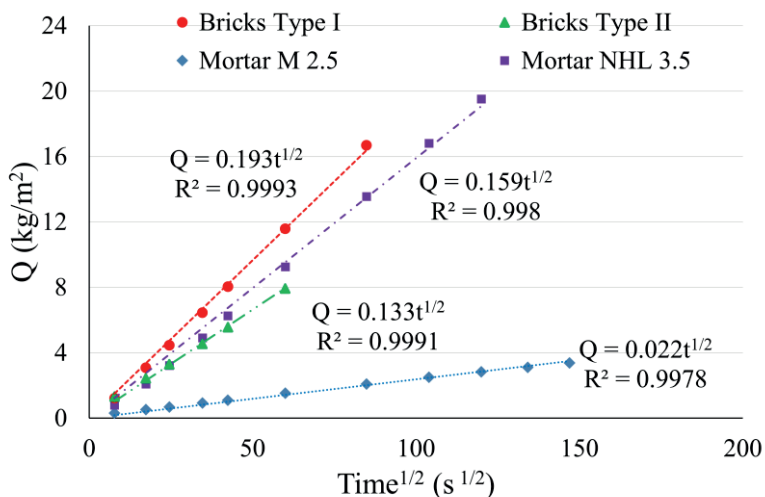
Figure 14. Average water absorption per unit area against the square root of time for bricks type I & II III and for mortar M 2.5 & NHL 3.5 during the initial stage of the test

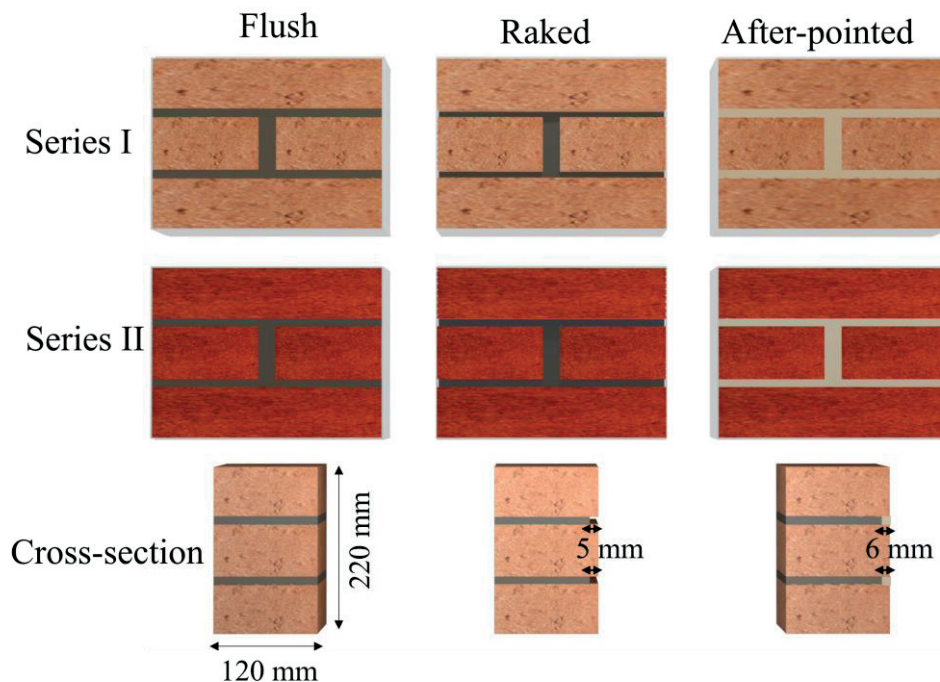
Figure 15. Representative specimens from each group and Series after sealing and Schematic of the mortar joint profile finishes (the bottommost row) [35]

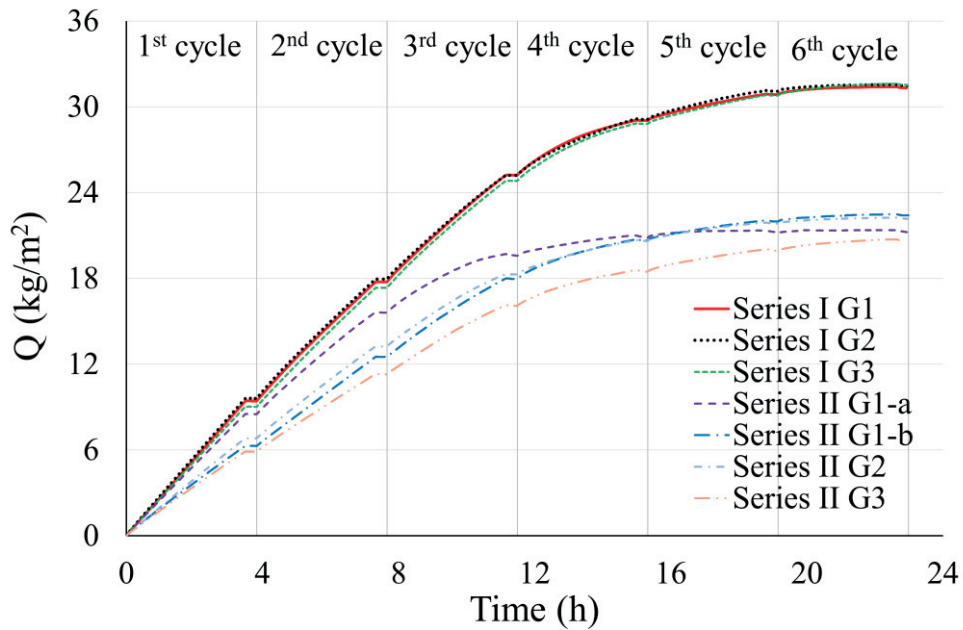
Figure 16. Average water absorption vs. time response of a) Series I and Series II group G1-a; b) Series II group G1-b, G2, and G3 in the first experimental campaign (A)

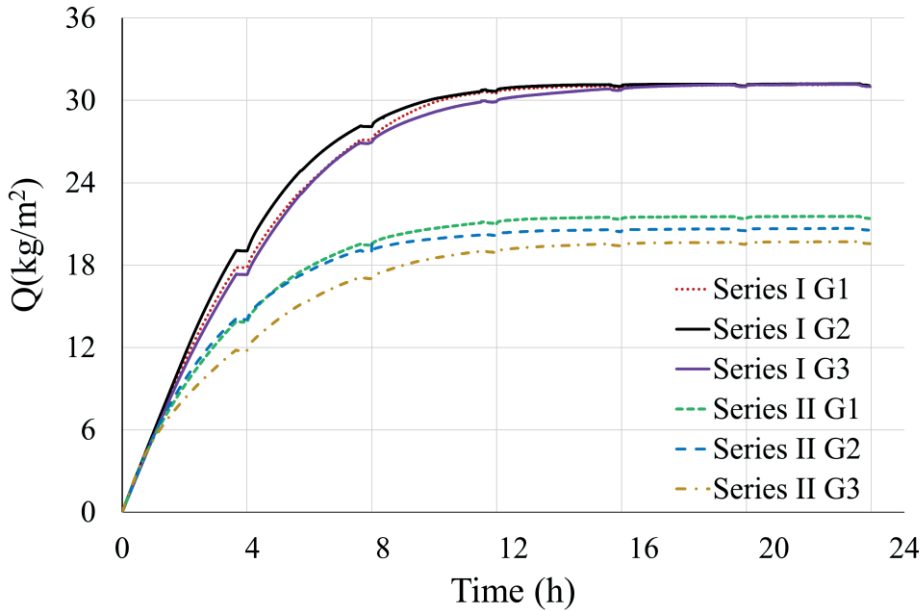
Figure 17. Average water absorption vs. time response of Series I, Series II, and Series III in the second experimental campaign (B), a) during 23 h of testing and b) during the first two hours after starting the test

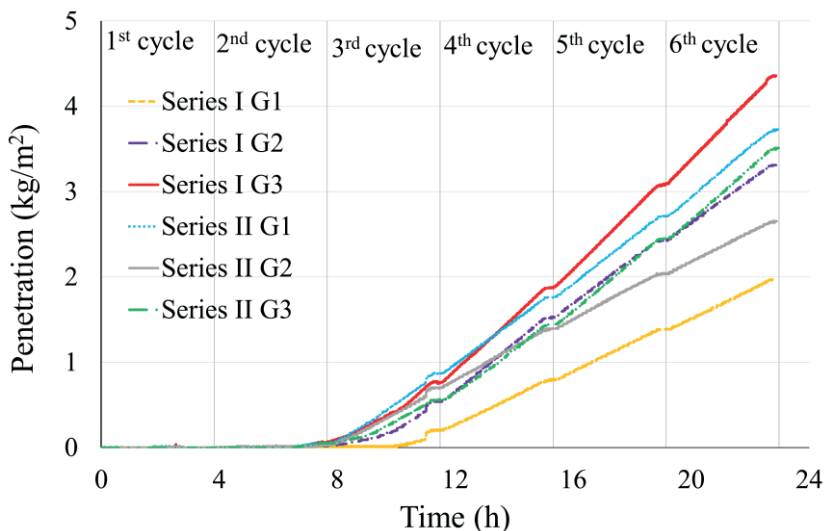
Figure 18. Average water penetration vs. time response of all Series in campaign B

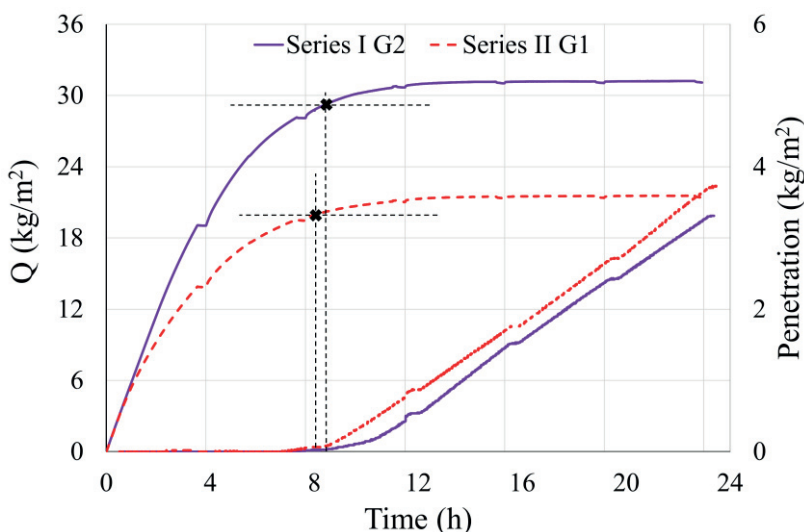
Figure 19. Water absorption and penetration of two representative groups of campaign B, indicating the correlation between the start of penetration and saturation level – the horizontal dashed lines indicate roughly 90 % saturation

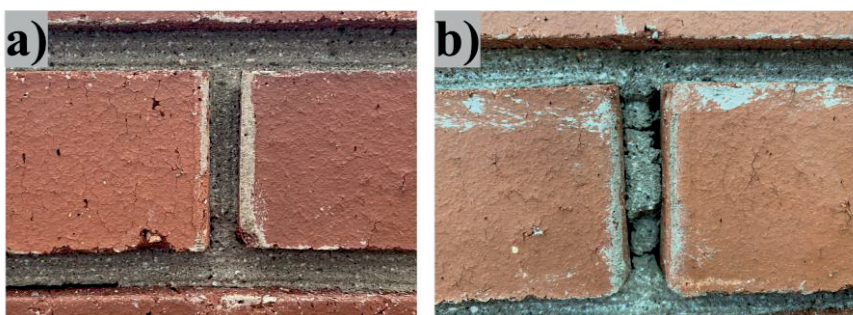
Figure 20. State of head joint of representative specimens after being raked out up to 25–30 mm: a) good/acceptable contact/bond and b) voids in the head joint

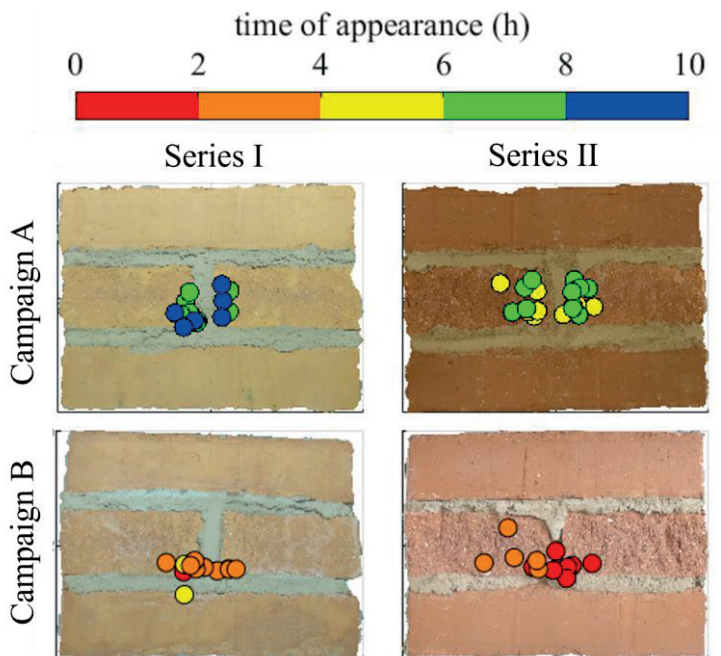
Figure 21. Location and time to the appearance of the first damp patch on the backside of specimens

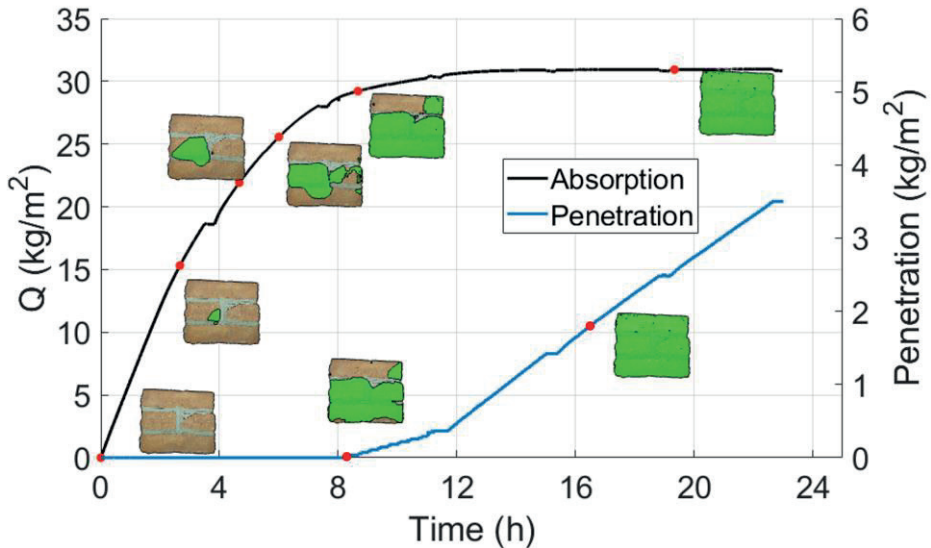
Figure 22. Appearance and growth of dampness (green marking) on the backside of a representative specimen at different times [35]

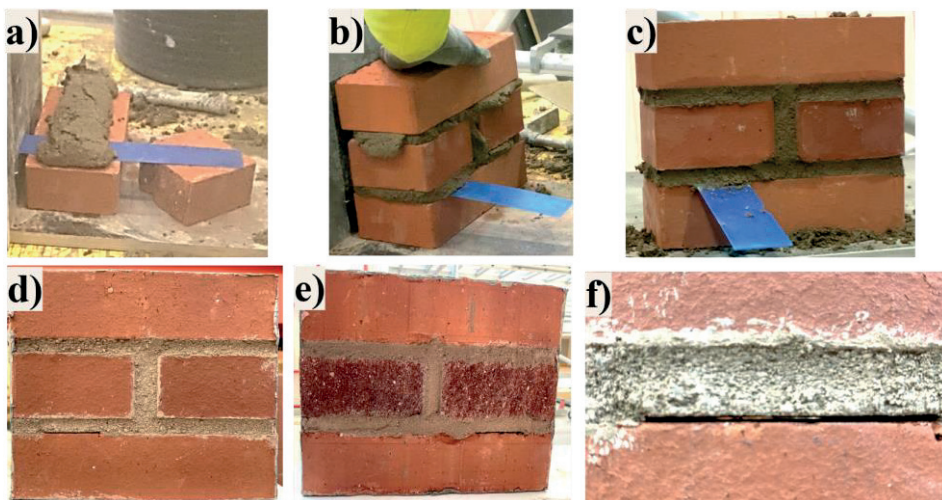
Figure 23. Preparation of specimens with an artificial crack: a) laying the first brick course and placing a plastic strip to create the crack, b) placing the third brick course, c) a 3-course masonry prism prior to removing the plastic strip, d & e) front view and backside, and f) close view of the artificial crack [135]

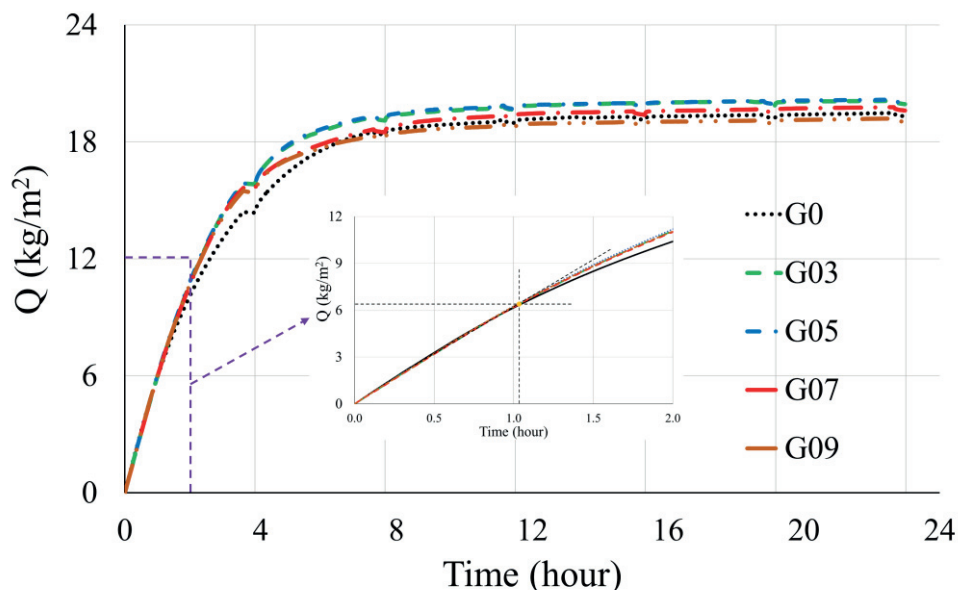
Figure 24. Average water absorption, Q , vs. time during 23 h of testing for all groups of Campaign C

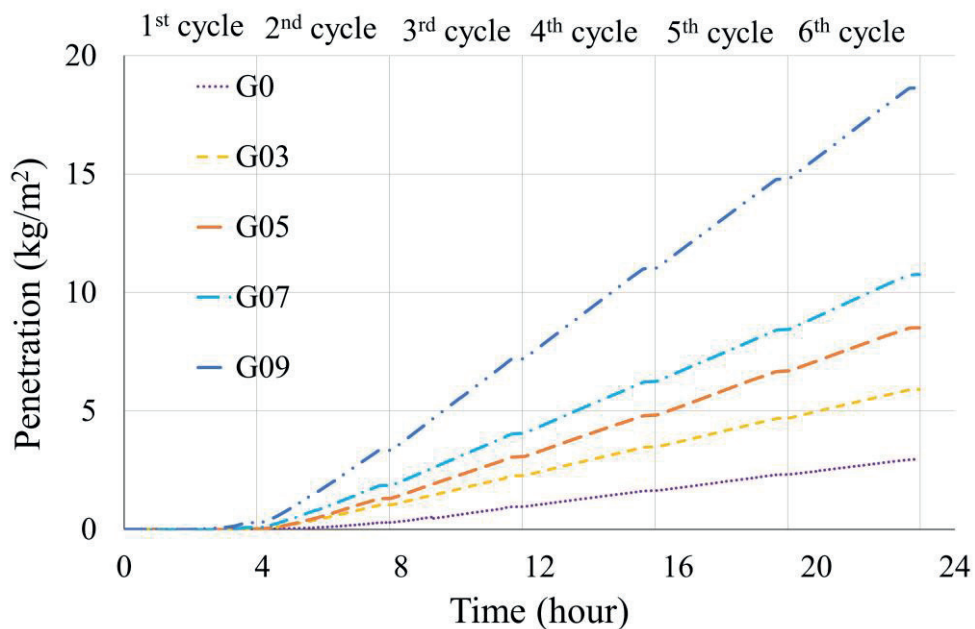
Figure 25. Average water penetration in each group during the 23 hours of testing

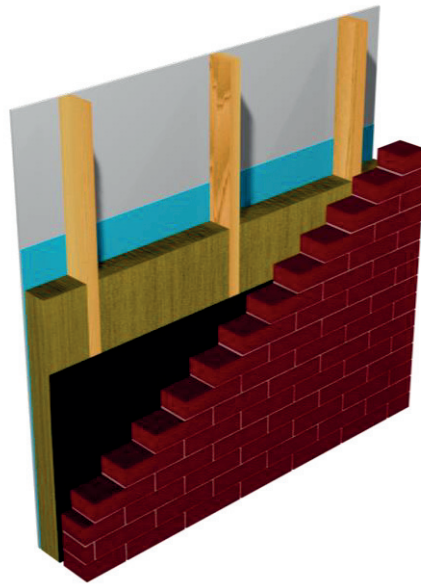
Figure 27. A schematic of a timber frame wall with brick veneer cladding; layers from the right (exterior) to the left (interior): brick masonry veneer (120 mm), air gap (20 mm), asphalt impregnated paper (1 mm), mineral wool insulation (95 mm), timber studs (95 mm × 45 mm) with a center to center distance of 600 mm, vapor retarder (1 mm), and gypsum board (12.5 mm)

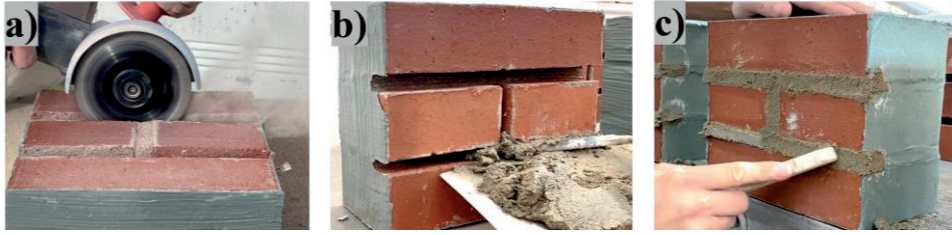
Figure 30. Different steps of repointing a specimen: a) raking out joints, b) applying new mortar, and c) compaction of the mortar [135]

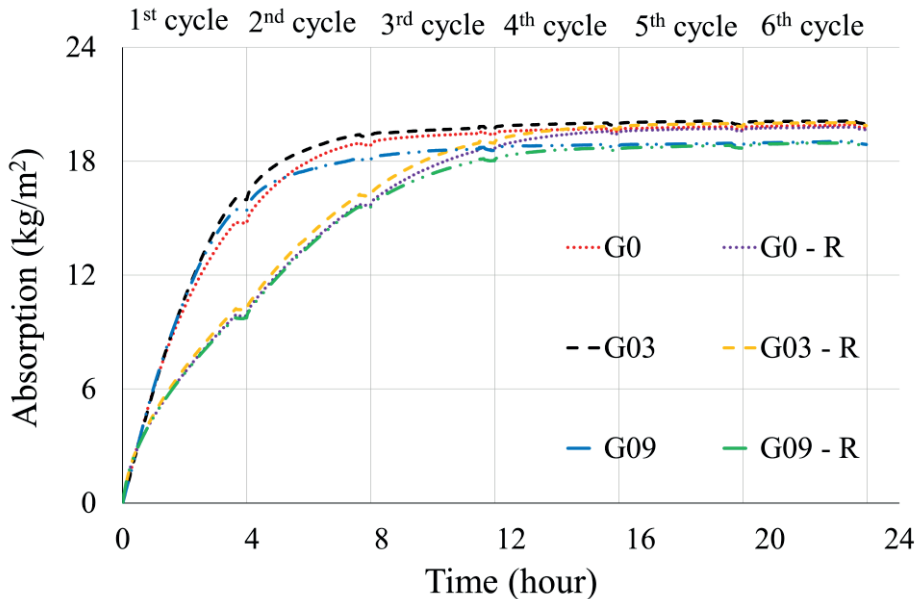
Figure 31. Average water absorption vs. time response during 23 h of testing for groups G0, G03, and G09 before and after repointing

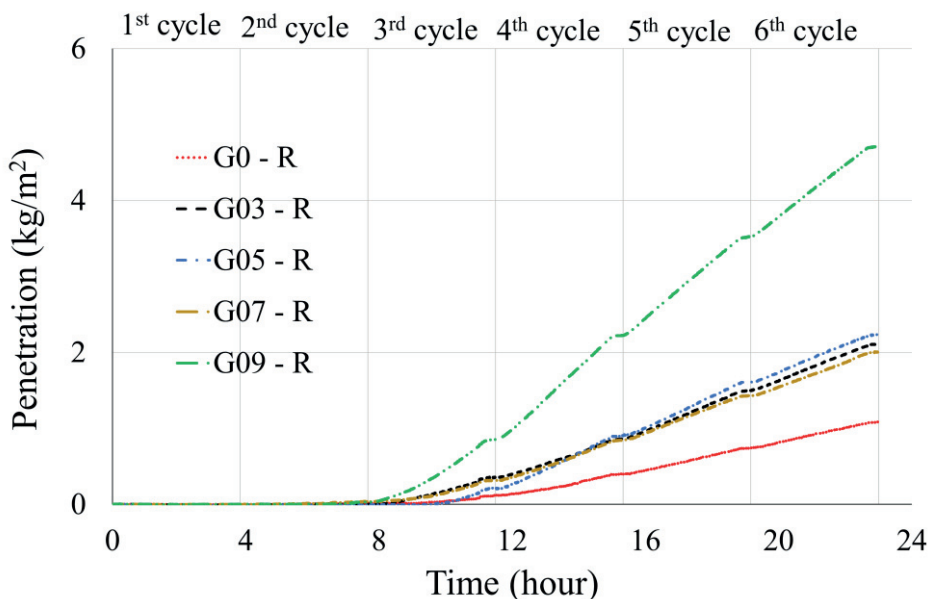
Figure 32. Average water penetration during the 23h of testing after repointing [135]

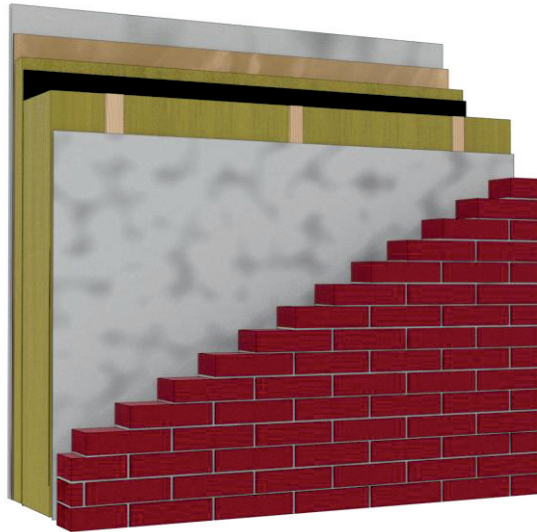
Figure 34. Schematic of a timber frame wall with brick veneer (total thickness of ~ 415 mm). Layers from the right side (exterior): brick masonry veneer (120 mm), air gap (30 mm), gypsum board (16 mm), wood fiber insulation (170 mm), vapor retarder, wood fiber insulation (50 mm), oriented strand board – OSB (12 mm), and gypsum board (16 mm) [150]

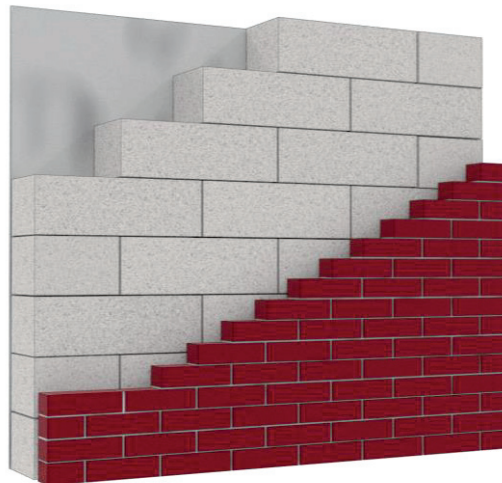
Figure 35. Schematic of a masonry cavity wall with brick veneer as the outer leaf and autoclaved aerated concrete (AAC) as the inner leaf (total thickness of ~ 345 mm). Layers from the right side (exterior): brick masonry veneer (120 mm), air gap (10 mm), AAC (200 mm), and gypsum board (16 mm) [150]

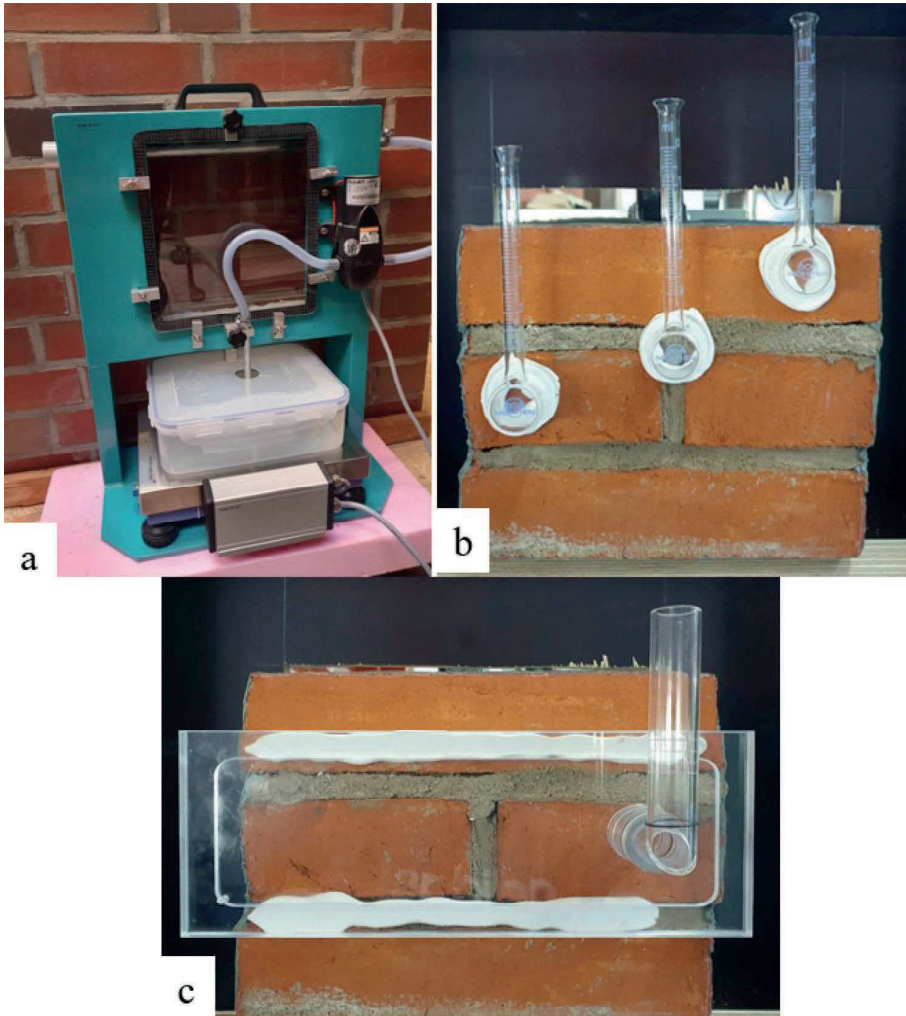
Figure 1. Apparatus and set-up of test methods measuring water absorption; (a) WAM Device, (b) RILEM tube test, (c) Franke Platte.

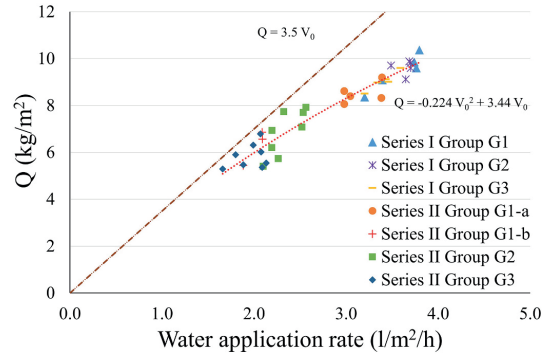
Fig. 6. Water absorption in the first cycle vs. water application rate, V₀.

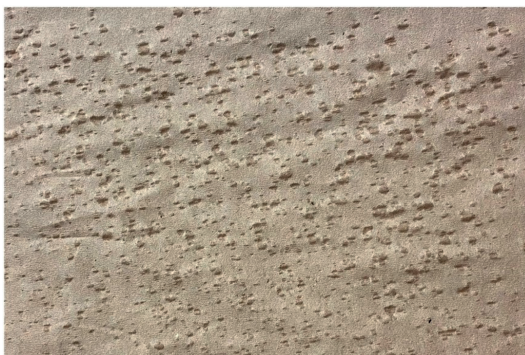
Fig. 13. Wet dots on a paper sheet exposed to water spray for 1–2 s.

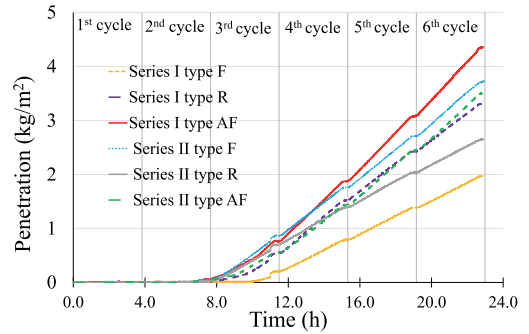
Fig. 4. Average water penetration vs time response.

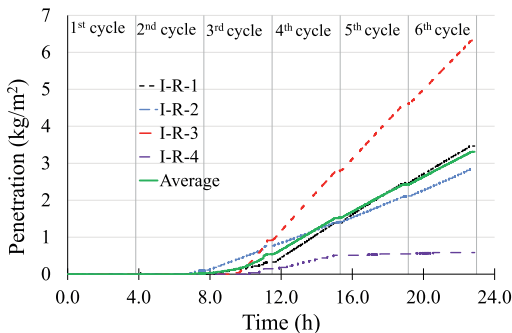
Fig. 5. Water penetration in the individual specimens of Series I type R.

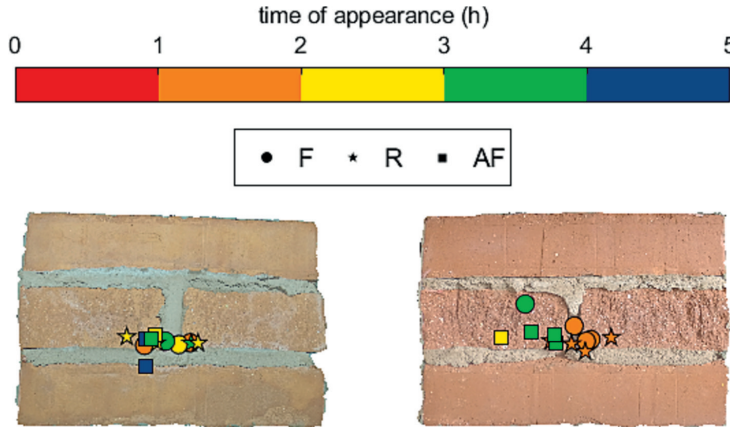
Fig. 6. Time and place at which the first dampness appears on the backside of the specimens.

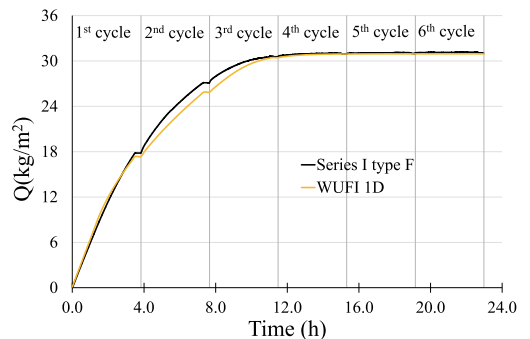
Fig. 8. Validation of the 1D WUFI model of masonry with respect to moisture absorption.

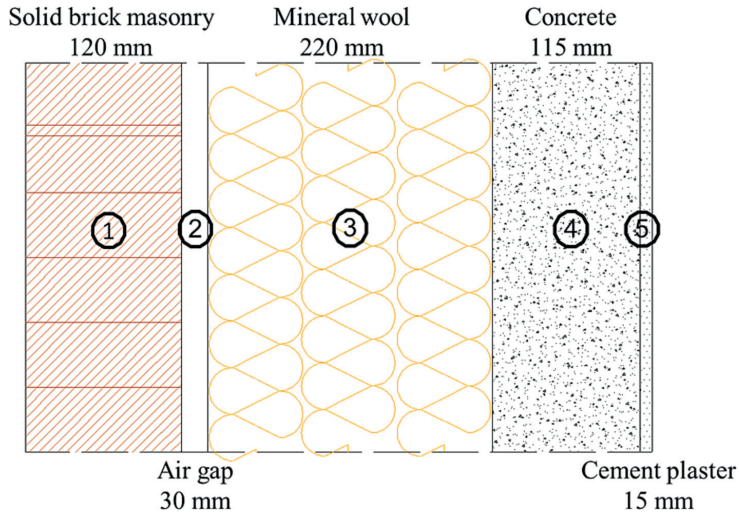
Fig. 9. Layers of the modeled wall in WUFI from outside (left): 1) solid brick masonry (120 mm), 2) air gap with ACH = 30 [1/h] (30 mm), 3) mineral wool insulation with thermal conductivity of 0.04 [W/m²K] (220 mm), 4) concrete C 35/45 (115 mm), and 5) cement plaster (15 mm).

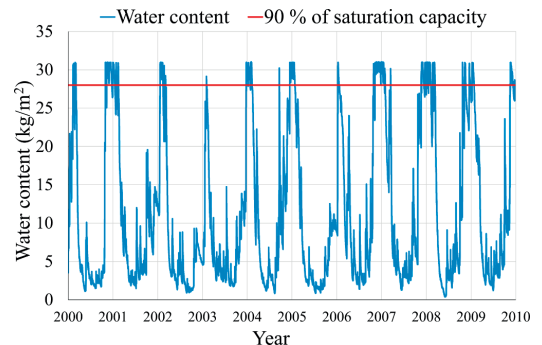
Fig. 10. Water content of masonry cladding in Gothenburg facing south according to simulation with WUFI 1D.

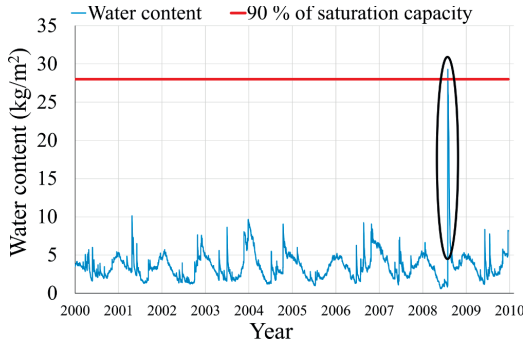
Fig. 11. Water content of clay brick masonry façade facing north in Gothenburg between 2000 and 2009 according to simulation with WUFI 1D.

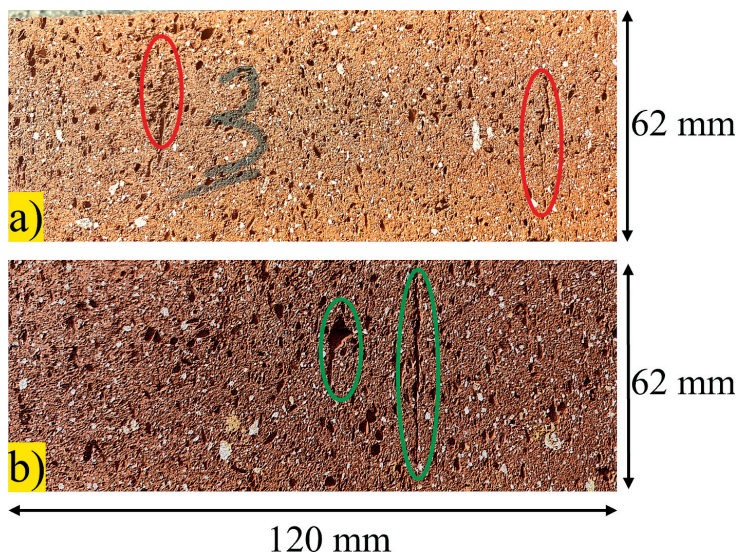
Fig. 12. Presence of micro-cracks in the structure of a) brick type I (saw cut perpendicular to the bed face along the length) and b) brick type II (saw cut perpendicular to the bed face along the width).

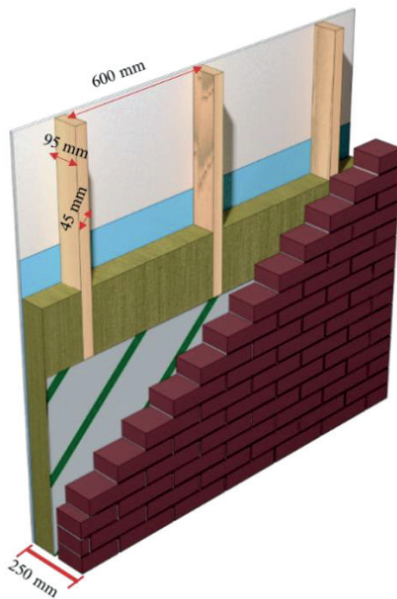
Figure 1. A typical schematic of a timber frame wall with brick veneer built in Sweden (thickness of $\sim 250 \text{ mm}$) modelled in this study. Different layers of the wall assembly and their corresponding dimension from right side (exterior): brick masonry veneer (120 mm), air gap (20 mm), asphalt impregnated paper (1 mm), mineral wool insulation (95 mm), timber studs (95 mm \times 45 mm) with center to center distance of 600 mm, vapor retarder (1 mm), and gypsum board (12.5 mm).

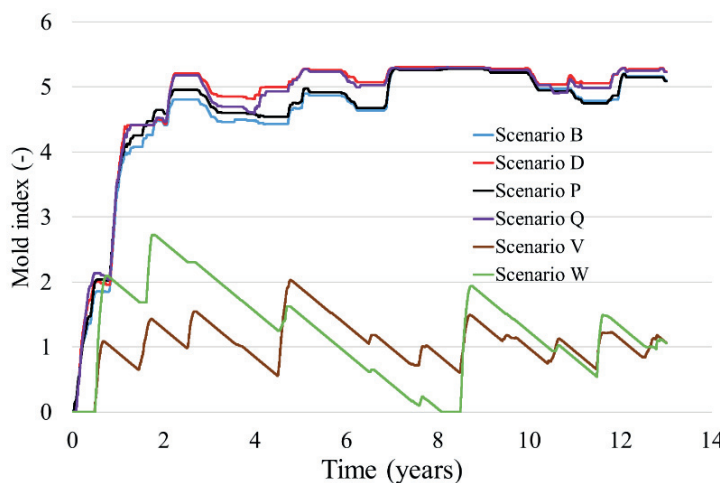
Figure 3. Mold index of scenarios B, D, P, Q, V, and W during the 13 years of the studied period.

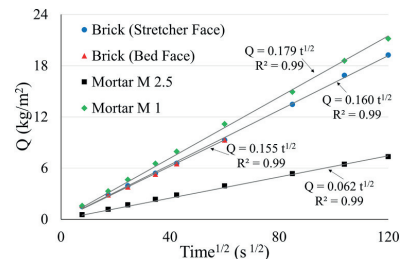
Fig. 1. Average water absorption per unit area, Q (kg/m²) against the square root of time for stretcher and bed face of brick and for mortar M 1 and 2.5 during the initial stage of the test.

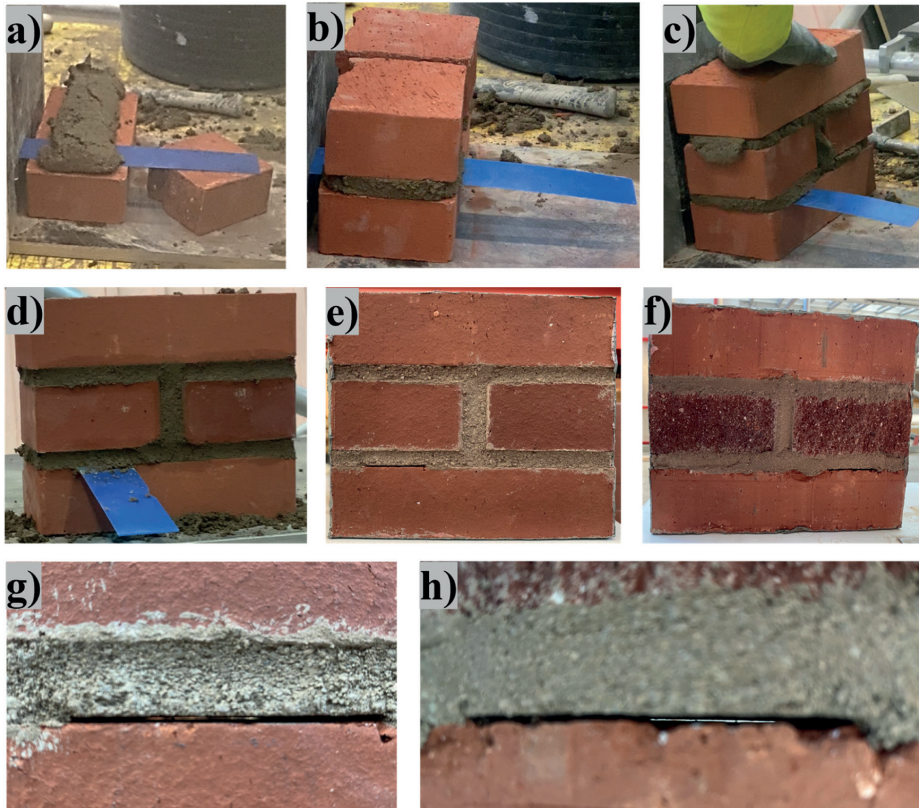
Fig. 2. Preparation of specimens with an artificial crack: a) laying the first brick course and placing a plastic strip to create the crack, b) applying mortar in the first bed joint, c) placing the third brick course, d) a 3-course masonry prism prior to removing the plastic strip, e & f) front view and backside, and g & h) close-up view of the created crack.

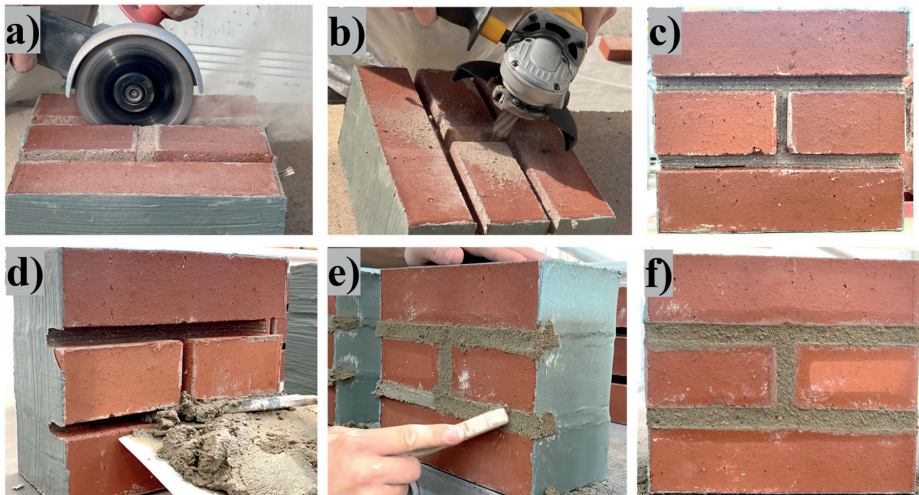
Fig. 3. Different steps of repointing a specimen: a) raking out bed joints, b) raking out the head joint, c) a gently washed specimen after raking, d) applying new mortar, e) compaction of the mortar, and f) a repointed specimen.

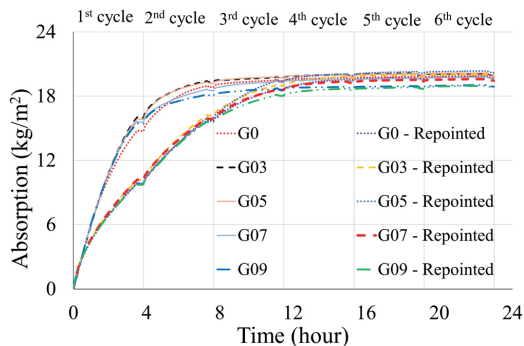
Fig. 5. Average water absorption vs. time response during 23 h of testing for all groups before and after repointing.

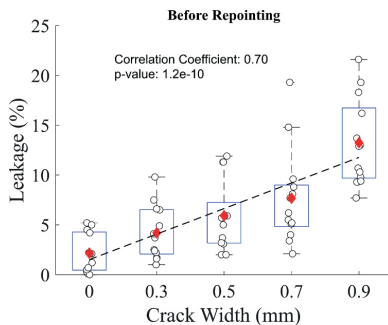
Fig. 10. Leakage (%) for individual specimens before repointing.

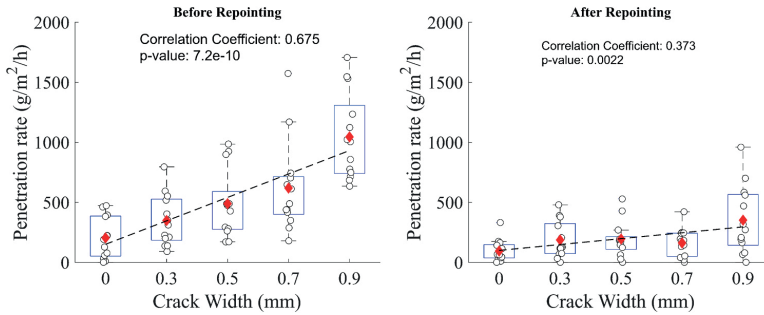
Fig. 11. Water penetration rate in individual specimens before and after repointing.

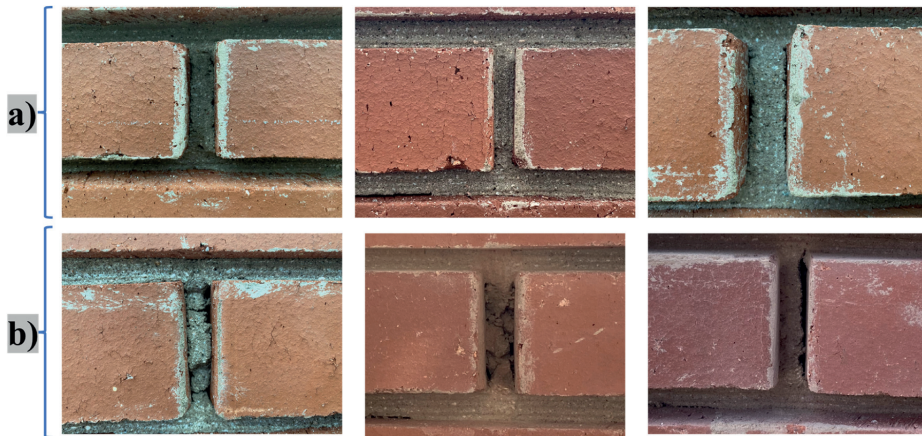
Fig. 12. Condition of head joints after being raked out to 25 mm – 30 mm: a) good/acceptable workmanship and b) poor workmanship.

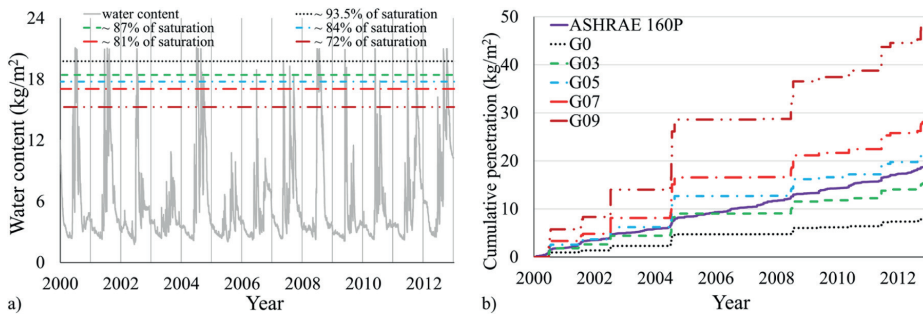
Fig. 17. a) Water content of the studied brick masonry cladding during 2000 – 2012 located in Rensjön and b) using different penetration criteria.

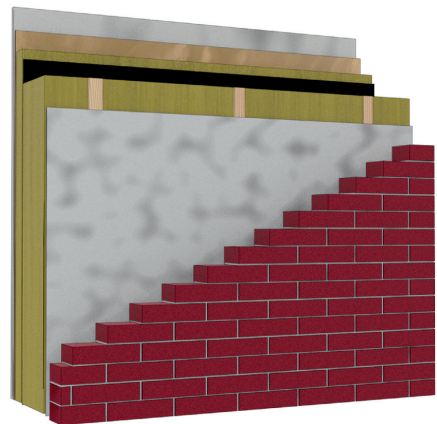
Fig. 1. Schematic of a modern timber frame wall with brick veneer constructed in Sweden (total thickness of approximately 415 mm). The composition from the exterior to the interior includes brick masonry veneer (120 mm), an air gap (30 mm), gypsum board (16 mm), wood fiber insulation (170 mm), a vapor retarder, additional wood fiber insulation (50 mm), oriented strand board (OSB) (12 mm), and another layer of gypsum board (16 mm).

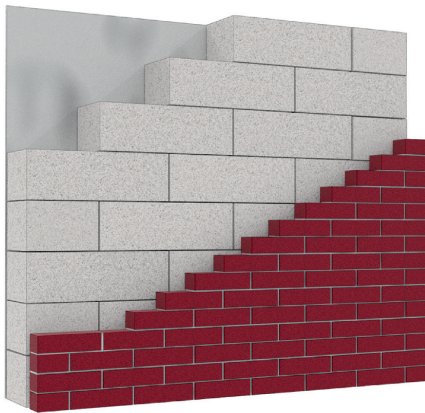
Fig. 2. Schematic of a masonry cavity wall built between 1940 and 1970 in Sweden, featuring brick as the outer leaf and autoclaved aerated concrete (AAC) as the inner leaf (total thickness of approximately 345 mm). From the exterior to the interior, the layers include brick masonry (120 mm), an air gap (10 mm), AAC (200 mm), and gypsum board (16 mm).

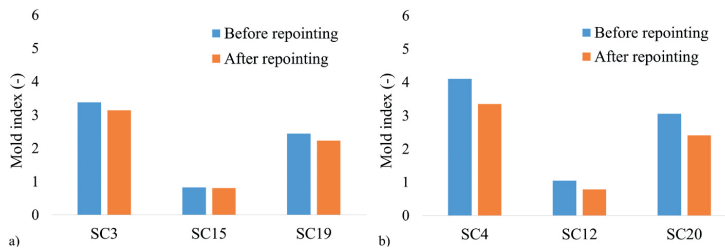
Fig. 4. Mold index before and after repointing for simulation case with the maximum mold index in each location for walls in a) good standard condition and b) deficient condition.

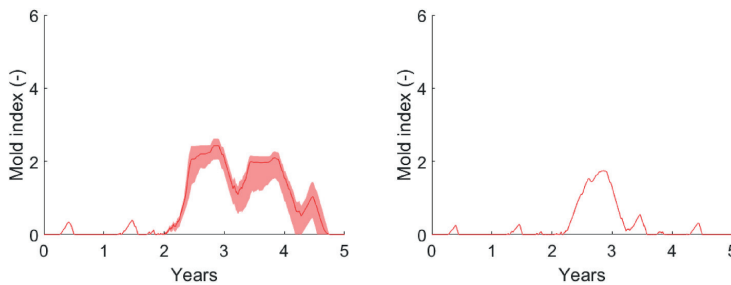
Fig. 5. Interval for possible mold index of 100 scenarios for SC 2 – timber frame wall in Gothenburg, facing north, in deficient condition before (left) and after (right) repointing.

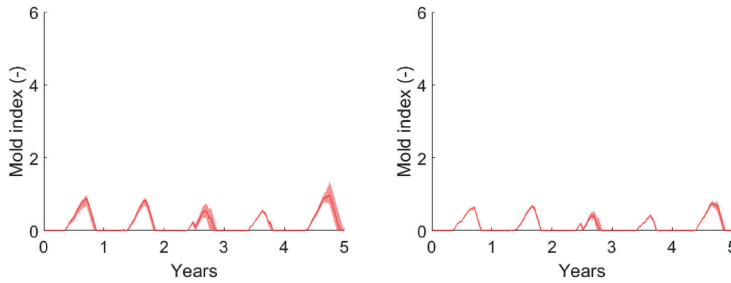
Fig. 6. Interval for possible mold index of 100 scenarios for SC 10 – timber frame wall in Rensjön, facing north, in deficient condition before (left) and after (right) repointing.

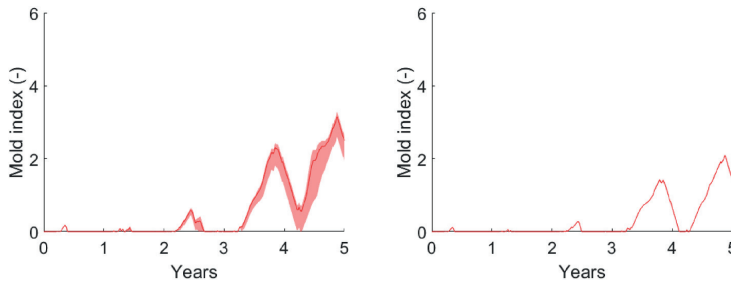
Fig. 7. Interval for possible mold index of 100 scenarios for SC 20 – timber frame wall in Uppsala, facing south, in deficient condition before (left) and after (right) repointing.

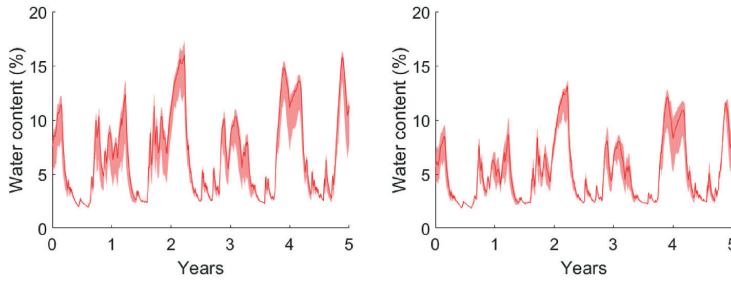
Fig. 8. Range of possible water content for SC 28—a masonry cavity wall in Gothenburg facing south in deficient condition—before (left) and after (right) repointing.

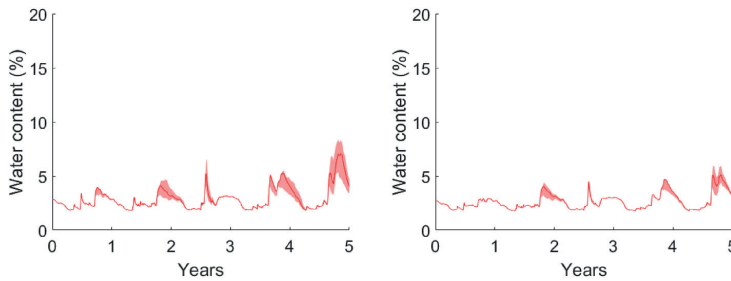
Fig. 9. Range of possible water content for SC 33—a masonry cavity wall in Rensjön facing north in good standard condition—before (left) and after (right) repointing.

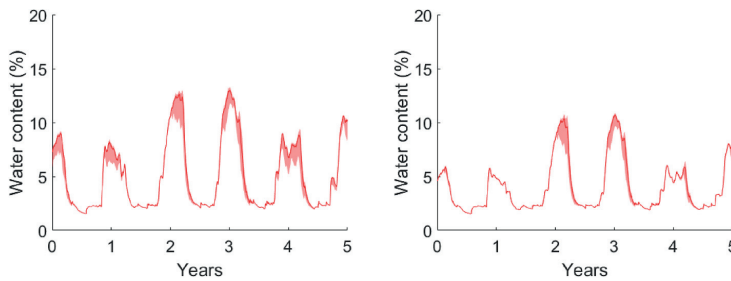
Fig. 10. Range of possible water content range for SC 48—a masonry cavity wall in Uppsala facing east and in deficient condition—before (left) and after (right) repointing.

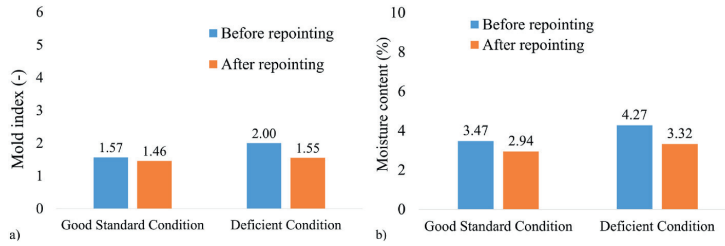
Fig. 11. Impact of repointing on walls classified as good standard and deficient, focusing on a) mold index and b) AAC layer's moisture content.

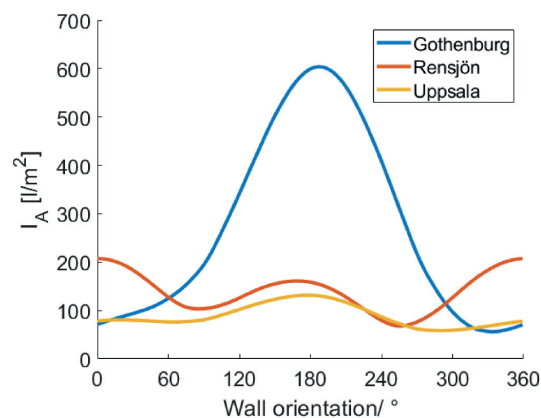
Fig. 12. Average annual WDR for three examined locations, considering different wall orientations (0° north, 90° east), between 2018 and 2023.

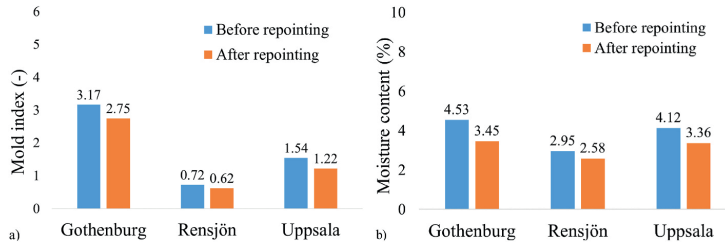
Fig. 13. Results before and after repointing in terms of a) mold index and b) AAC layer moisture content for three studied locations.
