Pluvial flood damage analysis

Case study Trelleborg, Sweden

Pluvial Flood Damage Analysis: A Case Study of Trelleborg, Sweden

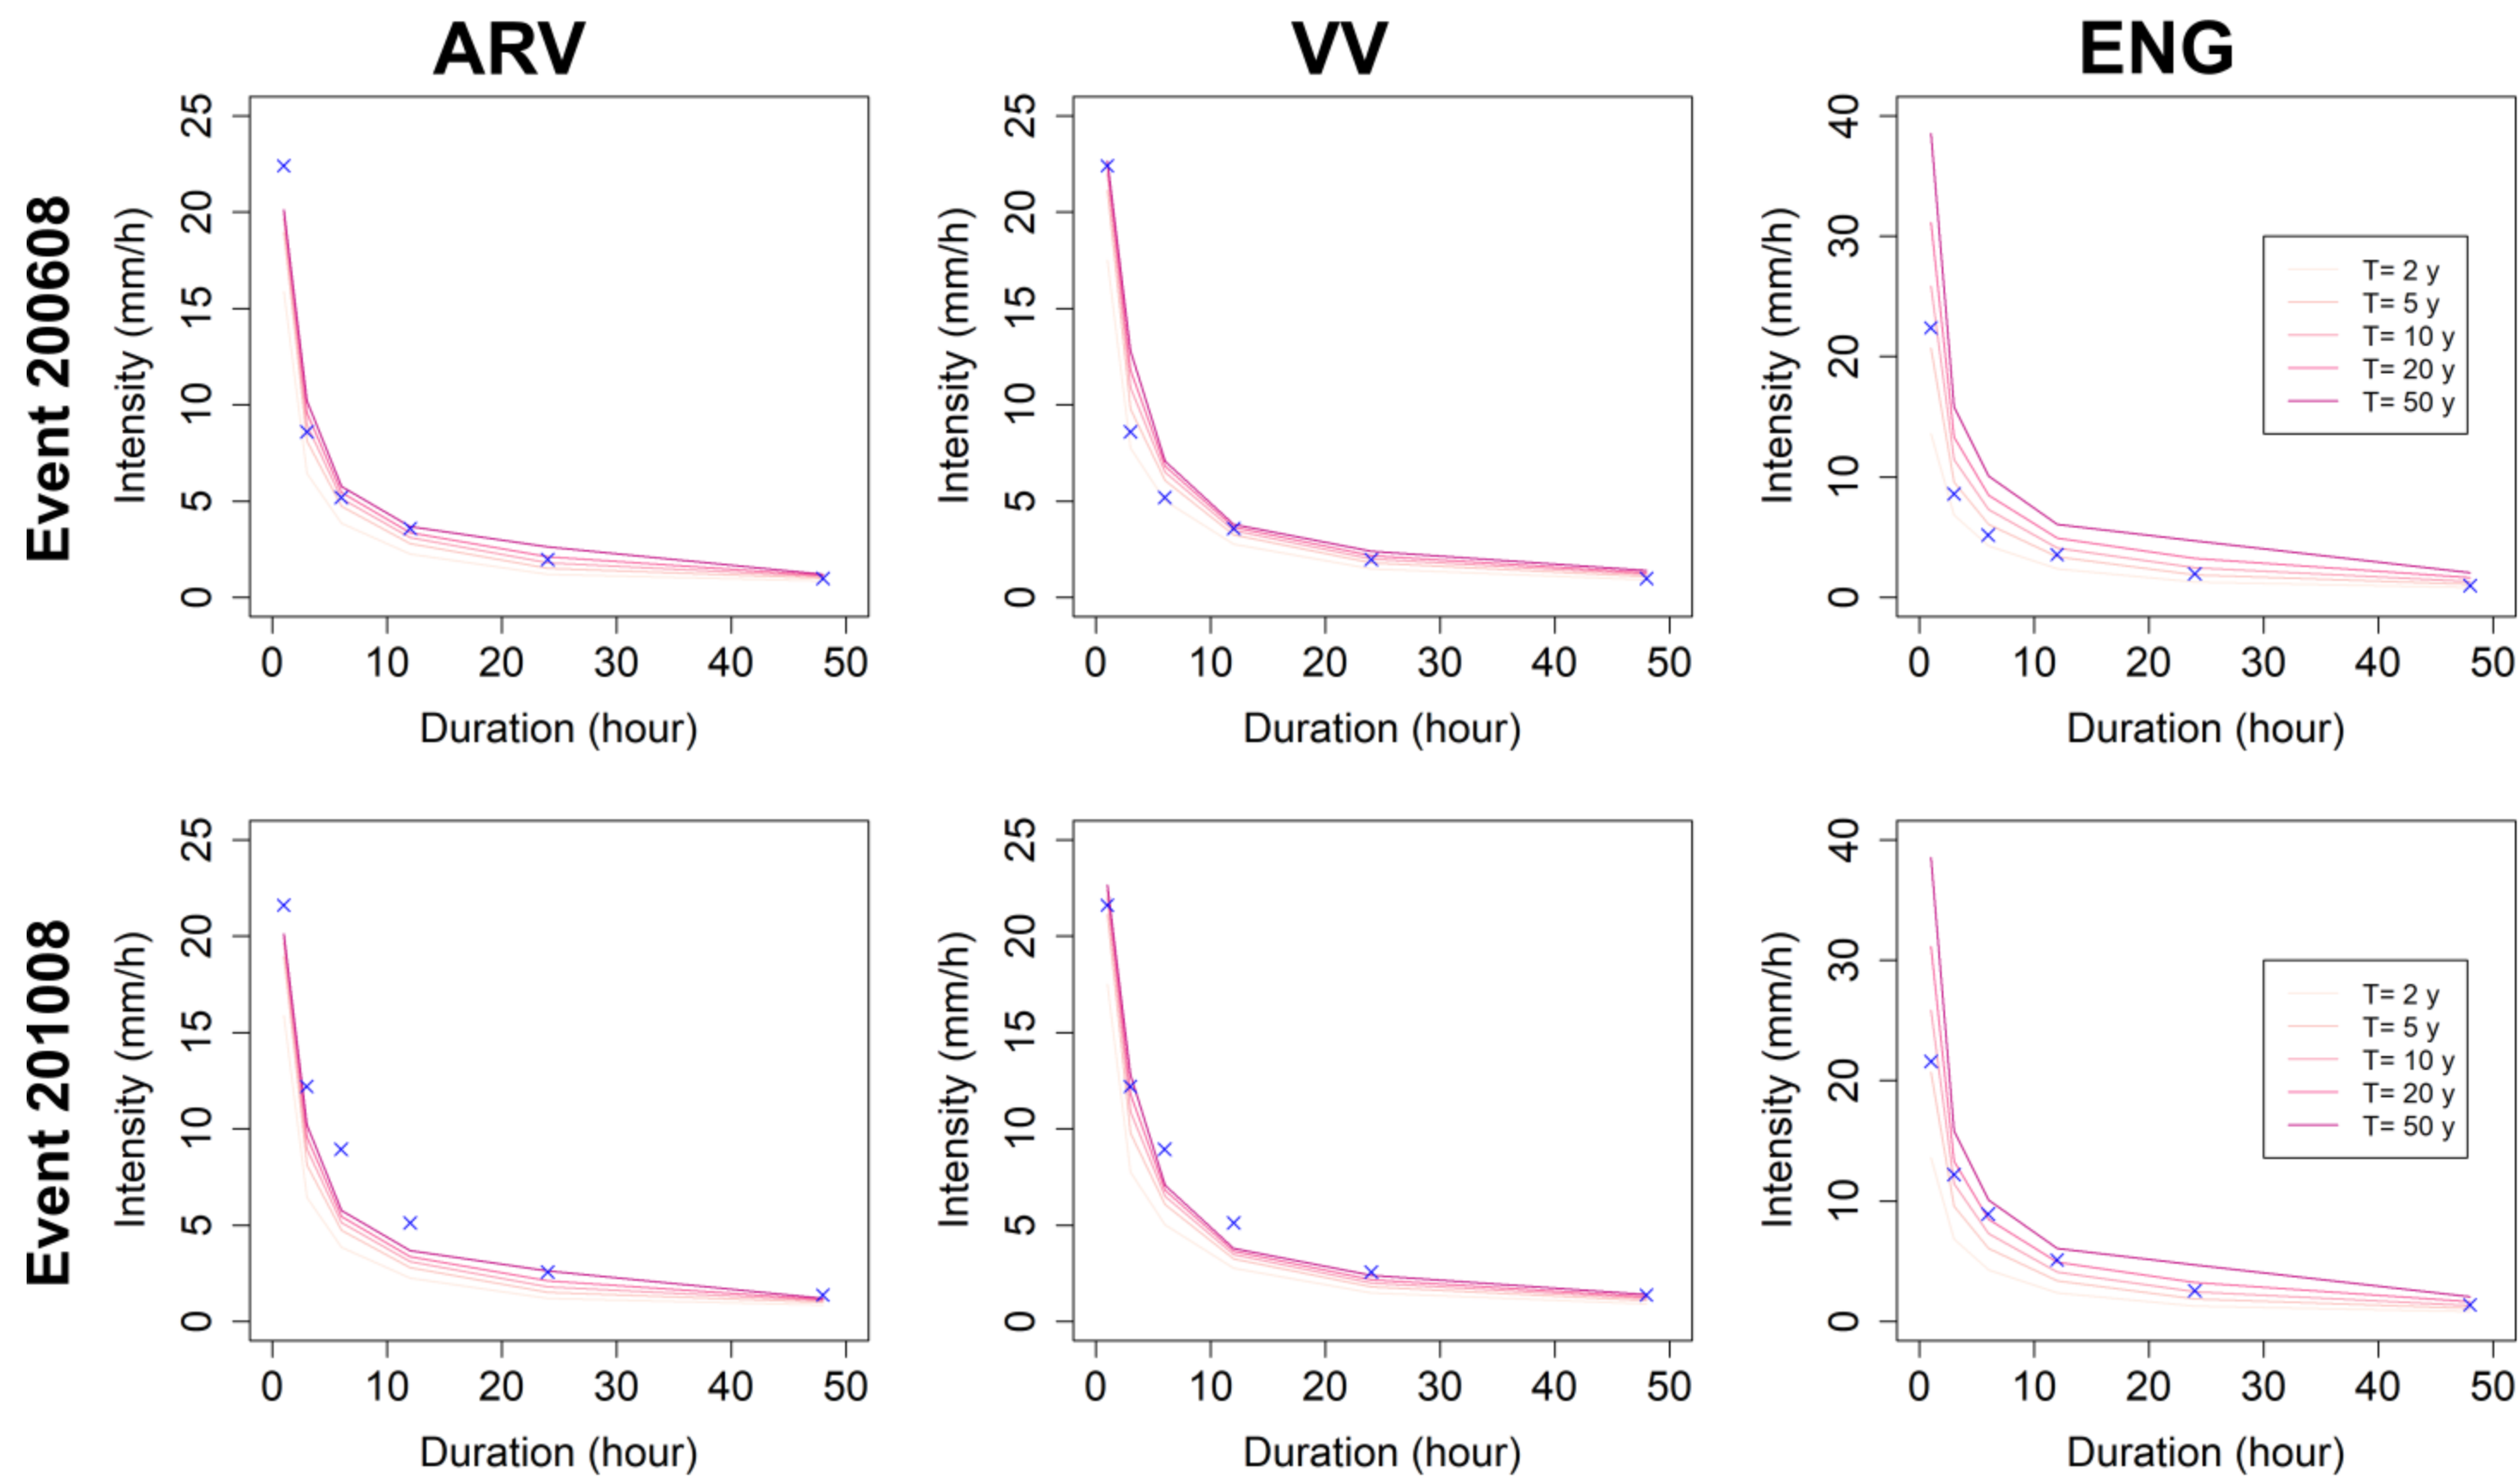
Figure 1 – 2006 and 2010 flood events. Intensity of rainfall event is marked with blue cross in relation to IDF curves .

The 2006 and 2010 flood events both had highly intensive rainfall of varying durations at different location of the city, especially at the short duration (1 hour), which posed challenge to the pipelines, and resulted in a highest number of flooded properties.

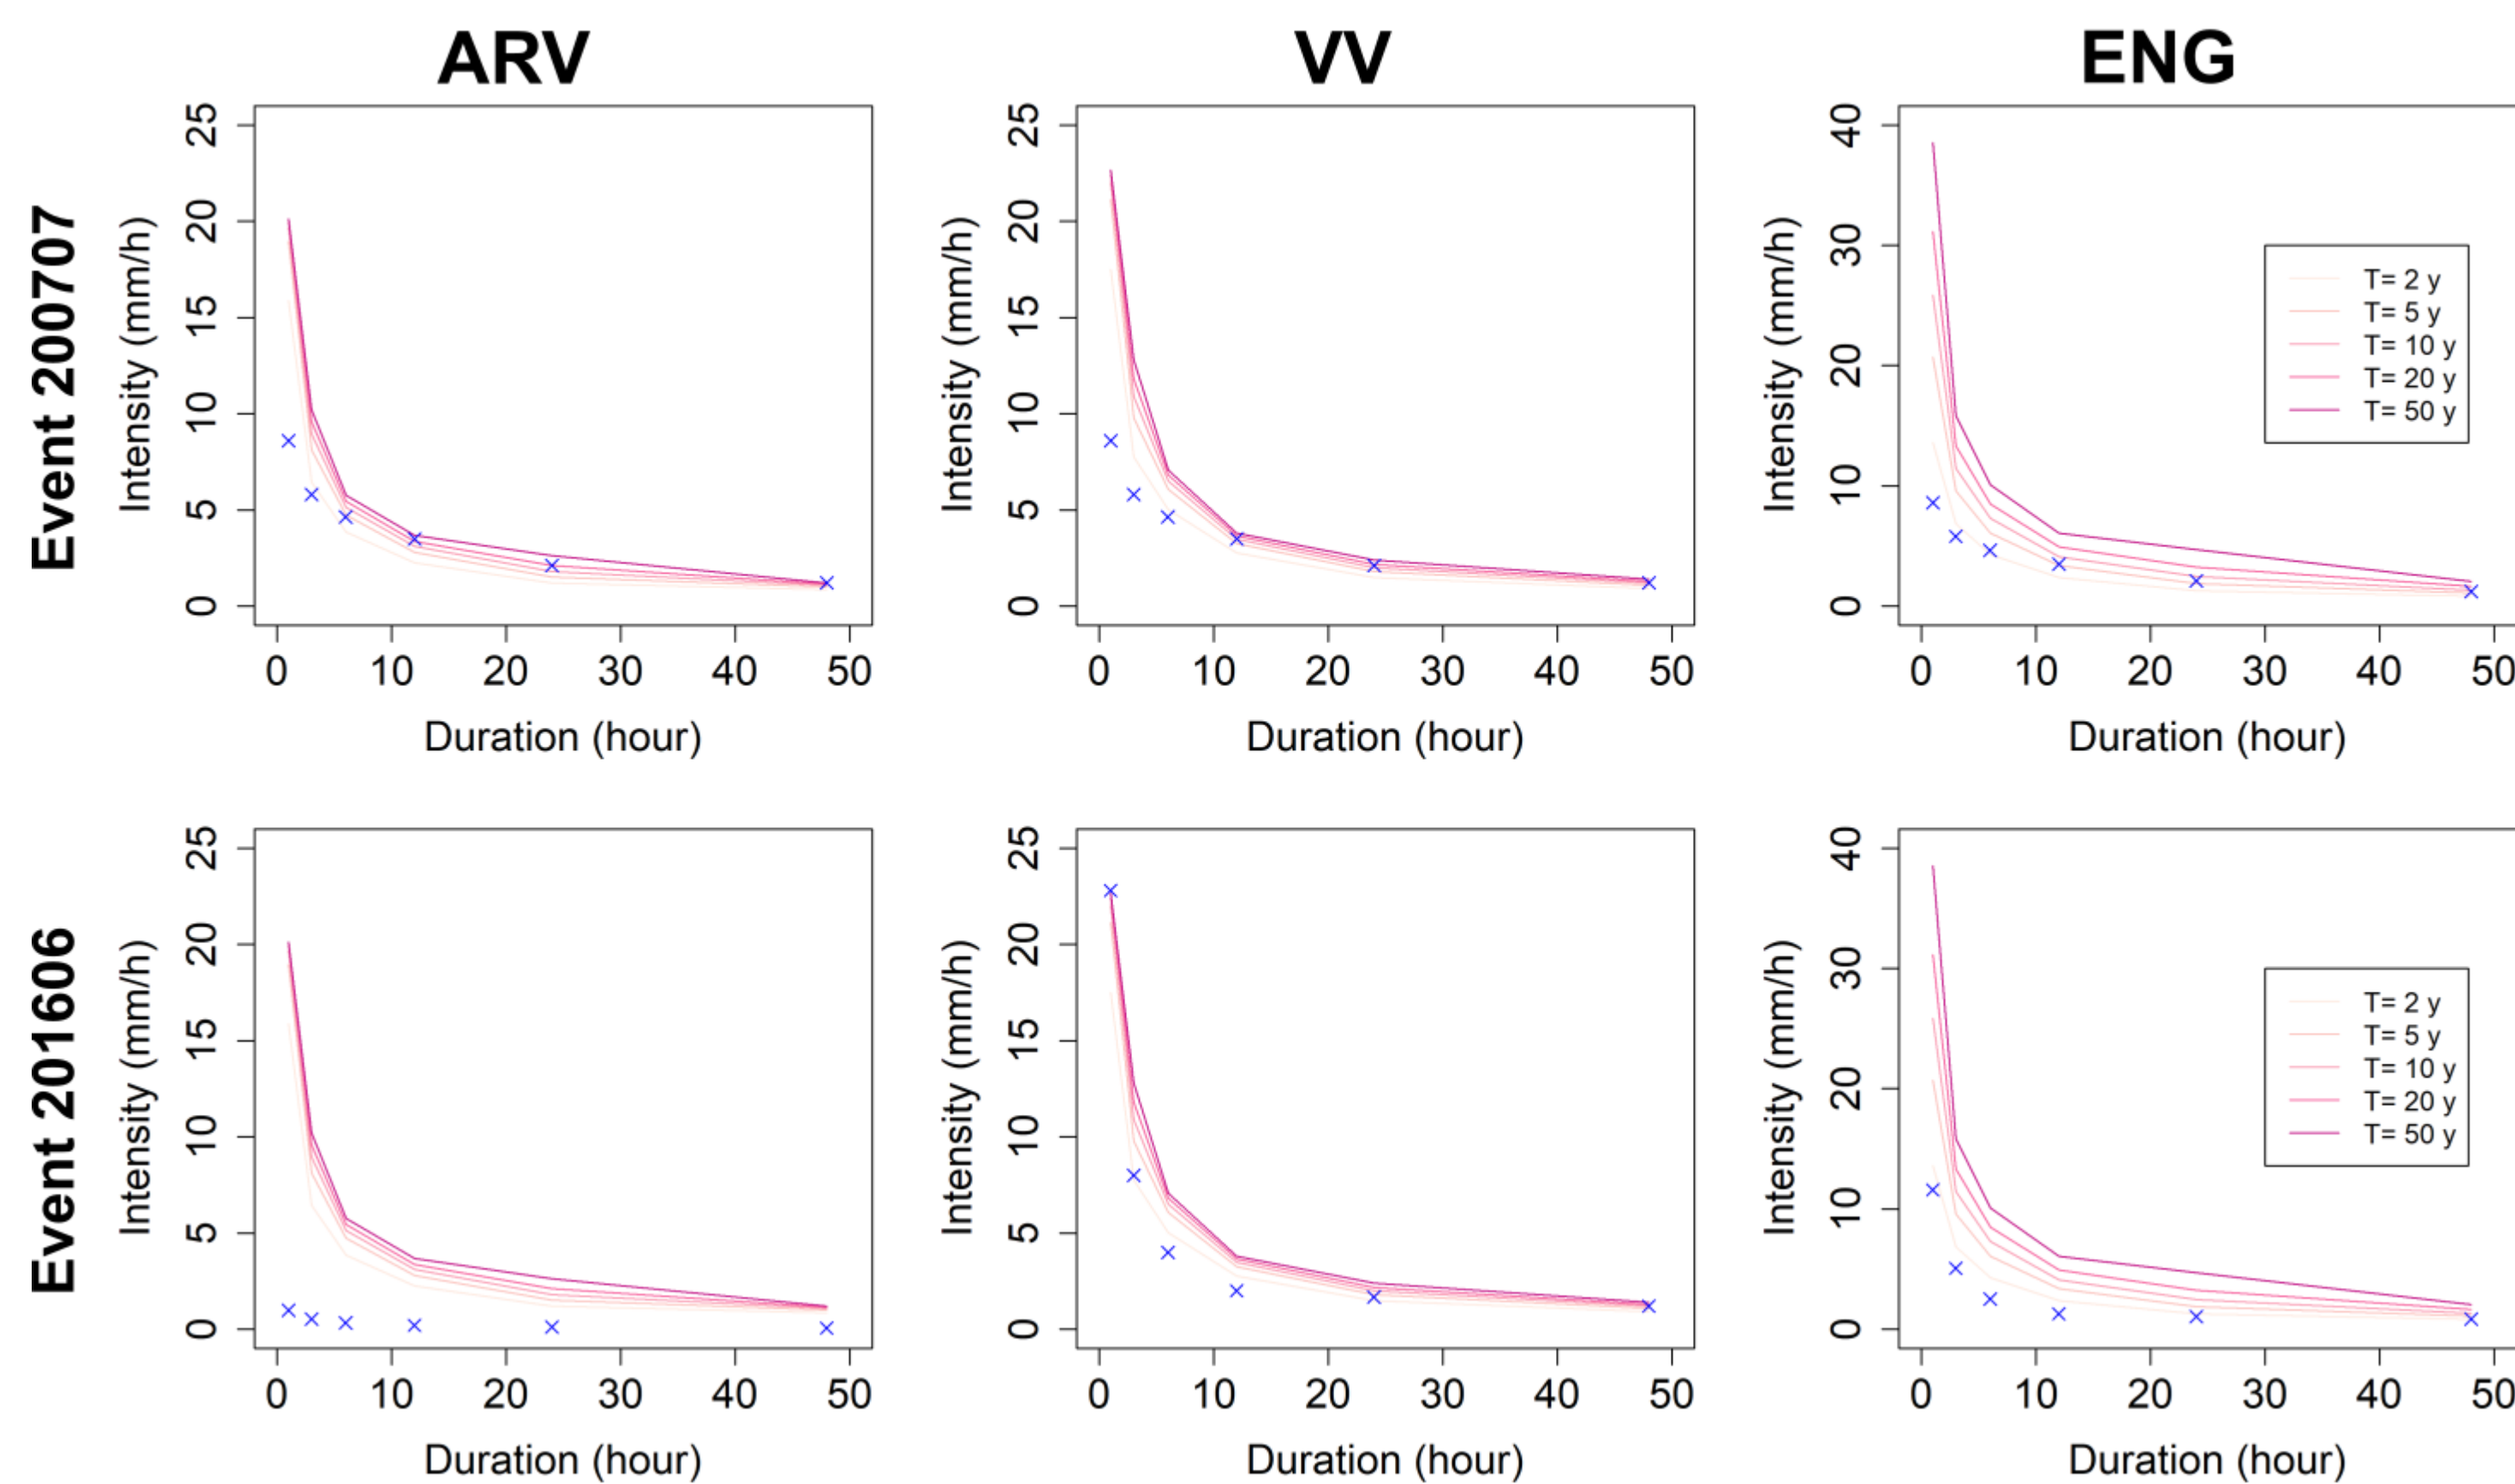
Figure 2 – 2007 and 2016 flood events. Intensity of rainfall event is marked with blue cross in relation to IDF curves.

The 2007 flood did not have a high return period for durations below 12 hours, while the 2016 flood was a small-scale event captured by only one station in the city center (VV). Consequently, neither resulted in a large number of flooded properties.
