# Passive houses in Sweden

From design to evaluation of four demonstration projects

Division of Energy and Building Design Department of Architecture and Built Environment Lund University Faculty of Engineering LTH, 2010 Report EBD-T--10/12

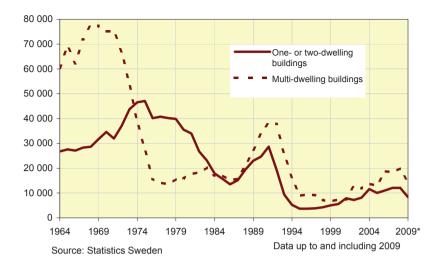
Looking at the statistics of new build residential buildings in Sweden since 1964; the overall production of both apartment buildings and single family houses is currently at a moderate level, as can be seen in Figure 1.1.

*Figure 1.1* New build residential buildings 1964 – 2009 (Statistiska Centralbyrån, 2010b).

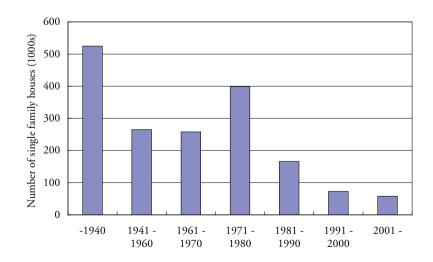
The final years of construction of the single family houses in the Swedish building stock are presented in Figure 1.3. Most single family houses in the Swedish building stock were built before 1940 and during 1960 - 1975, where many were built as a part of "Miljonprogrammet".

Figure 1.3 Final year of construction of the single family houses in the Swedish building stock, 1000s (Statistiska Centralbyrån, 2010b).

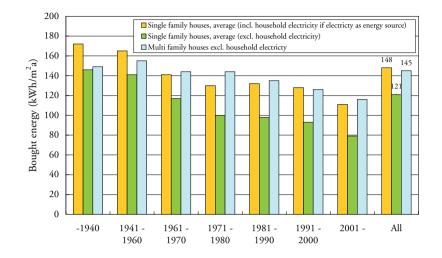
The total use of electricity in the building sector has been on the level of approximately 70 TWh per year since 1990 in figures revised according to degree days. Most of the electricity is used as common electricity in non-residential buildings; annually approximately 30 TWh since 1999. In 2008, the household electricity in single family houses was approximately 6000 kWh per household and year (Statens Energimyndighet, 2009a). Using a living area of 120 m<sup>2</sup> in single family houses (Johansson & Storm, 2001); the annual use of household electricity in single family houses, the use of household electricity was approximately 40 kWh/m<sup>2</sup>a in 2008 (Statens Energimyndighet, 2009c). The energy use for space heating, domestic hot water and household electricity (only included if electricity is the major energy source) in the existing building stock, broken down by final year of construction of the building, is presented in Figure 1.4.

Figure 1.4: Bought energy for space heating, DHW heating and electricity according to final year of construction of the building (Statens Energimyndighet, 2009b and c).

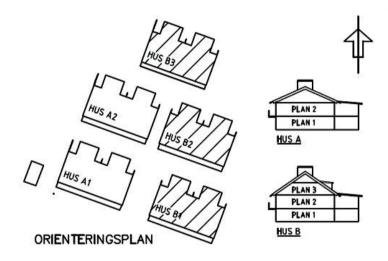
The work from the architect and the structural engineer resulted in a total of 40 apartments located in five separate buildings. Two of the buildings have two floors and three have 2.5 floors. The apartments have two, three, four or five rooms with either a balcony or with a patio on the ground floor (Figure 3.2). The ceiling height in the apartments is 2.50 m, except for the top floor in the buildings with 2.5 storeys, where the ceiling follows the roof slope. To distribute the daylight within the apartments, fanlights are placed over the interior doors, between rooms.

*Figure 3.2 Plan of the Oxtorget area and sections of the buildings (Drawing: bsv arkitekter).*

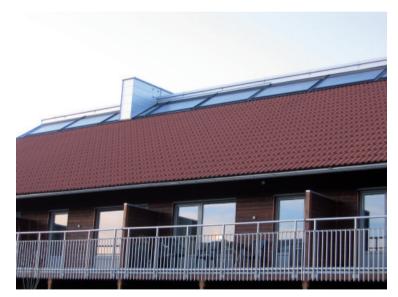
All five apartment buildings have solar collectors on the roof connected to a central room for domestic hot water production, one in each building, see Figure 3.3. There are  $25 \text{ m}^2$  of solar collectors on each building. The solar fraction was assumed in the planning process to be 50%. Additional heat for domestic hot water is supplied from an electric battery in the accumulator tank.

Figure 3.3 Solar collectors.

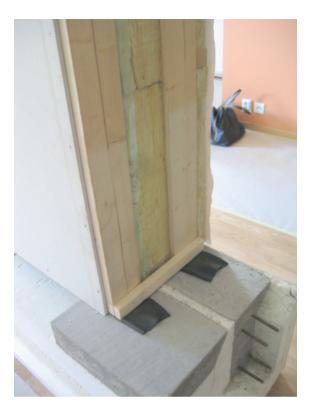
The full scale models of the roof, outer wall and foundation construction used on this day of education were kept on site, see Figure 3.5. The carpenters looked at these together with the drawings before working. These models were much appreciated by the contractors.

Figure 3.5 Model of wall and ground construction with the eps-insulation at bottom, the double concrete ground construction and the long side wooden wall.

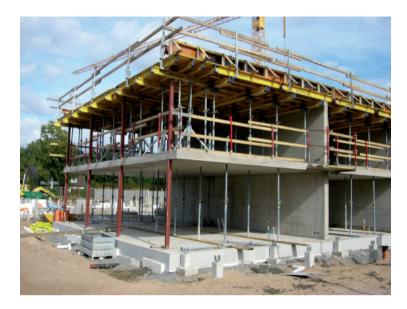
To cast concrete walls on site was more common about ten years ago and the contractor said to prefer using prefabricated concrete constructions, which was more commonly used by the contractor. The client insisted on casting the load bearing structure on site and in the planning process additional time was reserved to cover for uncertainties in this casting process. However, the work went very smoothly and the casting took much less time than assumed, saving not only time but money.

Figure 3.7 Concrete construction cast on site.

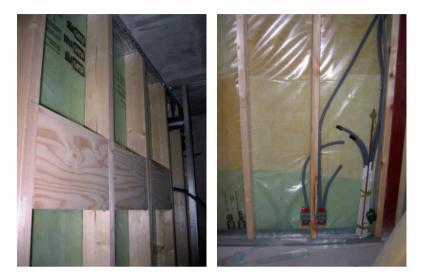
The placing of the plastic foil in the wall construction creates an installation layer of 120 mm that makes it easy to avoid damage to the plastic foil when mounting pipes and electrical equipment, see Figure 3.9.

Figure 3.9 Installation layer.

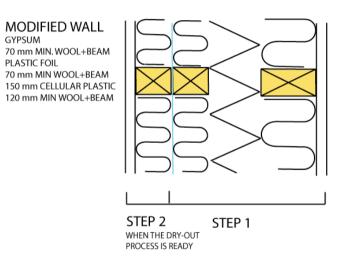
To mount the wooden walls from the outside was something the carpenters said was irrational. They thought it was especially inconvenient to work from the outside when pulling the plastic foil in front and behind the sills. The carpenters suggested a revised wall construction, as presented in Figure 4.11, where construction of the wall started outside and then work continued from the inside.

Figure 3.11 Suggested outer wall construction.

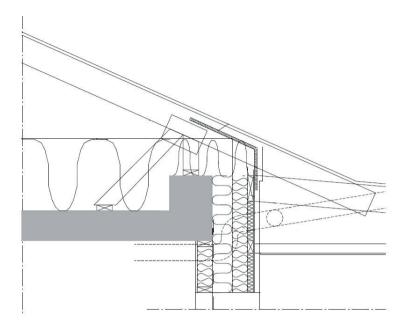
The remaining two buildings built in two storeys had a horizontal ceiling where the loose wool insulation was placed in the attic in a ventilated construction, see Figure 3.13.

Figure 3.13 Roof in building with two storeys (Drawing: bsv arkitekter).

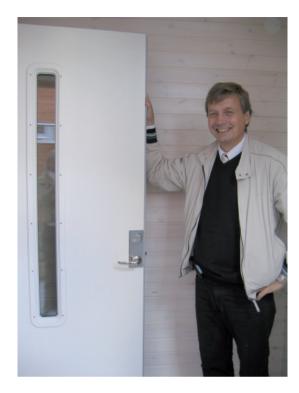
It was very difficult to find an entrance door on the Swedish market that had the requested U-value of 0.6 W/m<sup>2</sup>K. There were entrance doors with a sufficiently low U-value available on e.g. the German market, but German doors open inward and Swedish entrance doors must open outward. Therefore, the general manager of Finnvedsbostäder made his own door design and produced it at one of the largest Swedish door companies (Figure 3.14). The windows used in the project had a mean U-value of  $0.94 \text{ W/m}^2\text{K}$ .

*Figure 3.14 Per-Magnus Rylander working at Finnvedsbostäder and the entrance door.*

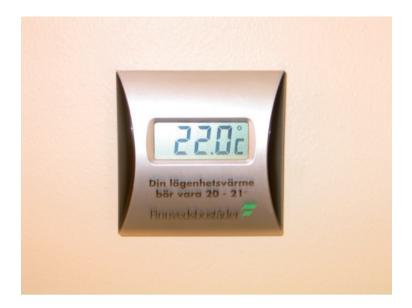
The indoor temperature is planned to be 20°C but can be set higher if required by the tenants. To help the tenants to know if their indoor temperature is at 20°C and therefore their energy bill will be low, there is a display mounted on the wall, one in each apartment, showing the indoor temperature, see Figure 3.15. For higher temperature in the bathrooms, there is an electrically heated towel rail in each bathroom. The towel rail has a timer, to make sure it is only switched on for maximum one hour.

Figure 3.15 Display showing the temperature in each apartment.

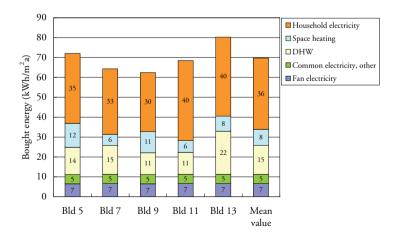
The annual measured bought energy demand in the five apartment buildings is presented in Figure 3.21, together with the measured mean energy use for the area with five buildings, broken down by different energy items.

Figure 3.21 Measured total annual energy use in the five buildings during the period 070201 to 080201.

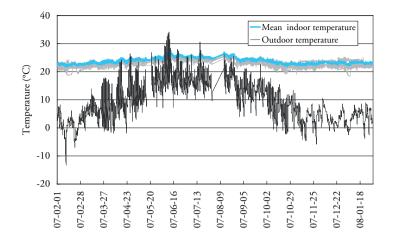
The variation of the indoor temperatures in the different apartments together with the outdoor temperature is presented in Figure 3.27. Due to troubles with some of the meters, some data are missing during the summer months, as can be seen by a straight line in Figure 3.27. Measured temperatures are missing during the periods 070515-070521 and 070731 – 070813. In the graph, the missing temperatures are replaced by mean values of the measured temperatures right before and right after the meter was broken.

Figure 3.27 Indoor and outdoor temperature during 070201 - 080201.

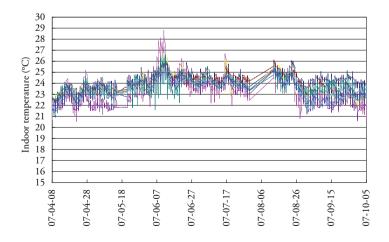
The mean value of the indoor temperatures measured in each apartment varies between 20.6°C and 26.5°C. The measured indoor temperature did not exceed 30°C in any of the apartments. This might be due to the well thought-out solar shadings in all buildings that protect the apartments from too much solar radiation and thus excessive indoor temperature in summer. The measured indoor temperature during summer in the eight apartments varies as presented in Figure 3.28.

Figure 3.28 Measured indoor temperature in eight apartments during spring, summer and autumn 2007, with missing temperatures during time period 070515-070521 and 070731 – 070813.

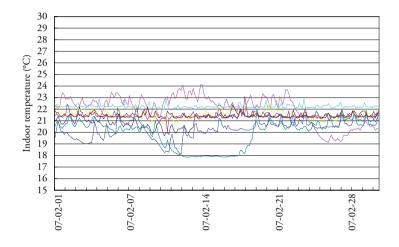
The lowest outdoor temperature during the year of measuring was on February 11, 2007, with a measured temperature of -14.7°C. The indoor temperature in the eight measured apartments during February 2007 is presented in Figure 3.29. The lowest outdoor temperature was reached on February 11 but the lowest indoor temperatures were measured on February 13 and 14, which is a result of the thermal inertia of the building construction.

Figure 3.29 Indoor temperature in eight apartments during February 2007.

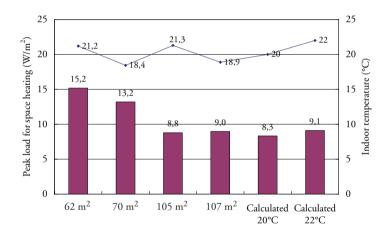
The peak load for space heating was measured in four apartments in building 13 during the period 070201 – 080201 with a measured mean value of 10.9 W/m<sup>2</sup> (Figure 3.26). The measurements and the calculated values at an indoor temperature of 20 °C and 22 °C are presented in Figure 3.31, together with the indoor temperature in each apartment measured at the time for peak load for space heating.

Figure 3.31 Peak load for space heating (bars) and indoor temperatures (curve) in four apartments during the period 070201 – 080201 together with calculated values at indoor temperatures of 20 °C and 22 °C.

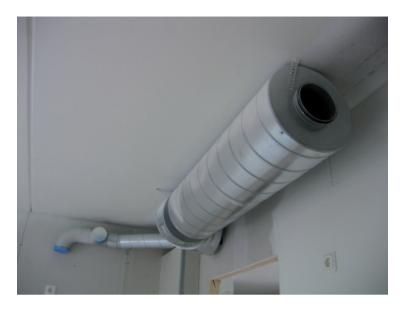
To avoid internal noise from the air supply unit, adequate silencers were mounted in the ventilation system; two on the supply air system and one in the exhaust air system, mounted close to the ventilation unit, see Figure 4.3.

Figure 4.3 Silencers mounted in the ceiling in the apartments in Frillesås.

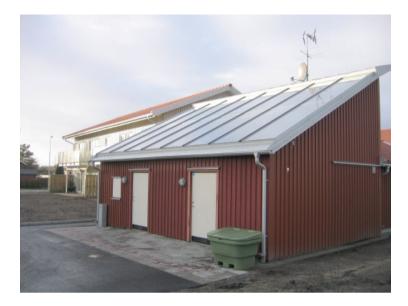
The domestic hot water is prepared by solar collectors mounted on the roof of a separate apparatus building; the "Heating centre" in Figure 4.1. All pumps and water heaters as well as the electricity distribution board for all buildings are placed in the apparatus building. Approximately 52  $m^2$  of solar panels were mounted on the roof, see Figure 4.4.

Figure 4.4 Solar collectors on the roof of the apparatus building.

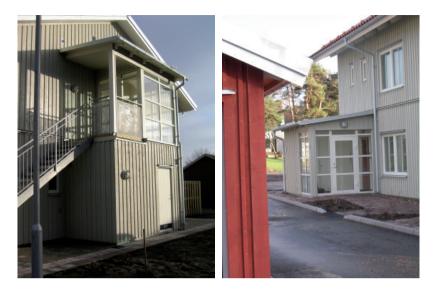
Figure 4.6 Glazed vestibules, Frillesås.

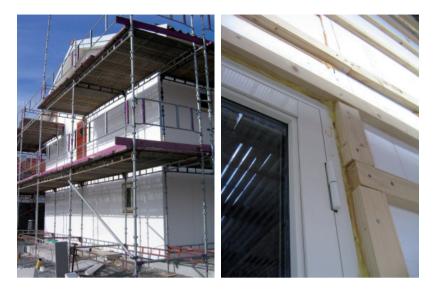
Figure 4.8 Outer walls covered by expanded polystyrene insulation (EPS).

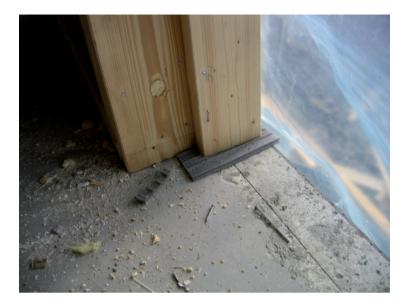
Figure 4.9 Moisture protection below the wooden sill construction.

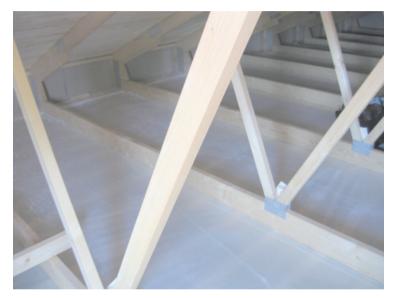
Figure 4.10 The attic, before the insulation was put in place.

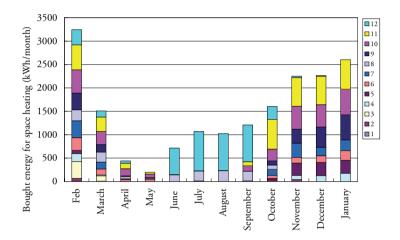
Figure 4.15 Bought energy for space heating during 070201 – 080201.

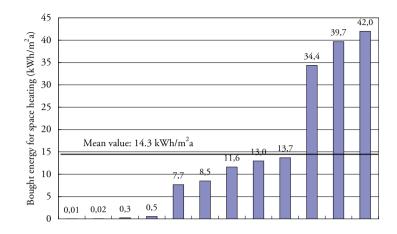
*Figure 4.16* Bought energy for space heating during the period 071110 - 081110.

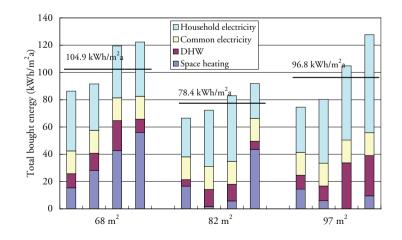
Figure 4.29 Bought energy broken down by the three different heated floor areas.

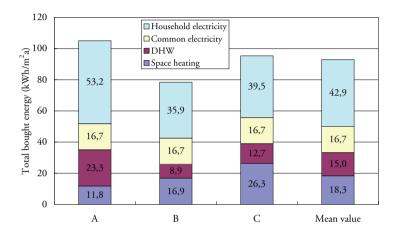
Figure 4.30 Bought energy broken down by the three different buildings, presented together with the mean value of the buildings.

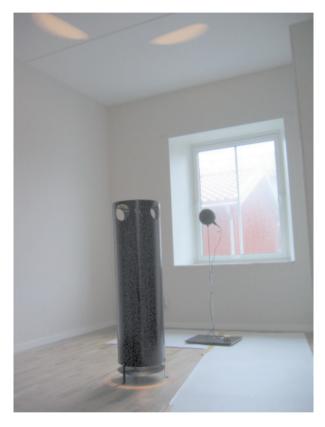
Figure 4.39 Measurement of operative temperature in one bedroom in the test apartment.

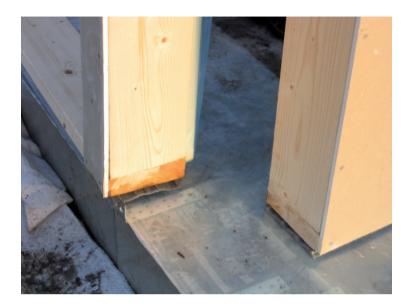
Figure 5.7 Moisture protection of wooden beam construction.

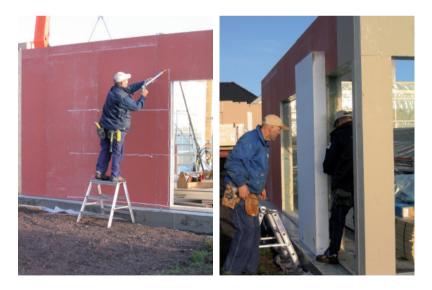
Figure 5.8 Polystyrene glued on the gypsum board.

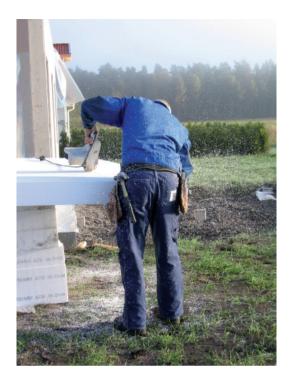
Figure 5.9 Polystyrene sawn up on site.

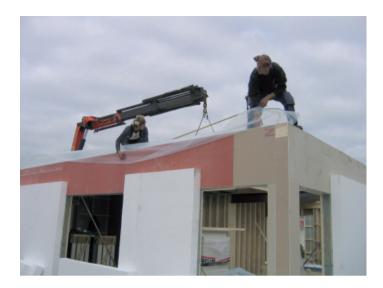
*Figure 5.10* Floor mounted on top of the walls with carful folding of the plastic foil.

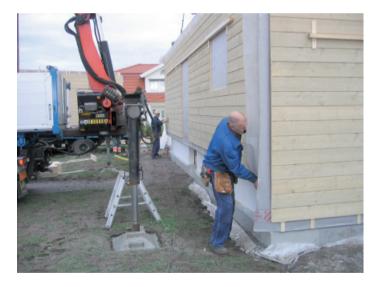
Figure 5.11 Outer wall slab mounted on the outside of the EPS insulation.

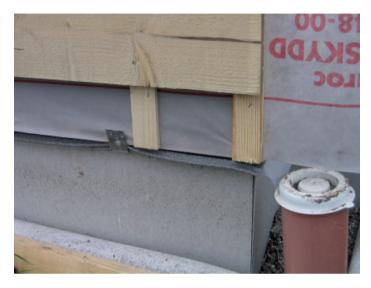
Figure 5.12 Lowest wooden panel detached to facilitate the mounting process.

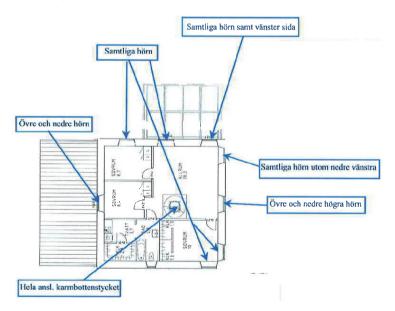
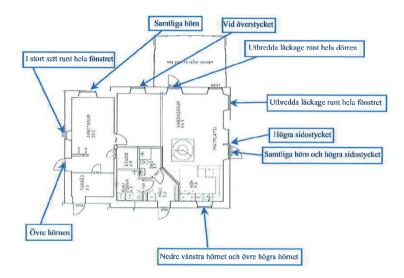
*Figure 5.17 Air leakage detected on first and second storey (Illustration: SP Sveriges Tekniska Forskningsinstitut).*

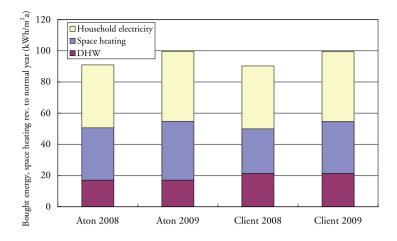
When the energy for space heating is revised according to a normal year as presented in Subsection 5.10.5, the total bought energy in 2008 and 2009 varies according to Figure 5.22.

*Figure 5.22 Total annual bought energy, Villa Malmborg, space heating revised according to a normal year.*

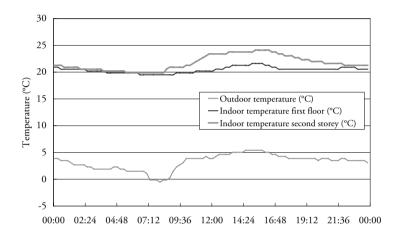
Figure 5.24 Indoor temperatures on both storeys and outdoor temperatures in February 14 2008.

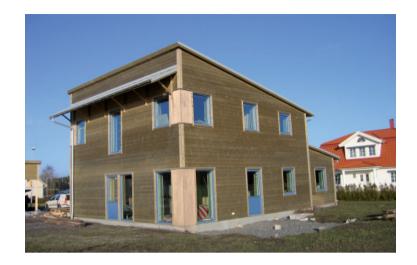
Figure 5.27 Lack of solar shadings on eastern façade.

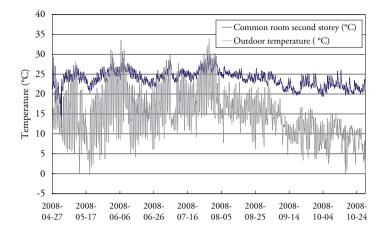
*Figure 5.28* Indoor temperatures in common room and the outdoor temperature, May 2008 – October 2008.

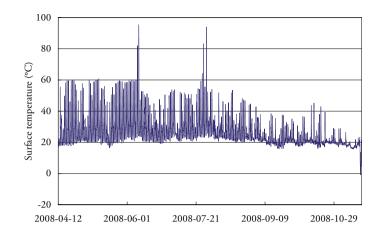
*Figure 5.29 Surface temperature on inner pane of window facing east in common room second storey.*

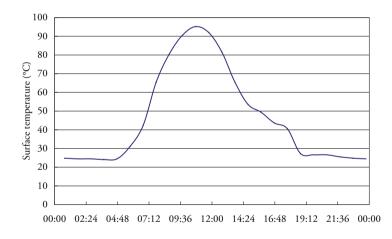
Figure 5.30 Surface temperature of inner pane on June 9 2008.

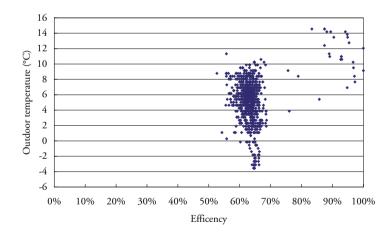
Figure 5.31 Efficiency of the heat exchanger based on exhaust air at different outdoor temperatures, February 6 - 23, 2008.

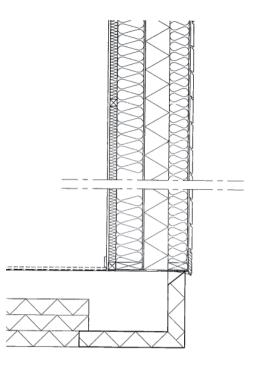
Figure 5.35 Foundation construction (Drawing: Vårgårdahus).

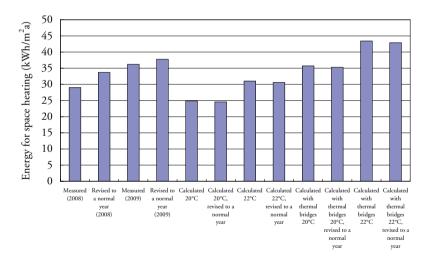
Figure 5.40 Measured and simulated energy demand for space heating.

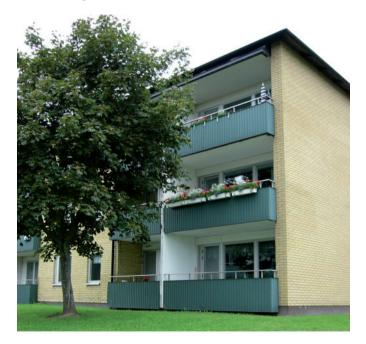
Figure 6.7 Original balcony construction inset into the apartments.

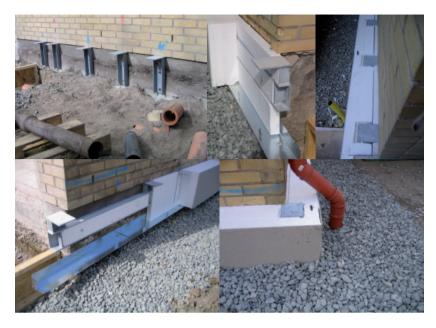
Figure 6.14 Thermal bridge insulation around foundation slab construction.

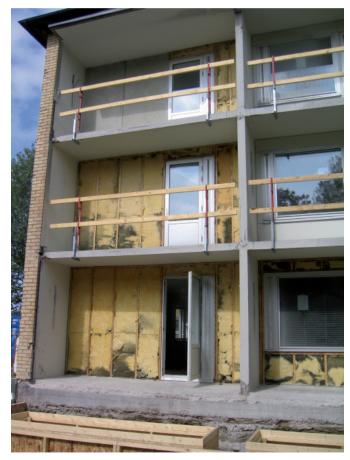
Figure 6.16 Discoloured mineral wool insulation.

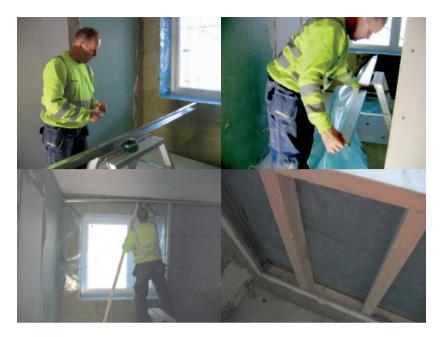
*Figure 6.18 Mounting of plastic foil and wooden beams, creating an installation layer.*

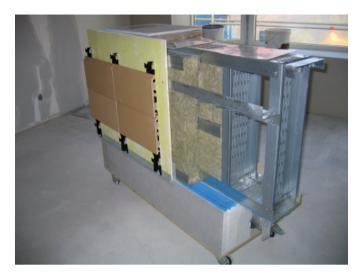
Figure 6.19 Model of exterior long side wall.

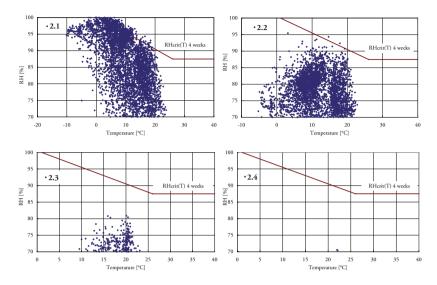
Figure 6.31 Relative humidity and temperatures in the four measuring points during the measuring period 081225 – 09122. Each point in the graph represents a mean measured value for one day and night (24h).

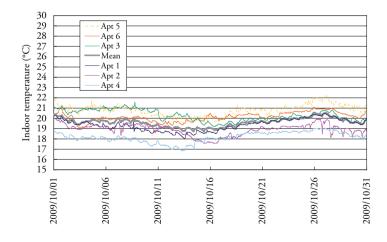
*Figure 6.37 Measured indoor temperatures in six apartments during October 2009.*

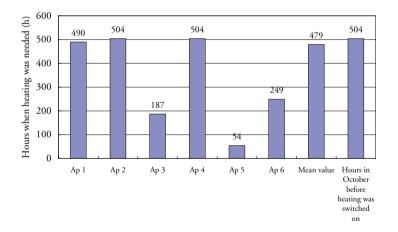
Figure 6.38 Number of hours when the indoor temperature was below 20°C and additional space heating was needed in the six measured apartments together with the total number of hours before the heating distribution was switched on.

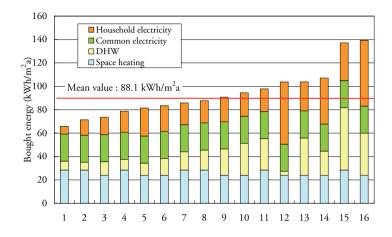
*Figure 6.42* Total annual bought energy, broken down by different energy items during the measuring period 090401-100401.

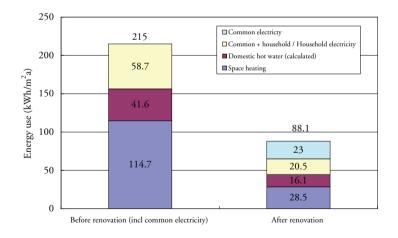
*Figure 6.43 Measured annual bought energy before (2004) and after renovation* (090401 – 100401).

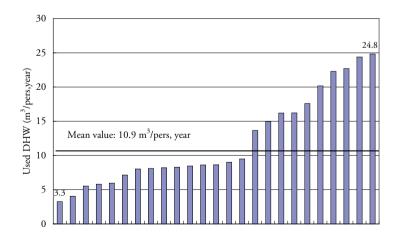
*Figure 7.2* Annual used volume of domestic hot water per person in 25 households in the four demonstration projects .

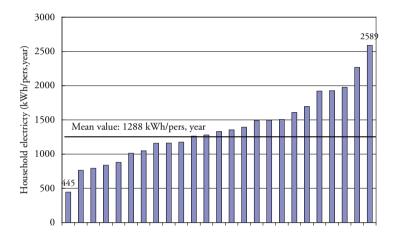
Figure 7.5 Annual use of household electricity.

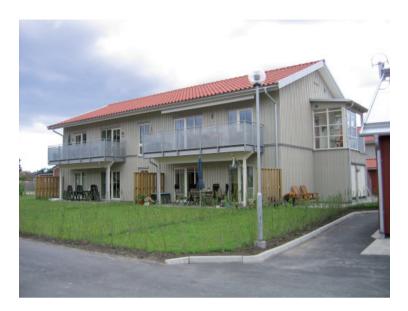
Figure 8.1 Measurement of the solar radiation in Frillesås, metering device mounted on apparatus building far to the right in the picture.

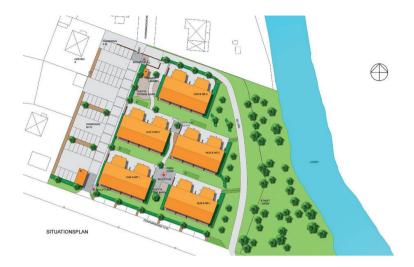
Figure 8.6 Site plan of the Oxtorget area (Drawing:bsv arkitekter).

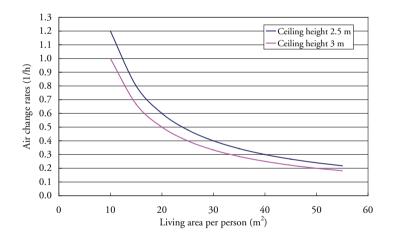
Figure 9.1 Air change rates per person with a ceiling height of 2.5 and 3 m and an air change rate of  $30 \text{ m}^3/h$  per person.
