Dense resistivity and induced polarization profiling for a landfill restoration project at Härlöv, Southern Sweden

Virginie Leroux, Torleif Dahlin and Mats Svensson
Waste Management Research 2007; 25; 49
DOI: 10.1177/0734242X07073668

A resistivity and time-domain induced polarization (IP) survey was conducted at a landfill site under restoration at Härlöv in Southern Sweden. The covering of the landfill had begun some years ago, without keeping precise records of the work done, as is usual in such procedures. The survey was conducted in two steps, on two adjacent areas. First, a number of geoelectrical sections were made on a partly covered area that had been investigated earlier by auger drilling, in order to assist restoration. Then, a second area that should have received its final cover was imaged, and some defects in the cover could be detected and repaired. The resistivity and time-domain IP results were consistent with the results of the geotechnical drillings, and they enabled quasi-continuous mapping along the profiles. Three-dimensional visualization showed the overall consistency of the two-dimensional lines, and helped to generate a global view of the site. In spite o

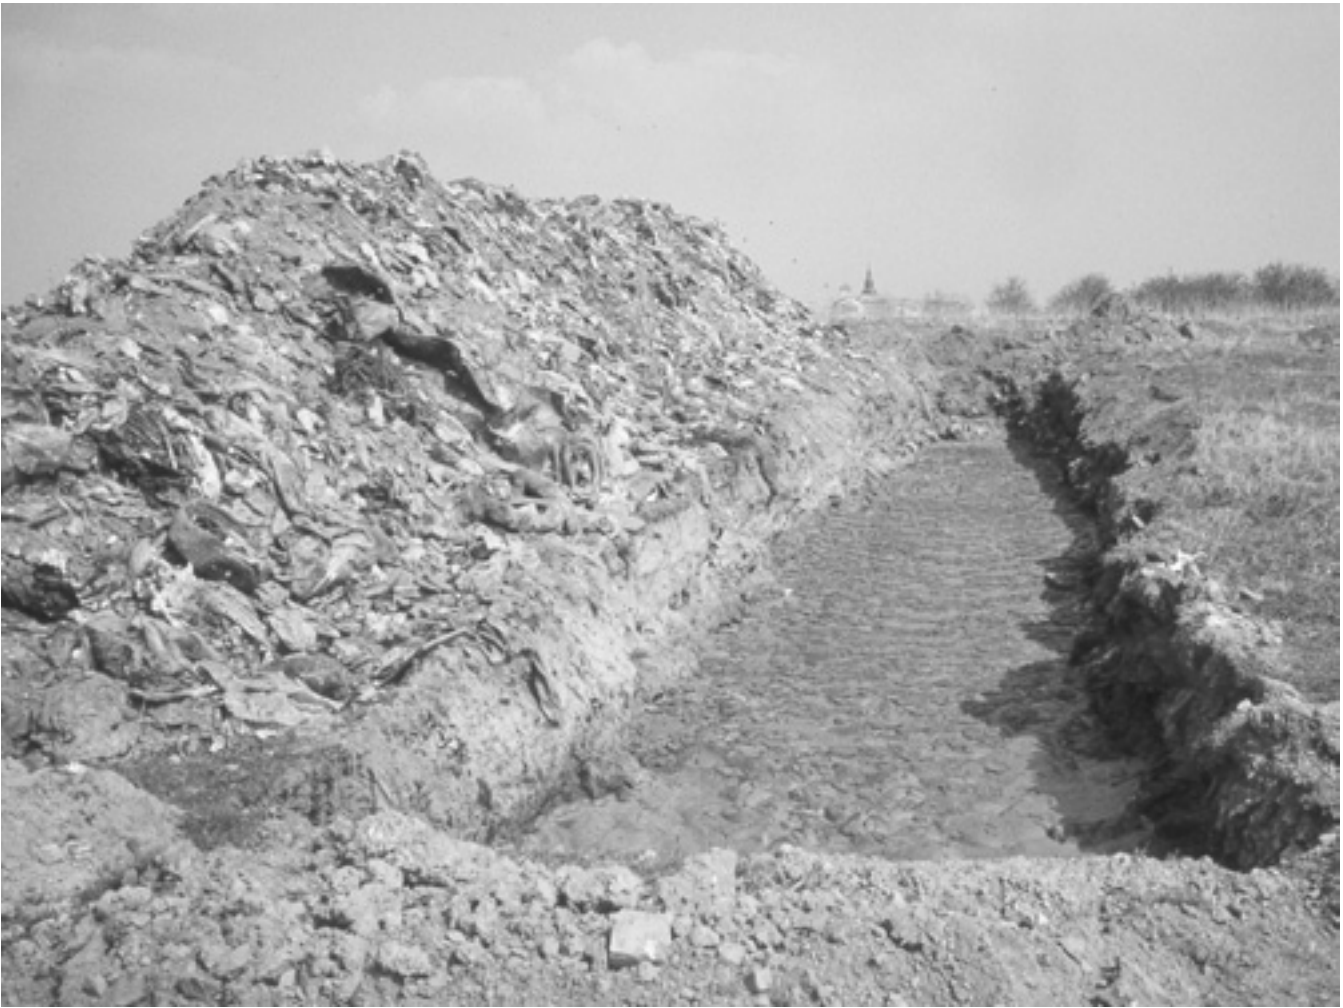
Fig. 2: View of excavated waste material in a trench.

No distinction was made between different kinds of waste. It is assumed that in the major part of the landfill it is similar to that photographed in Figure 2, which is mostly mixed materials with a lot of organic matter and plastic bags, and diverse disseminated objects. Trenches such as the one that was photographed were opened during the course of the survey and they rapidly filled with liquid mud to a depth of around 1 m.

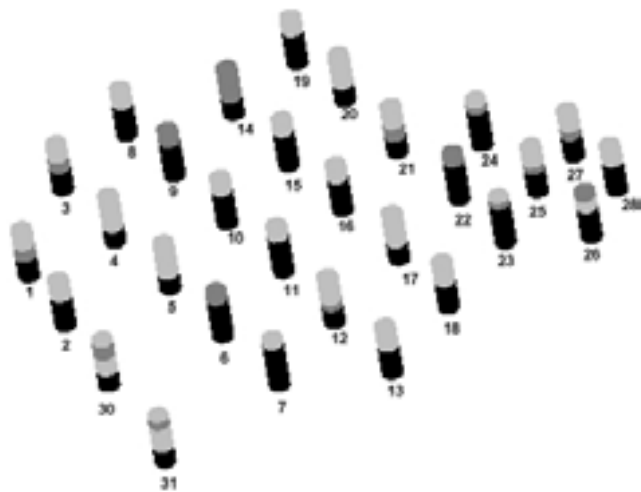
Fig. 3: Result of auger drilling investigation, view from SW. Legend: dark grey, clay; black, waste; light grey, other materials, often mixed (sand, gravel, clay till, lime, mould, sludge, bricks). Vertical enlargement: $\times 10$.

The distribution of the various materials found is summarized in Figure 3. The cover was very inhomogeneous,

and it was in general not possible to correlate two neighbouring points with certainty. Clay or other impermeable

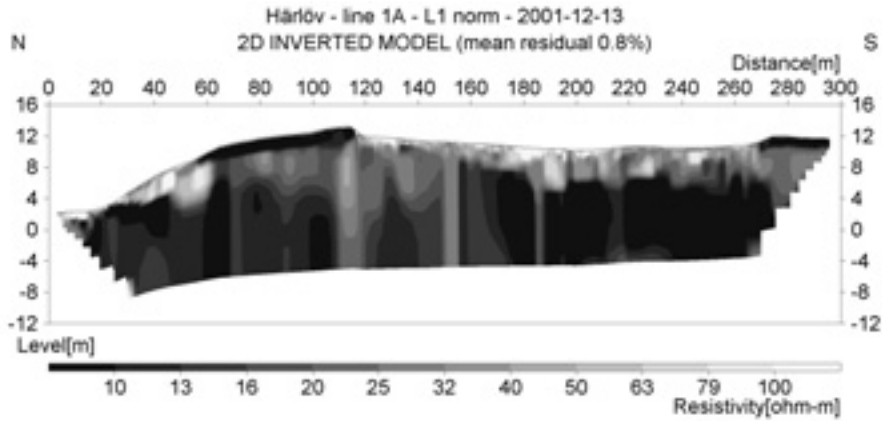
Fig. 7: Inverted resistivity section for line 1A (gradient array); (b) inverted chargeability section for line 1A (gradient array, 10–110 ms).

Line 1A can be used as an example (Figure 7a and b). On the interpreted sections, it can be seen that the first conductive layer – the clayey cover – is not continuous. It is clearly absent between x -coordinates 118 and 270 m, as well as between x -coordinates 0 and 50 m. The more resistive and very inhomogeneous

geneous superficial layer found between $x = 118$ m and $x = 270$ m is most probably composed of coarser materials. It has weak and mixed chargeability. The clayey cover is not chargeable. At depth, resistive material can be either waste or coarse soil materials. Material with high chargeability is probably waste. Boring 1 was situated on line 1A at around 121 m, boring 2 was very close to it at around 155 m and borings 30 and 31 were still rather close at 203 and 266 m, respectively. The clay layer seems to appear on the resistivity section around boring 1 but it is not clear on the IP section. It does not appear at the location of boring 2, as it does not exist there. Borings 30 and 31 might be located too far from the line to draw certain conclusions, but it seems that the waste was located deeper towards the southern end of profile 1A. Between 120 and 260 m the waste is covered by mainly non-clayey material, as is apparent on the geoelectrical sections and con-

firmed by the borings, contrary to the northern part of the profile between 60 and 100 m and the southern end, that are most probably covered by clay.
