Johansson, E., & Kalantari, F. (1989). *Leaking roofs in Tunisia*. (Report TVBM; Vol. 3039). Division of Building Materials, LTH, Lund University.

LEAKING ROOFS IN TUNISIA

Erik Johansson Farhad Kalantari

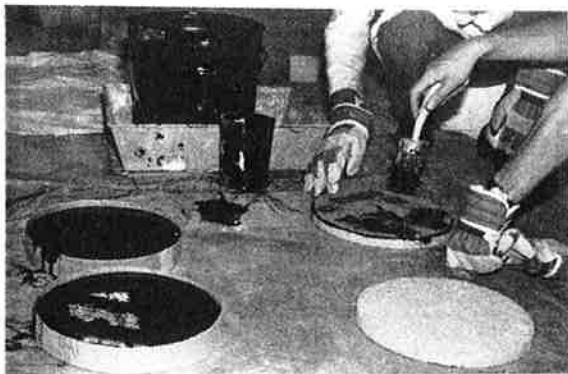
*Fig. 4. Left: Oxidized bitumen (proposal 2).
Right: Brushing out the membrane of proposal 1.*

The waterproof membrane of proposal 1 was made by distilled bitumen with the thickness 2 mm. The bitumen was heated to 180°C and two coats, having a jute cloth as reinforcement between them, were applied. Afterwards the membrane was heated with a blow torch in order to make sure that no pores existed.

The second proposal was to be made with a 5 mm thick waterproof membrane of oxidized bitumen. However, the oxidized bitumen used proved to be extremely difficult to handle. Once heated to a thin liquid it immediately solidified when put into room temperature, and was difficult to pour on top of the slab.

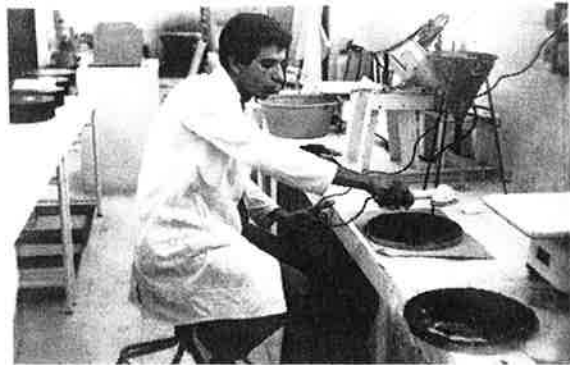
Fig. 5. Heating of the membrane of proposal 1.

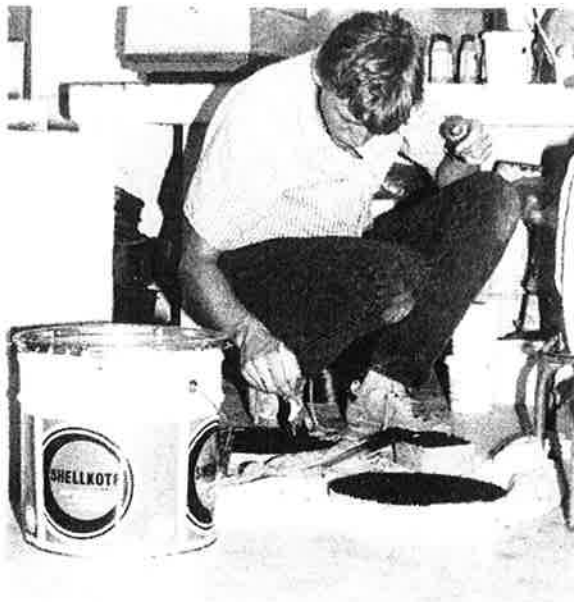
Fig. 6. Painting the bituminous emulsion in proposal 3.

In the third proposal the waterproof membrane of the bituminous emulsion Flintkote was produced by painting the bitumen on the slab. The procedure was repeated, once the first coat had got dry, but now painting perpendicular to the first direction. This product was very convenient to use, especially as no heating was needed.

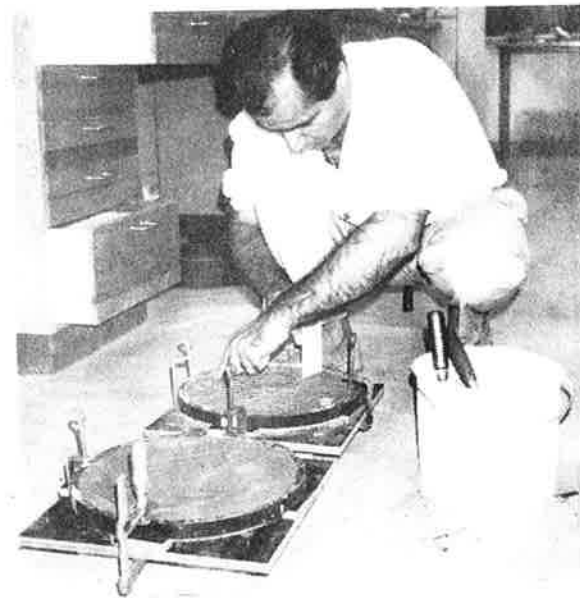
Fig. 7. Protective layer of mortar reinforced with chicken wire.

The protective layer of mortar, reinforced with chicken wire, was then applied on top of the Flintkote.

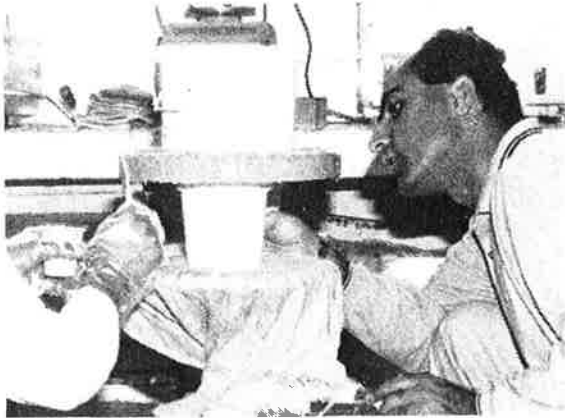
Fig. 8. Application of epoxy resin at the edge of the specimen.

Before starting the measurements the coat of epoxy resin had to be put on the sides of the specimens and on the part of the bottom not covering the bowl with the salt. Once this was done the specimens were put into plastic tubes and beeswax mixed with paraffin could be put in the slot between the specimens and the tubes.

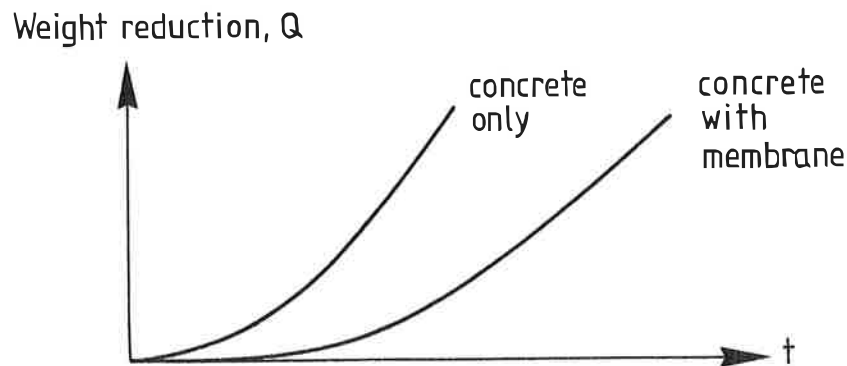
When the effects due to hydration and drying up have been made neglectible, the curves will probably have the shapes shown in fig. 11. The first part of the curve shows that when the water above the specimen passes the membrane it will take some time until the pores of the concrete slab get filled with water. Once the pores are filled with water a steady state will begin as in the latter part of the curve.

Fig. 11. The presumed shapes of the curves.

Preparing the concrete slabs as described above should make it possible to calculate the diffusion coefficient of the roofing membranes. It is then necessary to have dummies made of only concrete as comparison to the specimens made of concrete slab *and* membrane. The slope of the steady state parts of the curves in fig. 11 will be proportional to the diffusion coefficient, which can be calculated with the formula
