Performance and wear mechanisms of novel superhard diamond and boron nitride based tools in machining Al-SiCp metal matrix composite

Published in:
Wear

2017

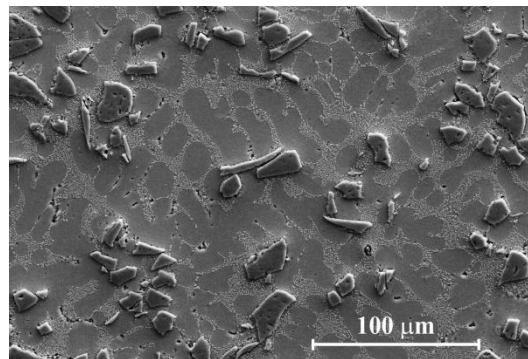
Fig. 1. Scanning electron microscope (SEM) image of the microstructure of Al-SiC_p MMC workpiece material.

2. Experimental setup

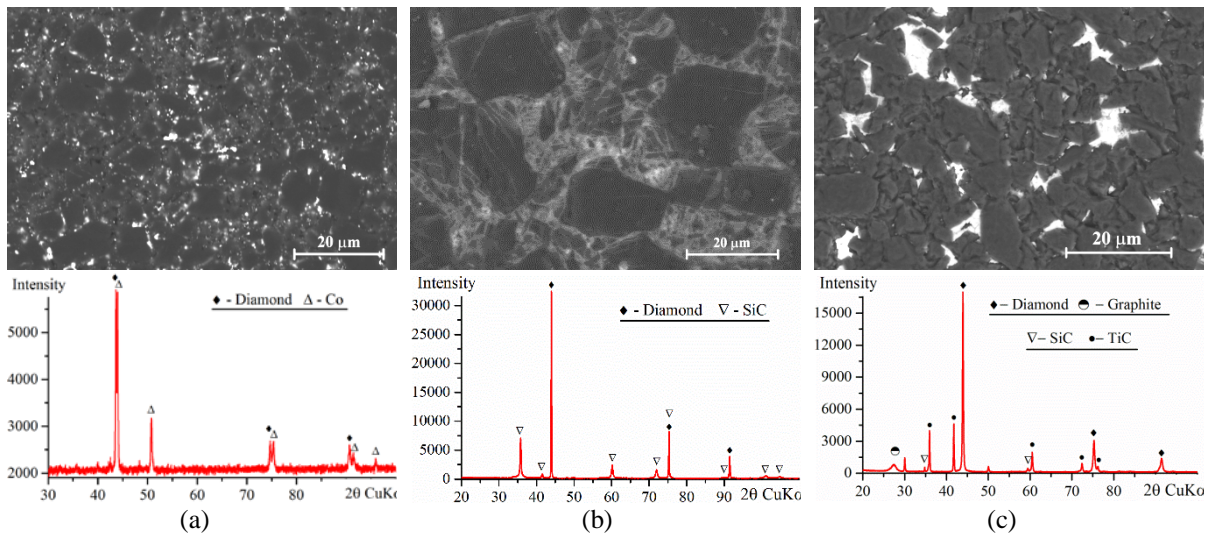
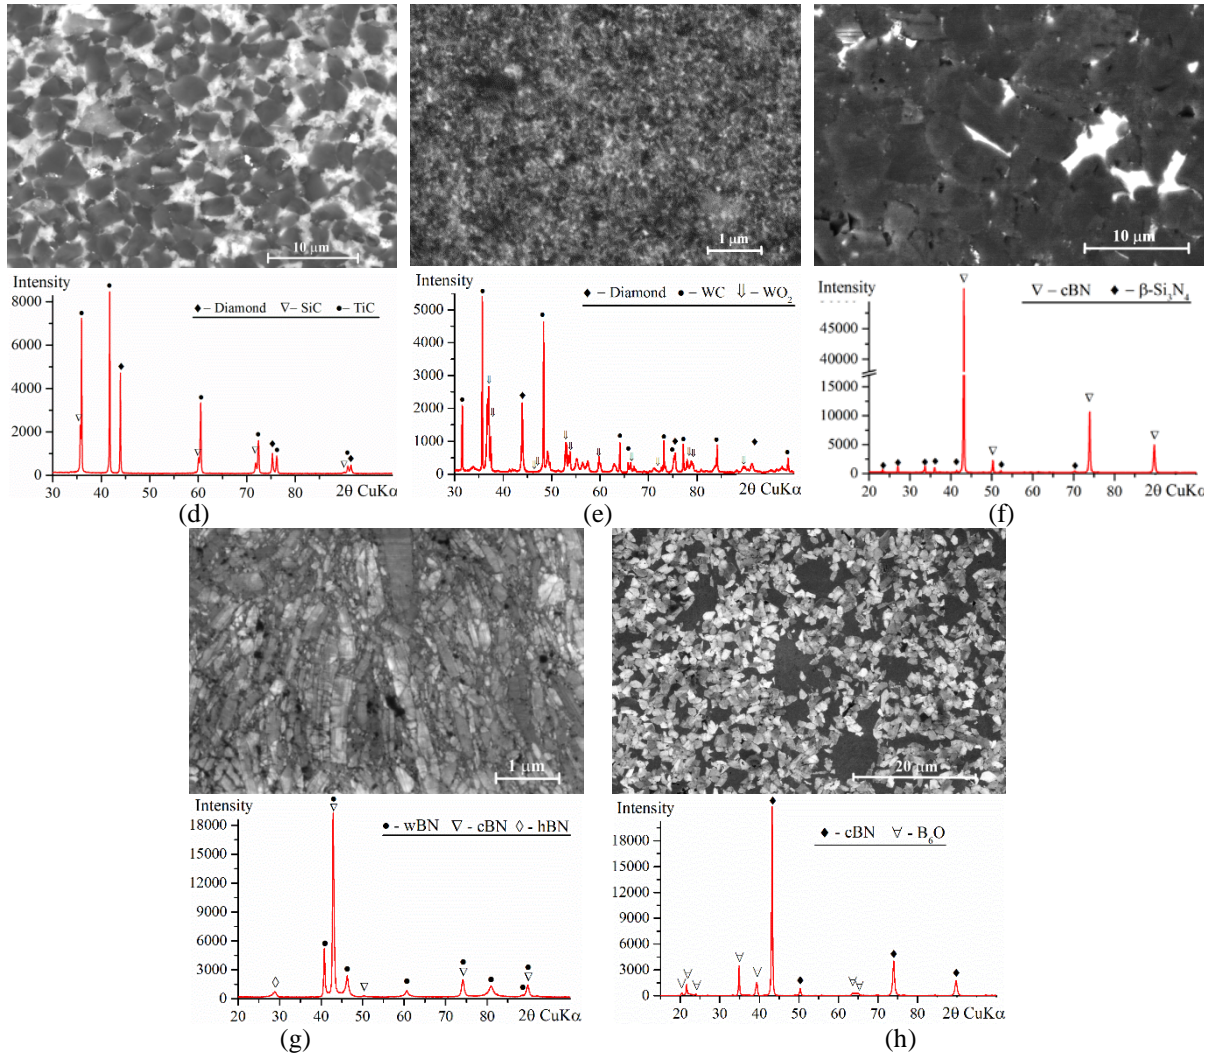
Fig. 2. SEM images of the microstructure and corresponding XRD pattern for tool materials: (a) D-Co, (b) D-SiC, (c) D-MAX₉₅, (d) D-MAX₆₀, (e) nD-nWC, (f) bcBN, (g) wBN-cBN, (h) B₆O-cBN.

1. D-Co – commercial polycrystalline diamond material which forms a solid diamond matrix as a result of intergrowth of diamond grains. The formation of strong diamond-to-diamond bonding is a result of dissolution-precipitation sintering mechanism when molten cobalt dissolves part of the diamond grain to the solubility limit of carbon in the Co-C solution and precipitates it as diamond on the diamond grains (Fig. 2.a). The material possesses high hardness of $HV = 89$ GPa (Fig. 3), high fracture toughness ($K_{IC} = 9.8 \text{ MPa} \cdot \text{m}^{1/2}$) and thermal conductivity of $k = 760 \text{ W/(m} \cdot \text{K)}$ [3].

2. D-SiC – thermostable polycrystalline composite which forms as a result of infiltration of molten silicon into the diamond preform and subsequent reaction of both phases with formation of silicon carbide matrix (Fig. 2.b). The material has hardness of $HV = 84$ GPa (Fig. 3), lower toughness of $K_{IC} = 7.6 \text{ MPa} \cdot \text{m}^{1/2}$ and lower thermal conductivity of $k \approx 200 \text{ W/(m} \cdot \text{K)}$ [8].

3. D-MAX₉₅ – experimental polycrystalline diamond material where the bonding of diamond is realized via decomposition of Ti_3SiC_2 MAX-phase during the sintering, release of TiC, elemental silicon and titanium and their subsequent reaction with the diamond [9]. Mixture of 95 vol.% diamond and 5 vol.% Ti_3SiC_2 was subjected to the sintering process (Fig. 2.c). The sintering resulted in a material with hardness of $HV = 71$ GPa (Fig. 3).

4. D-MAX₆₀ – similar experimental polycrystalline diamond material which contained 60 vol.% diamond and 40 vol.% Ti_3SiC_2 prior to the sintering (Fig. 2.d). Reduced diamond contents, compared to D-MAX₉₅, resulted in a lower hardness of $HV = 62$ GPa (Fig. 3).

5. nD-nWC – experimental material for which the nano-diamond (3-15 nm) is subjected to sintering with tungsten [10], the reaction products creating a nano-grained WC matrix (Fig. 2.e). Residual surface oxygen introduces an undesired by-product of WO_2 . Softer WC matrix and presence of WO_2 cause a reduced hardness of $HV = 52$ GPa (Fig. 3).

6. bcBN – experimental binderless cubic boron nitride material which possesses a solid cBN matrix as a result of diffusional bonding of cBN grains during the high temperature – high pressure sintering (2300 °C and 8 GPa). Additive of 3 vol.% of silicon nitride (Fig. 2.f) is introduced to the cBN matrix for enhancement of fracture toughness ($K_{IC} = 12.6 \text{ MPa} \cdot \text{m}^{1/2}$) [11]. The material has highest hardness of $HV = 54$ GPa and thermal conductivity of $k = 180 \text{ W/(m} \cdot \text{K)}$ [12] among the boron nitride based tooling.

7. wBN-cBN – experimental superhard material which forms as a result of controlled partial transformation (50 vol.%) of ultra-fine grain wurtzite boron nitride to a cubic one in the region of thermodynamic stability of cBN at pressure 8 GPa and temperature of 1700 °C (Fig. 2.g). While the mechanical properties are rather high (Fig. 3), its thermal conductivity is only $k = 26 \text{ W/(m} \cdot \text{K)}$ [13].

8. B₆O-cBN – experimental superhard material which combines superhard cBN grains bound in a superhard matrix of boron sub-oxide B₆O. The mixture of 40 vol. % B₆O and 60 vol.% cBN were sintered at pressure 8 GPa and temperature of 2000 °C (Fig. 2.h) [14]. High hardness of the material is combined with rather low fracture toughness ($K_{IC} = 4.7 \text{ MPa} \cdot \text{m}^{1/2}$) and low thermal conductivity of $k = 14 \text{ W/(m} \cdot \text{K)}$ [14].

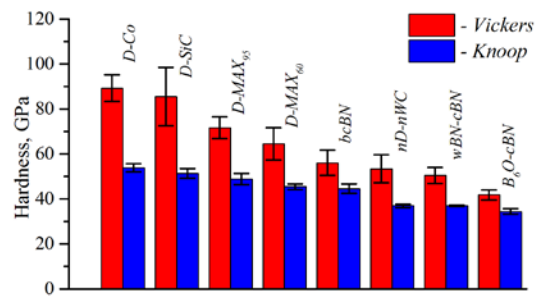
Fig. 3. Vickers and Knoop hardness of the tool materials.

Cutting forces were continuously recorded with Kistler 9129AA dynamometer, while tool wear and surface roughness were regularly inspected after 500 – 600 meters of machining. Leica MZ16 stereomicroscope was used for the measurement of flank wear VB , while Alicona InfiniteFocus 3D optical microscope was used for 3D analysis of worn tools. LEO/Zeiss 1560 high resolution scanning electron microscope (SEM) was used for the detailed inspection of the tool and workpiece material microstructure, worn tools, machined surface and sub-surface. FEI NanoLab 600 dual beam microscope was used for lamella preparation using focused ion beam (FIB) lift-out technique [15]. JEOL 3000F transmission electron microscope (TEM) was used for imaging, selected area electron diffraction (SAED) and energy dispersive X-ray (EDX) analysis (SDD X-Maxⁿ EDX system, Oxford Instruments). XRD analysis of tool materials was done on STOE Darmstadt diffractometer with CuK α source. Hardness of the tool materials was measured with Vickers and Knoop indenters at load 4.9 N (see Fig. 3) on Ernst Leitz Wetzlar microhardness tester.

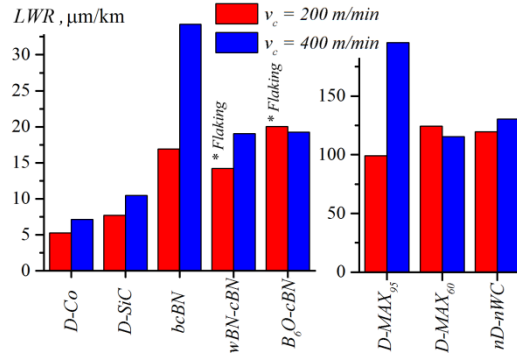
Fig. 5 presents the tests results in terms of linear wear rate ($LWR, \mu\text{m/km}$), defined as the ratio of the tool wear to the engagement distance measured within the normal wear region. It shows that D-Co material, the hardest among the tested (Fig. 3), possesses the highest wear resistance. The same relation is observed for D-SiC tool material that is the second hardest (Fig. 3), which follows the trend typical for abrasive wear. However the other diamond based materials have extremely low wear resistance due to, as shown later, intensive adhesive wear. The expected relation between the tool material hardness and the wear resistance was not directly followed for cBN-based materials either. wBN-cBN and B₆O-cBN tools showed lower linear wear rates at $v_c = 400 \text{ m/min}$ than that harder binderless cBN tool grade. This is related to the stable adhesion of the MMC workpiece material to the tool contact surfaces, mostly the rake, for these grades and protection of the tool against the abrasion of the incoming SiC particles. Even more intensive adhesion of the MMC to the tool surfaces for wBN-cBN and B₆O-cBN at lower cutting speed of $v_c = 200 \text{ m/min}$ (Fig. 22.b) resulted in flaking and chipping on the tool rake as indicated on Fig. 5.

Fig. 5. Linear wear rate (LWR) for different tool materials.

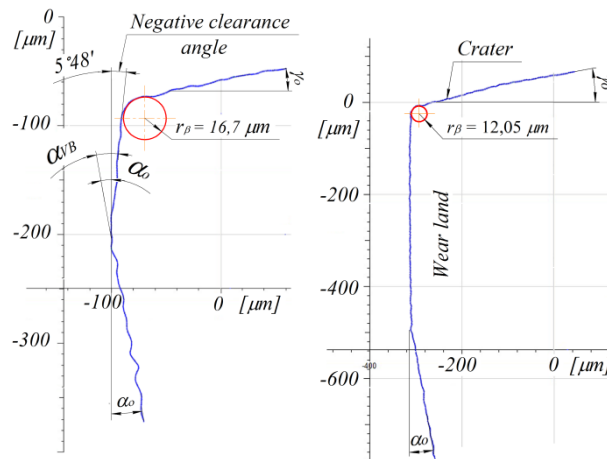
Subsequent analysis of the worn tools with the help of 3D microscopy has revealed that flank and crater wear do not completely characterize the wear topography. The original edge radius of $r_\beta = 15 \mu\text{m}$, identical for all tools, changed in the course of tool wear, as illustrated on Fig. 7. Apart from the edge radius, clearance angle α_{VB} (Fig. 7.a) was also found to deviate from its nominal value, which for the given insert and toolholder geometry should equal $\alpha_o = 9.7$ deg. [16]. Fig. 7 shows that a negative clearance angle is forming on the D-SiC tool, while bcBN grade attains the theoretical value.

Fig. 7. Cross-sectional data for the worn (a) D-SiC and (b) bcBN tools ($v_c = 400$ m/min).

Another, more conventional, mechanism of tool material softening at high cutting speed and related high tool temperature is often attributed to the abrasive tool wear. This mechanism is often observed for cemented carbide tools which exhibit strong loss of hardness at elevated temperature. However in case of superhard tooling the situation is not as pronounced. Chou and Liu [21] have shown that machining Al-SiCp composite at cutting speed of 180 m/min results in the maximum temperature of 410 °C on the tool. The room temperature hardness (Fig. 3) of cBN-based tool materials decreases significantly and in this range of cutting temperature attains values of $HV \approx 22$ GPa for bcBN [22] and $HV \approx 20$ GPa for wBN-cBN [23] materials. Therefore SiC particles in the MMC having slightly higher hardness ($HV = 25-27$ GPa) [24] can inflict mild abrasive wear to the cBN-based tooling. In the case of diamond, its hardness reduces only to $HV \approx 84$ GPa for the given process temperature [24] and thus abrasion by the much softer SiC is very unlikely. On the other hand, the chemical wear of diamond tooling, which results in nano-structured SiC (Fig. 19), enables abrasive wear since the formed SiC is softer than diamond. Therefore chemical wear followed by abrasion of its reaction products is likely to be one of the primary wear mechanisms for diamond tooling. The kinetics of the chemical reaction is linearly proportional to the process temperature. In this case, temperature gradients along the flank wear land, with the highest temperature at the edgeline, would imply the intensity of SiC formation to decrease from the tool edge towards the end of VB, thus explaining negative clearance α_{VB} found only on diamond tooling (Fig. 7.a and Fig 8.a).

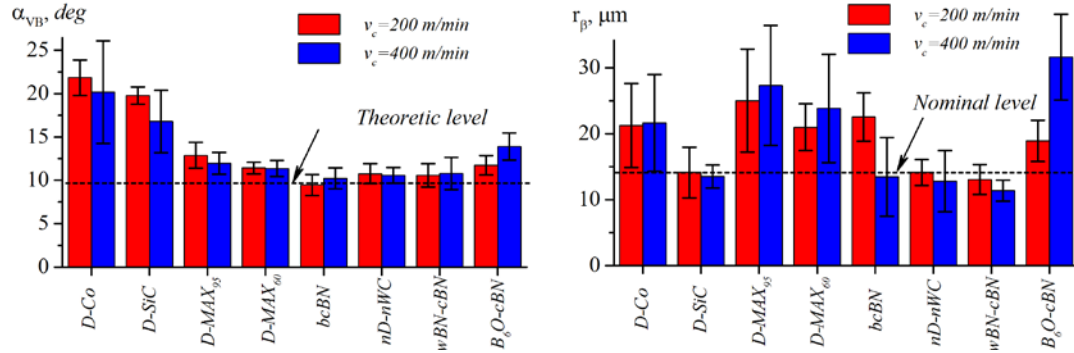
Fig. 8 summarizes the results of the measurement of edge radius r_β and clearance angle α_{VB} for different tool materials and test conditions. It shows that D-Co and D-SiC materials, which have the highest performance, form a highly negative clearance angle. This negative clearance angle is observed on the

etched tools, while the same measurement done prior to the etching indicates that the angle is on the level of the nominal one. This indicates that the workpiece material layer is adhering to the tool flank of D-Co and D-SiC tool and also acts as the tool protection layer (TPL) against the abrasion by SiC particles, which is also discussed later in the article. For other tooling materials the TPL was observed only on the rake.

Fig. 8. Measurement results of (a) clearance angle and (b) edge radius for worn tools.

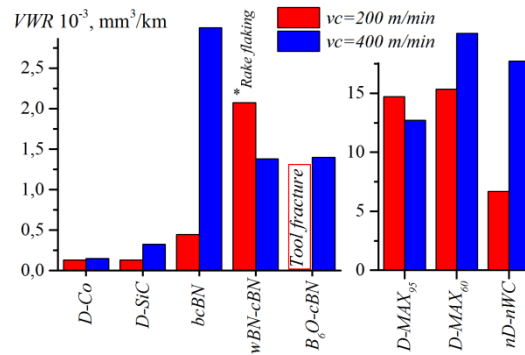
Formation of the negative clearance angle and presence of crater wear for several grades indicate that both the flank wear VB and linear wear rate LWR do not completely characterize the intensity of the wear process and that the volumetric changes should be accounted for. Volume difference measurement (VDM) module of the 3D microscope was used for such analysis. The VDM method calculates the difference between the surfaces of new and worn tool in the same location as exemplified for bcBN tool in Fig. 6. Fig. 9 summarizes the calculated results of the volumetric wear rate (VWR , mm^3/km) determined with the use of VDM method. It can be seen that diamond tool materials with MAX-phase binder have high wear rate which has minor dependence on the cutting speed. This is related to the adhesive pluck out of the diamond grains and binder (see Fig. 10.a) due to poor binding between these phases. For other materials the wear surfaces have smoothened appearance with apparent scratches due to abrasive wear, as exemplified for the D-SiC tooling shown on Fig. 10.b. Fig. 10.b also shows that diamond phase attained minimal abrasive damage while the softer SiC binder has been preferentially abraded from the tool rake.

Fig. 9. Volumetric wear rate (VWR) for different tool materials.

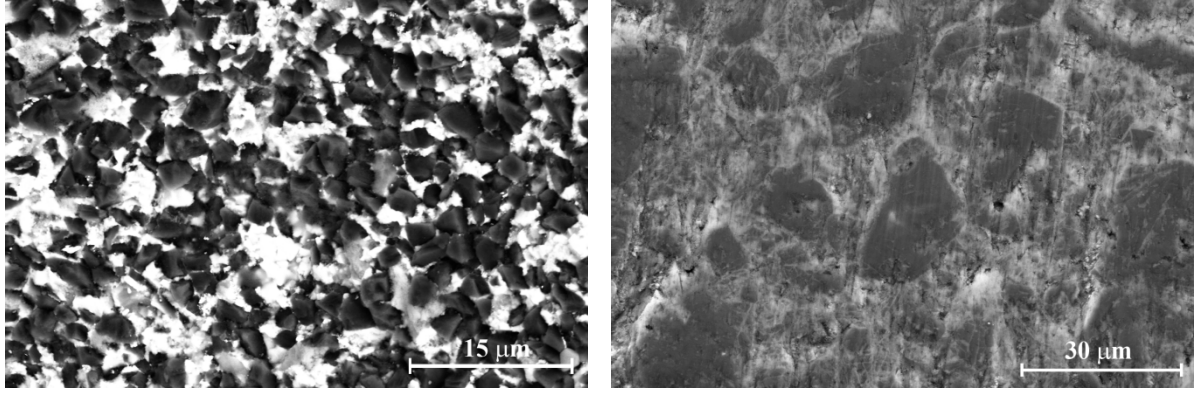
Fig. 10. SEM images of non-etched worn rake surface for (a) D-MAX₆₀ and (b) D-SiC at $v_c = 200$ m/min.

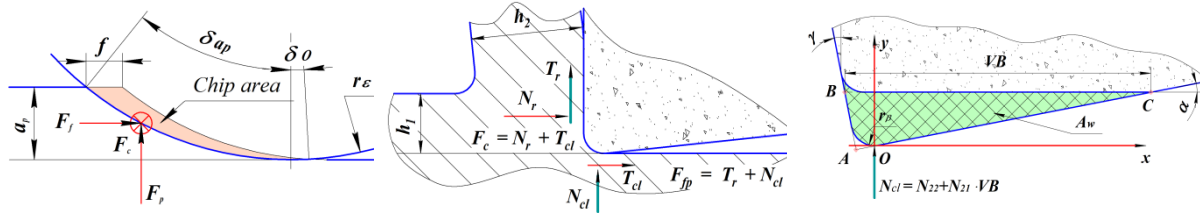
Fig. 12. Schematic of (a) cutting forces acting on a tool, (b) decomposition of forces acting on the rake and clearance for a new tool, (c) normal force N_{cl} on the worn clearance and respective wear area A_w .

where A_w – cross-sectional wear area (Fig. 12.c), b – active length of the cutting edge (Fig. 12.a), H_{tool} – hardness of the tool material (Fig. 3), N_{cl} – normal force acting on the clearance (Fig. 12.b), and e – tool engagement distance.

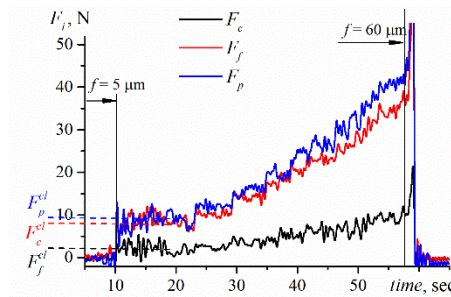
The normal force on the clearance N_{cl} for a new cutting tool can be identified by extrapolation of the F_f and F_p forces to the zero chip thickness [19], i.e. the moment when the tangential component T_r equals zero. Figure 13 shows an example of recorded cutting forces for machining MMC with the new D-Co tool at cutting speed $v_c = 200$ m/min when the feed was continuously increased from 5 to 60 $\mu\text{m}/\text{rev}$. The Figure 13 indicates that up to the feed of $f \approx 15$ $\mu\text{m}/\text{rev}$, which corresponds in our case [20] to the maximum theoretical chip thickness of $h_{lmax} = 4.9$ μm , the force components remain constant and represent the actual cutting forces acting only on the tool clearance.

Fig. 13. Development of cutting forces while continuously increasing feed ($f = 5 - 60$ $\mu\text{m}/\text{rev}$) for new D-Co tool ($v_c = 200$ m/min).

while the force component F_c^{cl} (Fig. 13) represents the tangential force on the clearance T_{cl} .

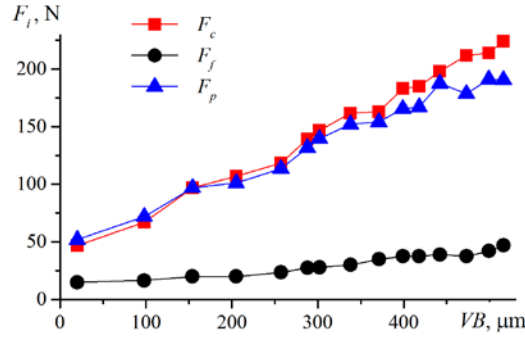
Both the N_{cl} (Eq. 3) and the T_{cl} forces found for a new tool are increasing with the development of the tool wear VB . Considering the absence of any significant crater wear, meaning that T_r and N_r force components (Fig. 12.b) are fixed, the increase of the cutting forces F_c , F_f , and F_p in the course of the tool wear can be only attributed to the progression of wear VB , as exemplified for bcBN tool (Fig. 14).

Fig. 14. Development of cutting forces with the wear for bcBN tool ($v_c = 400$ m/min).

Combination of Eq. 2 and Eq. 3 with the force vs. VB data similar to ones on Fig. 14 allows determination of the influence of the wear on the force F_{fp} . Fig. 15.a shows the examples of such calculated influence for the case of D-Co and D-SiC tool when machining MMC with $v_c = 400$ m/min. The slope of the line (Fig. 15.a) describes the influence of the tool wear and therefore the normal force on the clearance for worn tool can be calculated as:

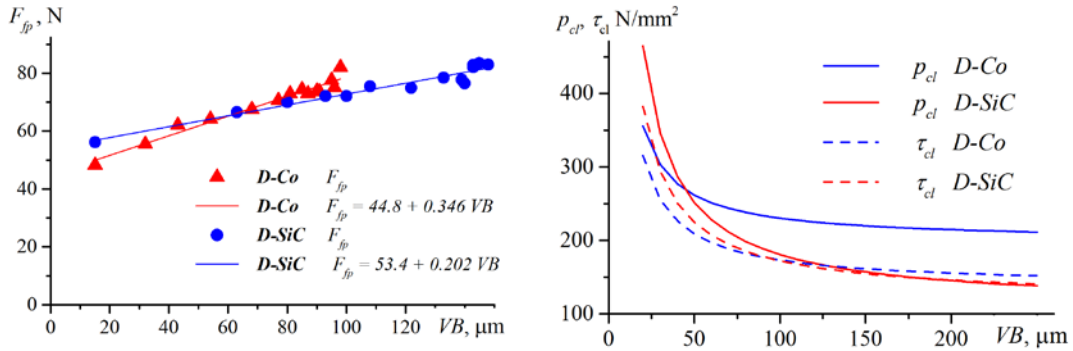
where N_{22} is the value for new tool (Eq. 3) and N_{21} is the tangent of the slope angle (see Fig. 15.a). Similarly, the tangential force can be described as $T_{cl} = T_{22} + T_{21} \cdot VB$.

Fig. 15. (a) Resultant force component F_{fp} and (b) respective average normal pressure p_{cl} and tangential stress τ_{cl} on the tool clearance as a function of wear land VB for D-Co and D-SiC ($v_c = 400$ m/min).

Figure 15.b illustrates the influence of tool wear on the determined contact stresses for machining with D-Co and D-SiC tools. It can be seen that the contact stresses in both cases are reducing with the increase of VB , yet for D-SiC tool such reduction is more pronounced. This should be attributed to the larger edge radius r_β and negative clearance angle α_{VB} that develop on the D-Co tool in the course of tool wear (Fig. 8) and the associated larger forces acting on the clearance possessing similar VB .

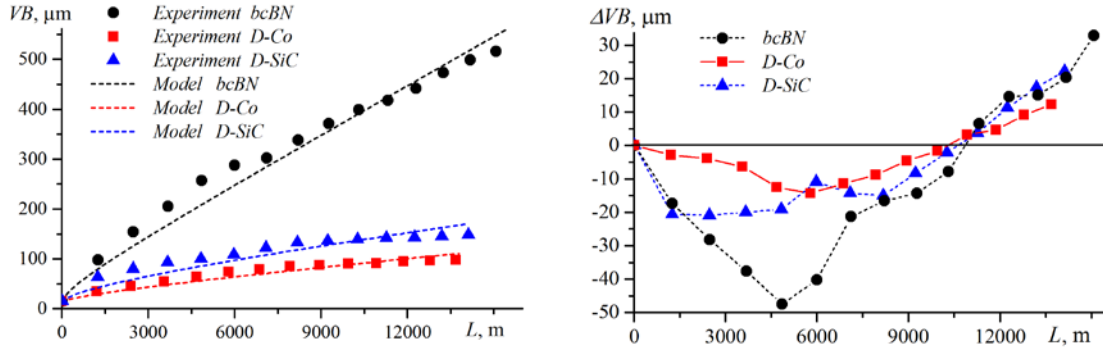
Figure 16.a shows the results of the modelling and the experiments exemplified for several high-performing materials. Good match between the model and the machining data with the correlation coefficient of 0.96-0.99 indicates the applicability of the model for the description of the tool wear. However a slight underestimation can be observed on the initial engagement alongside with the minor overestimation at the end of tool engagement. The difference between the model and the experiments observed over the entire tool engagement is shown in detail on Fig. 16.b. Such behavior can be explained by the change in the conditions of the abrasion process during the cutting process. As mentioned earlier, the formation and retention of the TPL varies during the cutting. Initial formation of the TPL was observed during the first 500-1000 meters of engagement, while it attained the stable form after 2500-4000 meters, depending on tool material and cutting speed. More intense tool wear can be expected at the absence of TPL and therefore the model is likely to underestimate the wear rate. This means that the wear constant K used in the model changes its value as a result of variation tribologic conditions in the course of the test.

Fig. 16. (a) Modeling results for Archard wear model and (b) difference between model and experimental data for bcBN, D-Co, and D-SiC tools ($v_c = 400$ m/min).

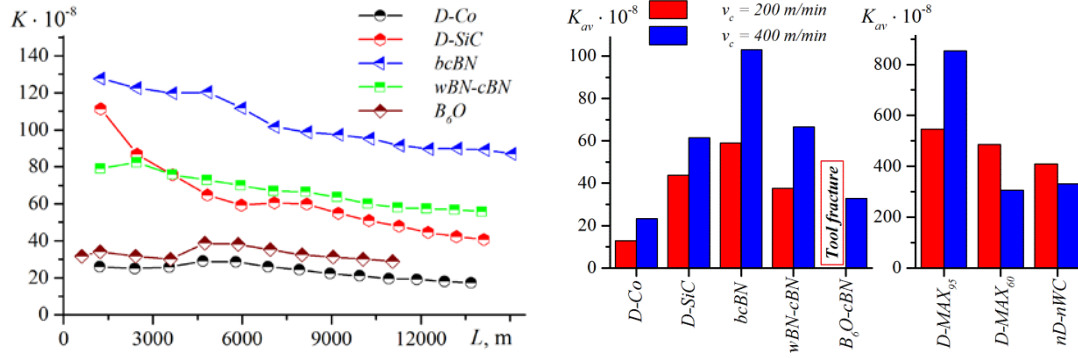
Fig. 17.a shows that K value, and thus the wear resistance of the tool material, initially decreases and eventually approaches some asymptotic value upon longer tool engagement. The tool run-in and stabilization of TPL are related to this initial period. Fig. 17.b presents the average value of K over the entire cutting process. This value characterizes the tribologic wear conditions, irrespectively of the hardness of the tool material H_{tool} , and therefore can be used for judgement of the wear process itself. For example D-Co and B₆O-cBN tool materials have similar K value for tests at $v_c = 400$ m/min and in both cases the edge radius r_β (Fig. 8.b) for the worn tools and the dimensions of TPL are similar too.

Fig. 17. (a) Variation of wear coefficient K during machining process ($v_c = 400$ m/min) and (b) average value of coefficient K for different tool materials.

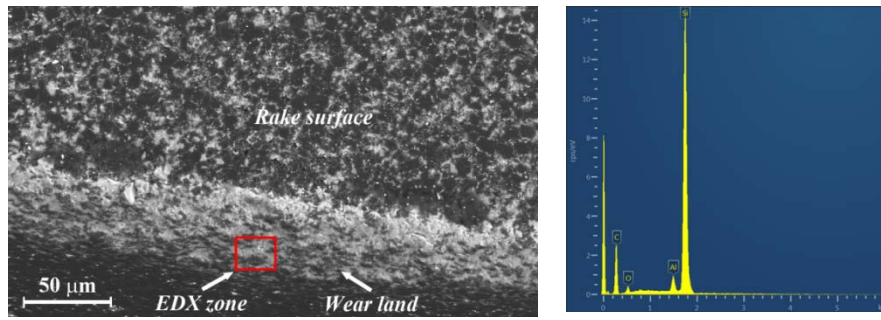
Removal of the tool protection layer by etching prior to 3D optical microscopy revealed additional features of the wear process. Post-etching reevaluation of the tool wear with SEM (Fig. 18.a) have shown that for D-Co and D-SiC tools a layer remains attached to the tool surfaces, even after prolonged etching. EDX analysis of the chemical composition of this layer has shown that the main constituents are Si and C, and also contains minor quantities of Al and O (see Fig. 18.b).

Fig. 18. (a) SEM close-up view of worn D-Co insert ($v_c = 400$ m/min) after etching, (b) EDX spectrum for layer adhered to the wear land.

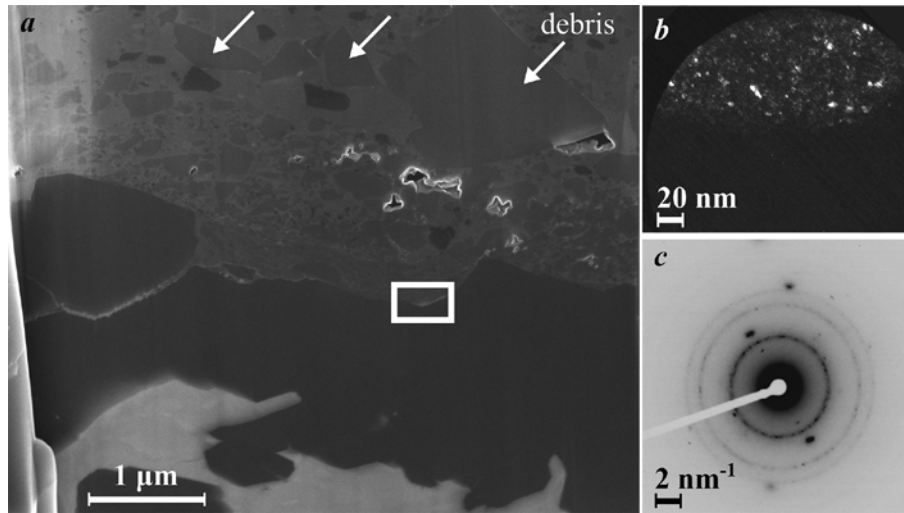
A lamella for TEM analysis was prepared using FIB lift-out in order to fully study transition from TPL, through this etch-resistant layer, to the tool material. The flank wear land of a non-etched D-Co tool was chosen for this purpose. Fig. 19 shows SEM and TEM images of the interface between D-Co and TPL, where the lower part of the image is of the tool and the top part is the TPL. Scanning TEM (STEM) EDX analysis proved that the layer mainly consists of SiC with about 1 at% of O and 2 at% Al. Dark field TEM imaging (Fig. 19.b) demonstrates nano-structuring of the layer with the typical grain size of about 2-3 nm, with an upper limit of 10 nm. The very dense diffraction rings observed in the selected area electron diffraction patterns (Fig. 19.c) support the nano-structuring. The diffraction rings match the lattice spacing of zinc blende SiC {111}, {022} and {113} -planes, respectively.

Fig. 19. (a) SEM image of the FIB prepared lamella and (b) dark field TEM image from the interface region between D-Co and TPL ($v_c = 400$ m/min). (c) SAED (inverted contrast) of the same region as in (b).

Presence of such SiC nano-crystalline layer, that is intimately attached to the diamond, implies chemical reaction between the diamond and elemental silicon from the MMC matrix material. The nano-structured reaction layer should not be confused with the micron-sized debris of SiC particles from the MMC, also observed on Fig 19.a. This observation indicates that the chemical wear mechanism plays an active role in the wear of diamond tooling.

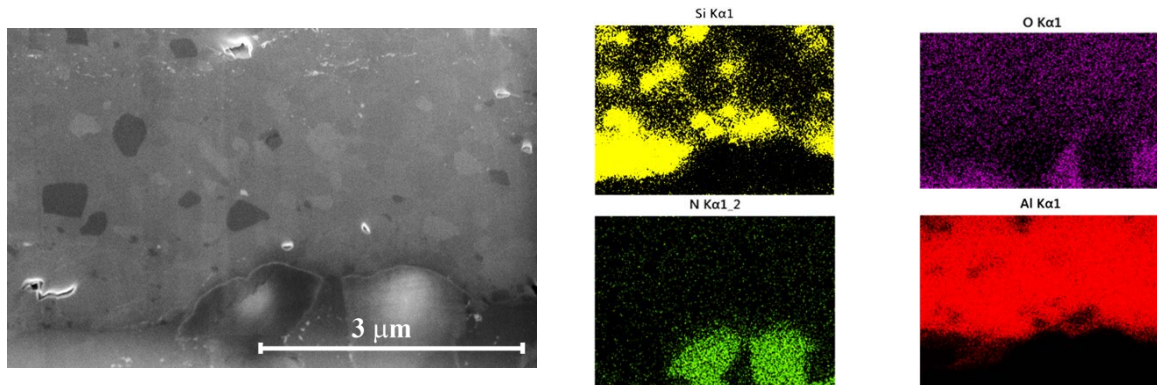
Analysis of a similar FIB milled lamella extracted from the B₆O-cBN tool (Fig. 20) indicates absence of chemical interaction between tooling and MMC. In this case the TPL contains fine debris particles of eutectic Si, from the matrix of the MMC material, which are loosely located on the contact surfaces. Which is in opposition to the nano-crystalline SiC layer on D-Co that is intimately attached to the diamond. This indicates that not only the intensity of formation of the TPL is different between diamond and cBN-based tooling, but also the composition and attachment of the TPL is affected.

Fig. 20. EDX map of a sample FIB milled from the TPL on the crater of non-etched B₆O-cBN insert ($v_c = 200$ m/min).

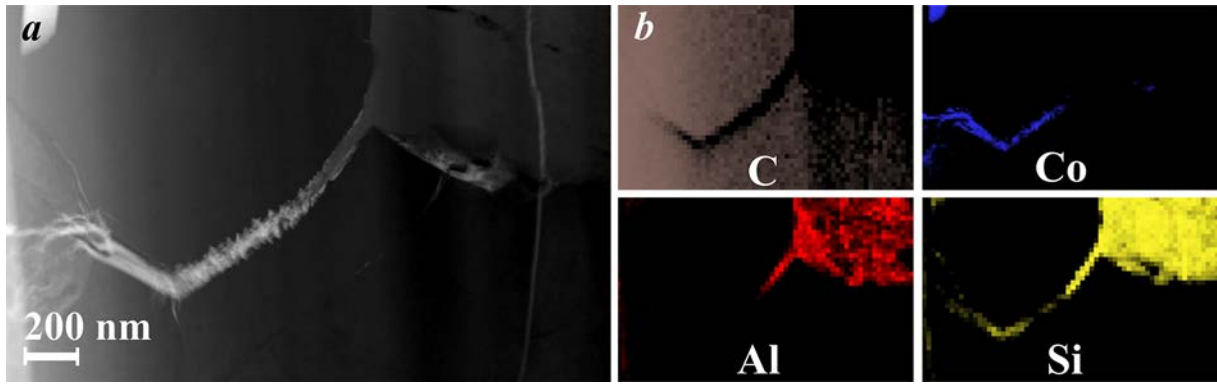
The evidence for diffusion wear in D-Co tooling can be seen in Fig. 21.a which is depicting high angle annular dark field (HAADF) image of a crack in the D-Co tool, also visible on Fig. 19.a. From the STEM EDX elemental maps (Fig. 21.b) it is clear that Co is present in the majority of the crack. This indicates that the crack was formed in the presence of liquid Co, i.e. during sintering of the tool material. However, an approx. 0.5 μm long region of the crack opening (close to the TPL) did not bear any Co signal, instead, Al and Si was found in this region. Si is also present, to a lesser amount, throughout the rest of the visible crack. This clearly shows the diffusional removal of Co from the tool into the workpiece material, its replacement by Si and Al from the MMC matrix, and strong ingress of Si throughout the Co phase.

Fig. 21. (a) STEM HAADF image and (b) EDX elemental maps (C $K\alpha_{1,2}$, Co $K\alpha_1$, Al $K\alpha_1$, Si $K\alpha_1$) of a FIB lamella in the crack region of the D-Co tool ($v_c = 400$ m/min).

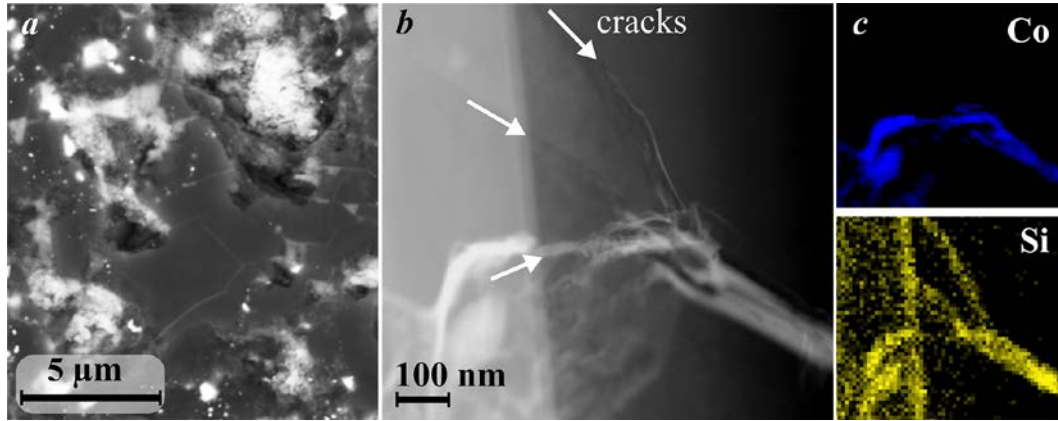
Fig. 22. (a) SEM image of cracking and fracturing of diamond grains on the rake of D-Co ($v_c = 200$ m/min), (b) STEM HAADF image of the crack network in D-Co ($v_c = 400$ m/min) and (c) EDX elemental maps (Co $K\alpha_1$, Si $K\alpha_1$) of the same region.

Another aspect of intensification of tool wear with the increase of cutting speed from 200 m/min to 400 m/min can be attributed to the reduction or destabilization (Fig. 11) of TPL, thus reducing its protective action. Andrewes et al. [25] argue that the higher hardness of diamond, compared to SiC, turns abrasive wear into a micro-mechanical damaging phenomenon, rather than micro-cutting one. Such mechanism of localized cracking and removal of the hard and brittle tool materials, similarly to the case of erosive wear [26], would explain the intensified wear rate observed at higher cutting speed. Formation and propagation of such localized cracks upon high energy impact of hard workpiece inclusions, such as SiC particles, is likely to intensify at high cutting speed. Indeed, Fig. 22.a shows evidence of cracking and partial removal of diamond grains from the rake surface of the worn D-Co tool and Fig. 22.b-c show evidence of a network of cracks forming in D-Co tool during the metal cutting. Co is expected to be found in all cracks formed during the tool liquid state sintering, while any cracks formed during metal cutting are expected to lack Co signal. In the high magnification image and elemental maps (Fig. 22.b-c) three cracks are visible, all connected to the major crack displayed in Fig. 21. The three cracks contain Si whereas only one contains Co, indicating that two were formed during cutting, in the absence of liquid Co. Loss of Co due to diffusional wear (Fig. 21) is expected to reduce the bonding and facilitate the cracking and breakage of diamond grains. It is expected that reduction or removal of TPL at high cutting speed of $v_c = 400$ m/min for all tooling leads to a higher intensity of SiC particles impacts and thus to accelerated tool wear.

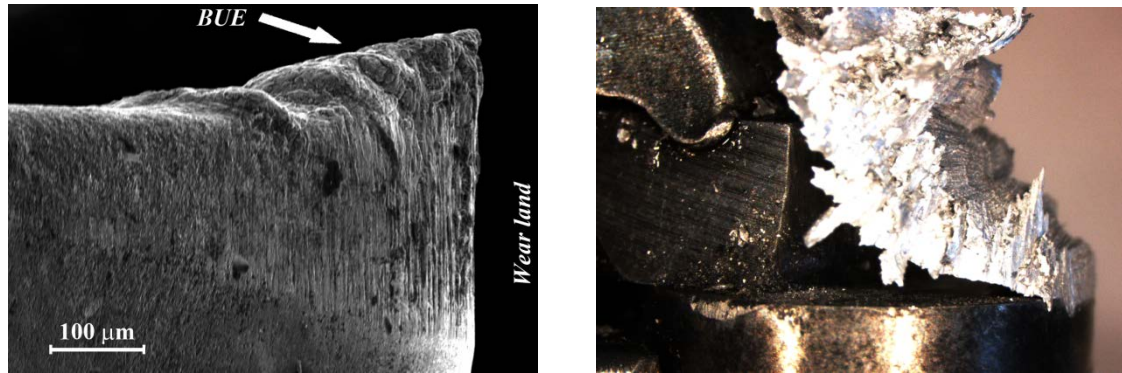
Even though TPL has a positive effect on the tool life, its excessive formation is the cause of built-up edge (BUE) as shown on Fig. 23.a. In case of B_6O -cBN and wBN-cBN superhard tool materials such excessive BUE resulted in seizure of the chips to the tool (Fig. 23.b), which eventually lead to rake flaking (Fig. 4.a and Fig. 9.a) and edge chipping.

Fig. 23. (a) SEM image of build-up edge on the D-Co tool ($v_c = 200$ m/min) and (b) optical image of seizure of the chips to the rake of B_6O -cBN tool ($v_c = 200$ m/min).

The size of BUE, as shown on Fig. 23.a, is around 100 to 150 μm while the roughness in the respective case was only $Ra = 1.1 - 1.5$ μm . Cross-sectional analysis of the chips and the machined surface was performed in order to identify the cause of such difference. Fig. 25.a shows that the built-up edge predominantly remains with the chips while only a small fraction of BUE remains on the machined surface. It can be assumed that flank wear land of the tool additionally smoothens the machined surface after BUE breakage (Fig. 25.b), thus reducing its negative influence on the surface quality.

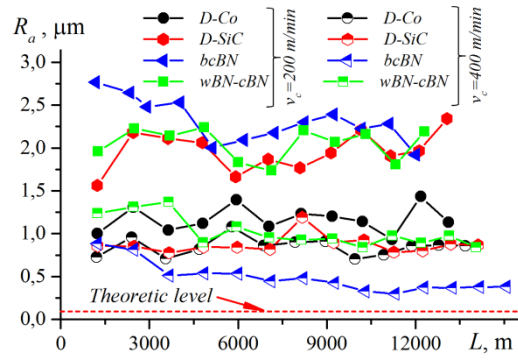
Formation of BUE, apart from its direct effects on the tool life and tool wear, negatively affects the roughness and integrity of the machined surface. Fig. 24 shows that the obtained roughness in all machining cases was significantly higher than the theoretically calculated value. Only in the case of bcBN machining at speed $v_c = 400$ m/min, which is accompanied by the loss of TPL, the surface roughness approached the expected level. Machining at $v_c = 200$ m/min is characterized by surface roughness being approximately two times higher, for respective tool materials, than the surface quality at higher cutting speed. This is related to the decrease of BUE dimensions with increased cutting speed and follows previous findings [7].

Fig. 24. Development of the surface roughness during the machining process.

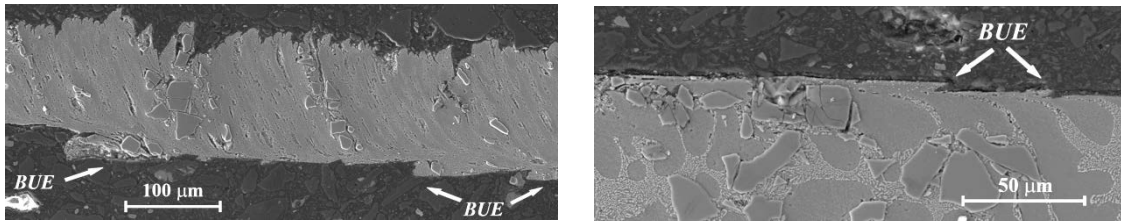
Fig. 25. SEM images of elements of build-up edge on (a) chips and (b) machined surface for D-Co tool ($v_c = 200$ m/min).

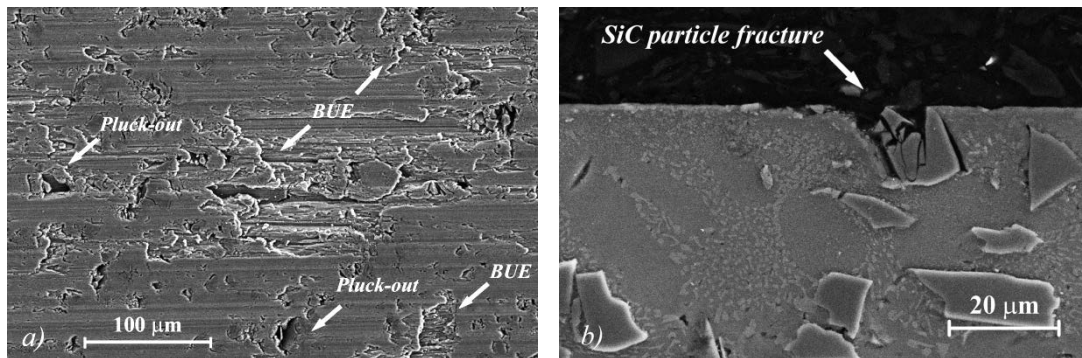
On the other hand BUE is not the only source of increased surface roughness. Fig. 26.a shows that intensive SiC particle pluck-out in the course of the cutting process deteriorates the machines surface significantly. Fig. 26.b presents the details of the machined subsurface which reveal that fracture of the SiC particles by the incoming cutting edge and subsequent pluck-out of the SiC debris by the workpiece material adhered to the tool flank leaves pores and cavities, as deep as 10-20 μm , on the machined surface. Fig. 26.a also confirms that partial smoothing of the BUE remains over the machined surface by the tool flank.

Fig. 26. SEM image of (a) machined surface and (b) subsurface with D-Co ($v_c = 200$ m/min).
