Performance and wear mechanisms of novel superhard diamond and boron nitride based tools in machining Al-SiCp metal matrix composite

Published in:
Wear

2017

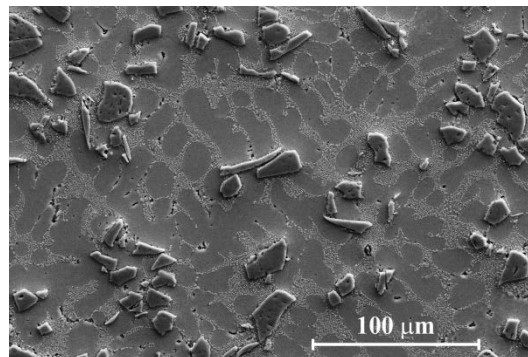
Fig. 1. Scanning electron microscope (SEM) image of the microstructure of Al-SiC_p MMC workpiece material.

The following metal matrix composite (MMC) material was used in experiments – AlSi9Mg0.3 aluminum alloy reinforced with SiC particles (20% vol.) having the grain-size of 10 to 30 μm . The molten Al-SiC_p MMC material was gravity cast (directly from the industrial furnace, Amtek Components Sweden AB) into tubular stainless steel moulds. The moulds were allowed to cool for 30 seconds on air and then rapidly cooled in a water basin. This sequence was found to minimize the sinking of SiC particles and provide the MMC microstructure identical to the industrial one (see Fig. 1). Cast MMC ingots were pre-machined to bars of 56 mm in diameter and 400 mm in length prior to the actual machining tests.

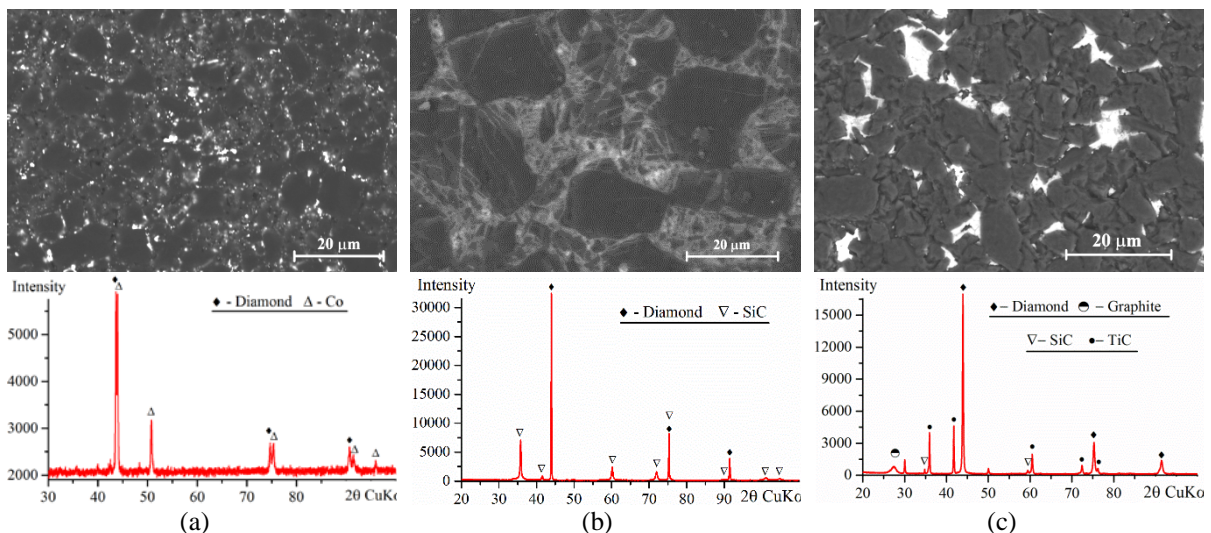
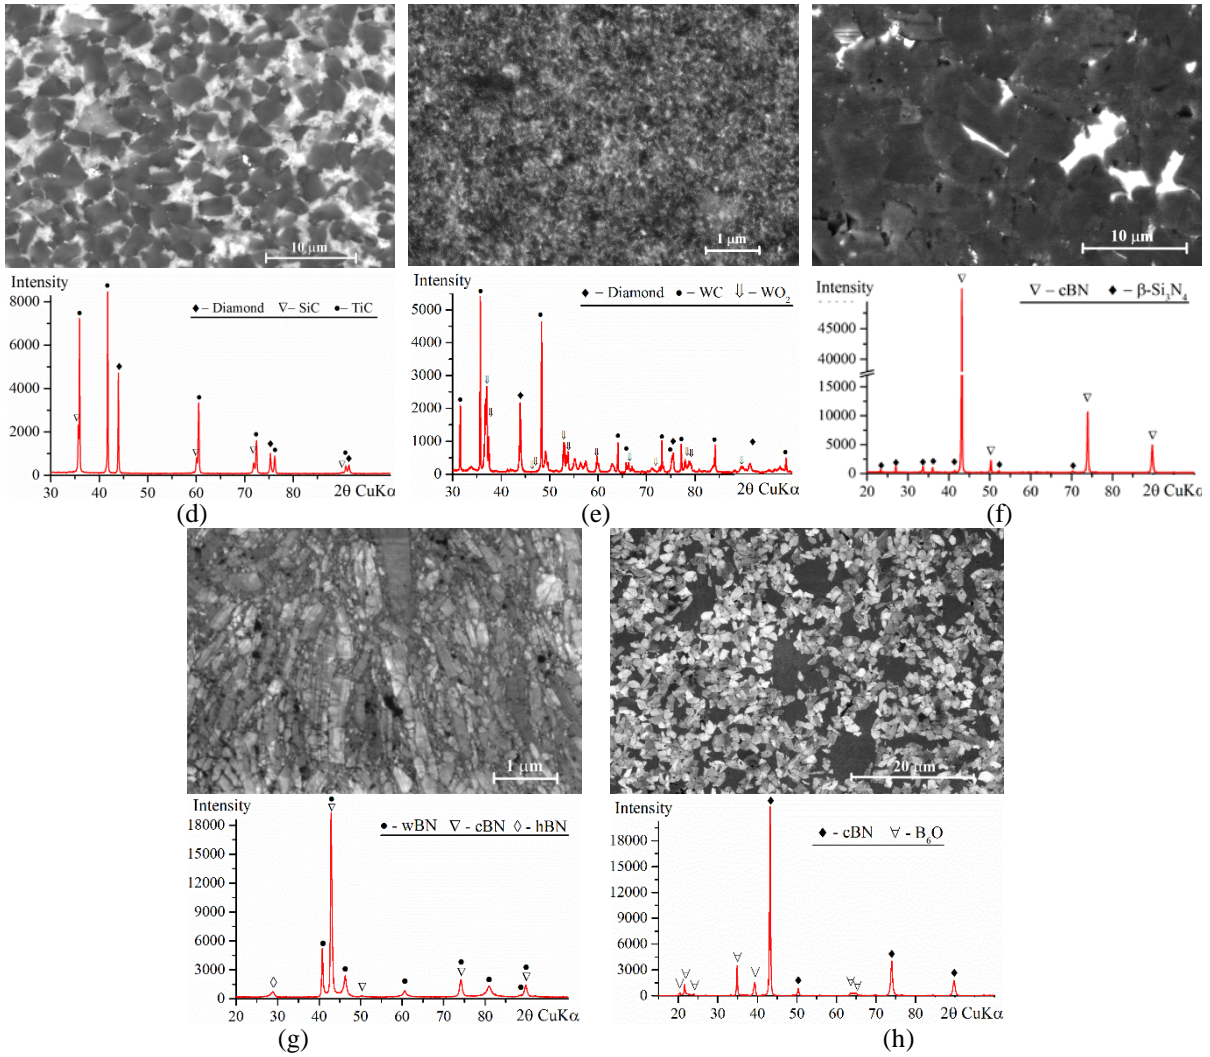
Fig. 2. SEM images of the microstructure and corresponding XRD pattern for tool materials: (a) D-Co, (b) D-SiC, (c) D-MAX₉₅, (d) D-MAX₆₀, (e) nD-nWC, (f) bcBN, (g) wBN-cBN, (h) B₆O-cBN.

2. D-SiC – thermostable polycrystalline composite which forms as a result of infiltration of molten silicon into the diamond preform and subsequent reaction of both phases with formation of silicon carbide matrix (Fig. 2.b). The material has hardness of $HV = 84$ GPa (Fig. 3), lower toughness of $K_{IC} = 7.6$ MPa·m^{1/2} and lower thermal conductivity of $k \approx 200$ W/(m·K) [8].

4. D-MAX₆₀ – similar experimental polycrystalline diamond material which contained 60 vol.% diamond and 40 vol.% Ti₃SiC₂ prior to the sintering (Fig. 2.d). Reduced diamond contents, compared to D-MAX₉₅, resulted in a lower hardness of $HV = 62$ GPa (Fig. 3).

5. nD-nWC – experimental material for which the nano-diamond (3-15 nm) is subjected to sintering with tungsten [10], the reaction products creating a nano-grained WC matrix (Fig. 2.e). Residual surface oxygen introduces an undesired by-product of WO₂. Softer WC matrix and presence of WO₂ cause a reduced hardness of $HV = 52$ GPa (Fig. 3).

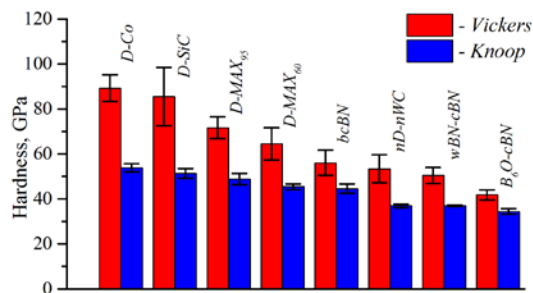
Fig. 3. Vickers and Knoop hardness of the tool materials.

3. D-MAX₉₅ – experimental polycrystalline diamond material where the bonding of diamond is realized via decomposition of Ti₃SiC₂ MAX-phase during the sintering, release of TiC, elemental silicon and titanium and their subsequent reaction with the diamond [9]. Mixture of 95 vol.% diamond and 5 vol.% Ti₃SiC₂ was subjected to the sintering process (Fig. 2.c). The sintering resulted in a material with hardness of $HV = 71$ GPa (Fig. 3).

Cutting forces were continuously recorded with Kistler 9129AA dynamometer, while tool wear and surface roughness were regularly inspected after 500 – 600 meters of machining. Leica MZ16 stereomicroscope was used for the measurement of flank wear VB , while Alicona InfiniteFocus 3D optical microscope was used for 3D analysis of worn tools. LEO/Zeiss 1560 high resolution scanning electron microscope (SEM) was used for the detailed inspection of the tool and workpiece material microstructure, worn tools, machined surface and sub-surface. FEI NanoLab 600 dual beam microscope was used for lamella preparation using focused ion beam (FIB) lift-out technique [15]. JEOL 3000F transmission electron microscope (TEM) was used for imaging, selected area electron diffraction (SAED) and energy dispersive X-ray (EDX) analysis (SDD X-Maxⁿ EDX system, Oxford Instruments). XRD analysis of tool materials was done on STOE Darmstadt diffractometer with $\text{CuK}\alpha$ source. Hardness of the tool materials was measured with Vickers and Knoop indenters at load 4.9 N (see Fig. 3) on Ernst Leitz Wetzlar microhardness tester.

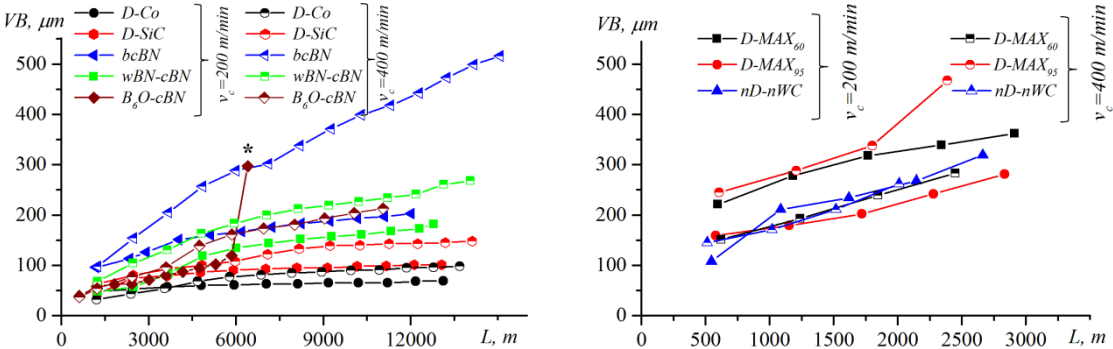
Fig. 4. Tool wear development when machining with (a) high performance and (b) low performance tooling.

Fig. 4 shows the development of the flank wear VB for all tool materials at both cutting speeds employed. Based on the results of the tests, the materials can be grouped into high- and low-performance ones. Fig. 4.b shows that both diamond-based materials with MAX-phase binders and the nano-diamond tooling reached the tool life criterion of $VB = 300 \mu\text{m}$ within the first 2500 – 3000 meters of tool engagement. All other tool materials (Fig. 4.a) were tested for the engagement of 14 000 meters. It can be seen that the increase in the cutting speed from $v_c = 200 \text{ m/min}$ to 400 m/min results in the increases of the tool wear for the high-performing tooling. On average, 50 % to 100 % intensification of the tool wear is attributed to the increased cutting speed.

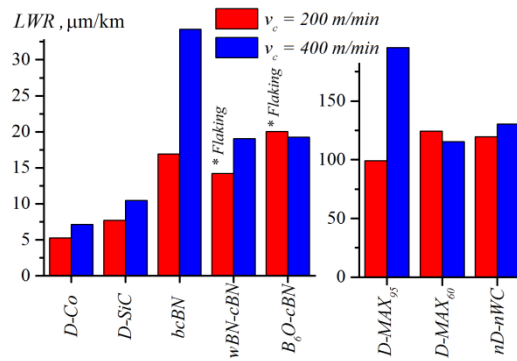
Fig. 5. Linear wear rate (LWR) for different tool materials.

Fig. 5 presents the tests results in terms of linear wear rate ($LWR, \mu\text{m}/\text{km}$), defined as the ratio of the tool wear to the engagement distance measured within the normal wear region. It shows that D-Co material, the hardest among the tested (Fig. 3), possesses the highest wear resistance. The same relation is observed for D-SiC tool material that is the second hardest (Fig. 3), which follows the trend typical for abrasive wear. However the other diamond based materials have extremely low wear resistance due to, as shown later, intensive adhesive wear. The expected relation between the tool material hardness and the wear resistance was not directly followed for cBN-based materials either. wBN-cBN and B₆O-cBN tools showed lower linear wear rates at $v_c = 400 \text{ m/min}$ than that harder binderless cBN tool grade. This is related to the stable adhesion of the MMC workpiece material to the tool contact surfaces, mostly the rake, for these grades and protection of the tool against the abrasion of the incoming SiC particles. Even more intensive adhesion of the MMC to the tool surfaces for wBN-cBN and B₆O-cBN at lower cutting speed of $v_c = 200 \text{ m/min}$ (Fig. 22.b) resulted in flaking and chipping on the tool rake as indicated on Fig. 5.

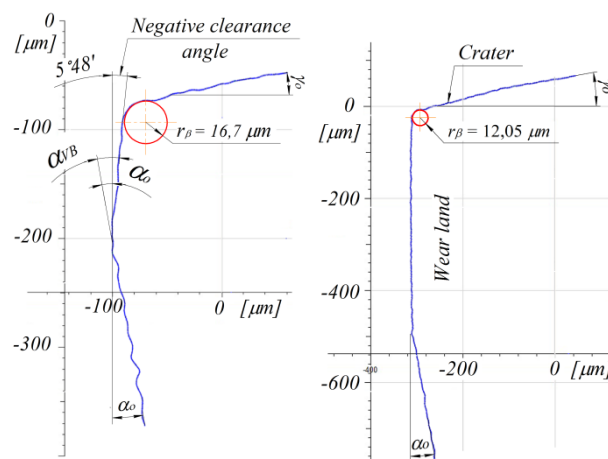
Fig. 7. Cross-sectional data for the worn (a) D-SiC and (b) bcBN tools ($v_c = 400 \text{ m/min}$).

Subsequent analysis of the worn tools with the help of 3D microscopy has revealed that flank and crater wear do not completely characterize the wear topography. The original edge radius of $r_\beta = 15 \mu\text{m}$, identical for all tools, changed in the course of tool wear, as illustrated on Fig. 7. Apart from the edge radius, clearance angle α_{VB} (Fig. 7.a) was also found to deviate from its nominal value, which for the given insert and toolholder geometry should equal $\alpha_o = 9.7 \text{ deg}$. [16]. Fig. 7 shows that a negative clearance angle is forming on the D-SiC tool, while bcBN grade attains the theoretical value.

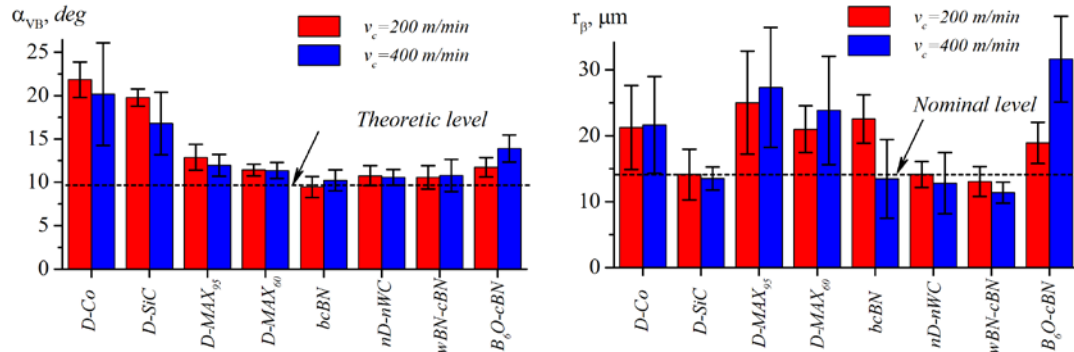
Fig. 8. Measurement results of (a) clearance angle and (b) edge radius for worn tools.

Fig. 8 summarizes the results of the measurement of edge radius r_β and clearance angle α_{VB} for different tool materials and test conditions. It shows that D-Co and D-SiC materials, which have the highest performance, form a highly negative clearance angle. This negative clearance angle is observed on the

etched tools, while the same measurement done prior to the etching indicates that the angle is on the level of the nominal one. This indicates that the workpiece material layer is adhering to the tool flank of D-Co and D-SiC tool and also acts as the tool protection layer (TPL) against the abrasion by SiC particles, which is also discussed later in the article. For other tooling materials the TPL was observed only on the rake.

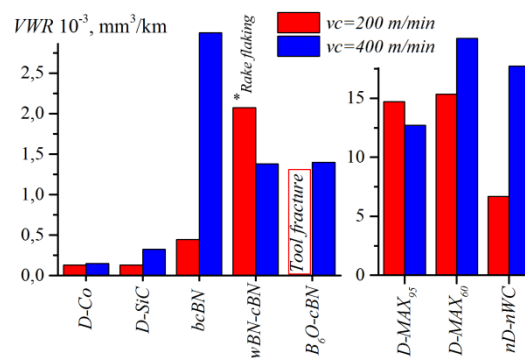
Fig. 9. Volumetric wear rate (VWR) for different tool materials.

Formation of the negative clearance angle and presence of crater wear for several grades indicate that both the flank wear VB and linear wear rate LWR do not completely characterize the intensity of the wear process and that the volumetric changes should be accounted for. Volume difference measurement (VDM) module of the 3D microscope was used for such analysis. The VDM method calculates the difference between the surfaces of new and worn tool in the same location as exemplified for bcBN tool in Fig. 6. Fig. 9 summarizes the calculated results of the volumetric wear rate (VWR , mm^3/km) determined with the use of VDM method. It can be seen that diamond tool materials with MAX-phase binder have high wear rate which has minor dependence on the cutting speed. This is related to the adhesive pluck out of the diamond grains and binder (see Fig. 10.a) due to poor binding between these phases. For other materials the wear surfaces have smoothed appearance with apparent scratches due to abrasive wear, as exemplified for the D-SiC tooling shown on Fig. 10.b. Fig. 10.b also shows that diamond phase attained minimal abrasive damage while the softer SiC binder has been preferentially abraded from the tool rake.

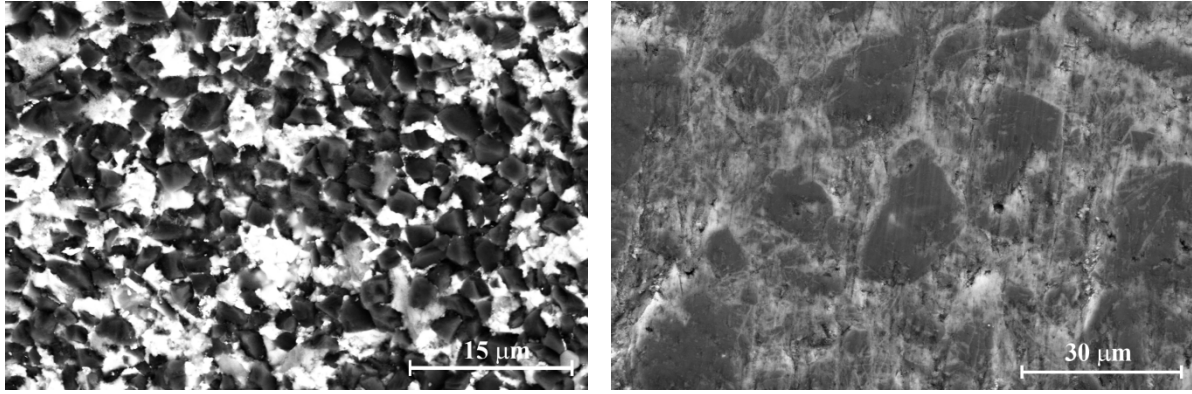
Fig. 10. SEM images of non-etched worn rake surface for (a) D-MAX₆₀ and (b) D-SiC at $v_c = 200$ m/min.

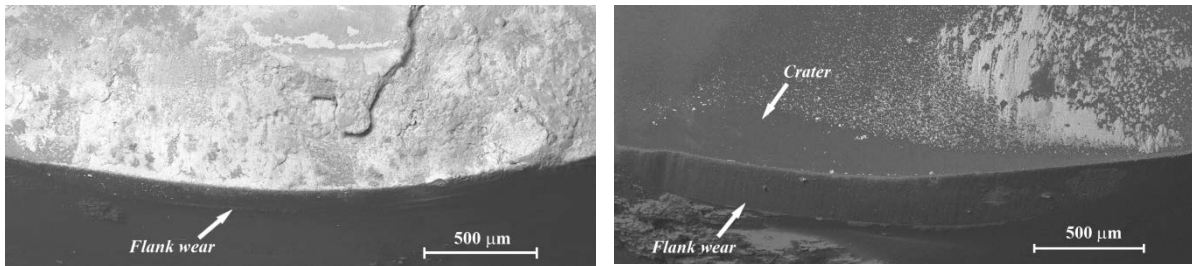
Fig. 11. SEM images of bcBN tools worn at cutting speed (a) $v_c = 200$ m/min and (b) $v_c = 400$ m/min.

The dramatic difference in the volumetric wear rate (VWR) for machining at $v_c = 200$ m/min and $v_c = 400$ m/min with bcBN tooling is related to the changes in formation and retention of the tool protective layer that forms due to built-up of workpiece material on the tool surfaces. Fig. 11.a shows that the entire rake of the bcBN tool is covered with the TPL at $v_c = 200$ m/min, yet only a minor workpiece adhesion outside the cutting area is observed in the case of $v_c = 400$ m/min. Continual microscopic observations for the case of $v_c = 400$ m/min have shown that only a slight TPL was forming on the tool at the initial engagement, but was destabilized and removed in the course of machining with the progression of tool wear. For all other high-performing tool materials the TPL was maintained at all test conditions, even though the stability and dimensions of the TPL were decreasing at increased higher speed.

Another aspect of intensification of tool wear with the increase of cutting speed from 200 m/min to 400 m/min can be attributed to the reduction or destabilization (Fig. 11) of TPL, thus reducing its protective action. Andrewes et al. [25] argue that the higher hardness of diamond, compared to SiC, turns abrasive wear into a micro-mechanical damaging phenomenon, rather than micro-cutting one. Such mechanism of localized cracking and removal of the hard and brittle tool materials, similarly to the case of erosive wear [26], would explain the intensified wear rate observed at higher cutting speed. Formation and propagation of such localized cracks upon high energy impact of hard workpiece inclusions, such as SiC particles, is likely to intensify at high cutting speed. Indeed, Fig. 22.a shows evidence of cracking and partial removal of diamond grains from the rake surface of the worn D-Co tool and Fig. 22.b-c show evidence of a network of cracks forming in D-Co tool during the metal cutting. Co is expected to be found in all cracks formed during the tool liquid state sintering, while any cracks formed during metal cutting are expected to lack Co signal. In the high magnification image and elemental maps (Fig. 22.b-c) three cracks are visible, all connected to the major crack displayed in Fig. 21. The three cracks contain Si whereas only one contains Co, indicating that two were formed during cutting, in the absence of liquid Co. Loss of Co due to diffusional wear (Fig. 21) is expected to reduce the bonding and facilitate the cracking and breakage of diamond grains. It is expected that reduction or removal of TPL at high cutting speed of $v_c = 400$ m/min for all tooling leads to a higher intensity of SiC particles impacts and thus to accelerated tool wear.

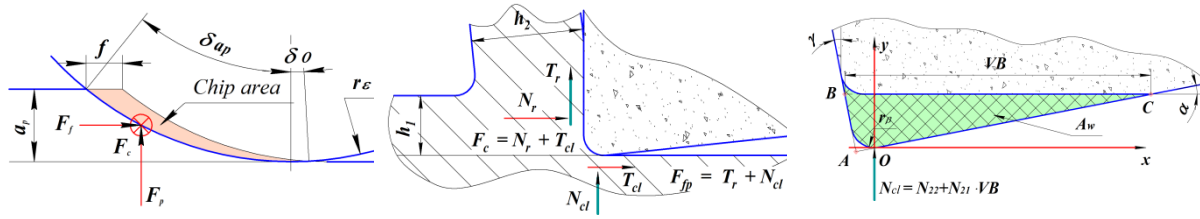
Fig. 12. Schematic of (a) cutting forces acting on a tool, (b) decomposition of forces acting on the rake and clearance for a new tool, (c) normal force N_{cl} on the worn clearance and respective wear area A_w .

where A_w – cross-sectional wear area (Fig. 12.c), b – active length of the cutting edge (Fig. 12.a), H_{tool} – hardness of the tool material (Fig. 3), N_{cl} – normal force acting on the clearance (Fig. 12.b), and e – tool engagement distance.

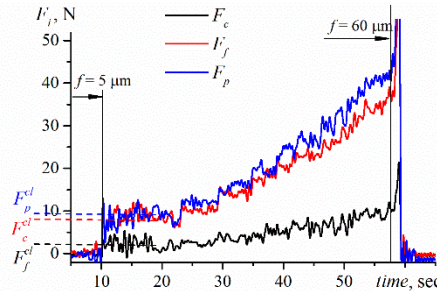
Fig. 13. Development of cutting forces while continuously increasing feed ($f = 5 - 60$ $\mu\text{m}/\text{rev}$) for new D-Co tool ($v_c = 200$ m/min).

The normal force on the clearance N_{cl} for a new cutting tool can be identified by extrapolation of the F_f and F_p forces to the zero chip thickness [19], i.e. the moment when the tangential component T_r equals zero. Figure 13 shows an example of recorded cutting forces for machining MMC with the new D-Co tool at cutting speed $v_c = 200$ m/min when the feed was continuously increased from 5 to 60 $\mu\text{m}/\text{rev}$. The Figure 13 indicates that up to the feed of $f \approx 15$ $\mu\text{m}/\text{rev}$, which corresponds in our case [20] to the maximum theoretical chip thickness of $h_{1max} = 4.9$ μm , the force components remain constant and represent the actual cutting forces acting only on the tool clearance.

while the force component F_c^{cl} (Fig. 13) represents the tangential force on the clearance T_{cl} .

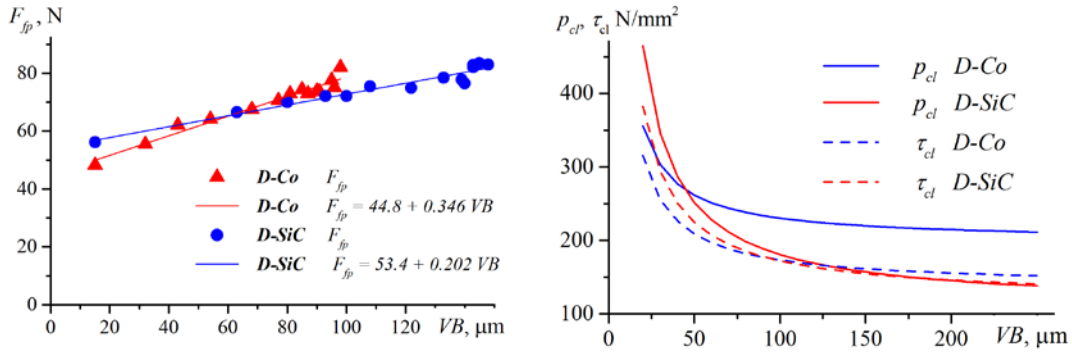
Fig. 15. (a) Resultant force component F_{fp} and (b) respective average normal pressure p_{cl} and tangential stress τ_{cl} on the tool clearance as a function of wear land VB for D-Co and D-SiC ($v_c = 400$ m/min).

Combination of Eq. 2 and Eq. 3 with the force vs. VB data similar to ones on Fig. 14 allows determination of the influence of the wear on the force F_{fp} . Fig. 15.a shows the examples of such calculated influence for the case of D-Co and D-SiC tool when machining MMC with $v_c = 400$ m/min. The slope of the line (Fig. 15.a) describes the influence of the tool wear and therefore the normal force on the clearance for worn tool can be calculated as:

where N_{22} is the value for new tool (Eq. 3) and N_{21} is the tangent of the slope angle (see Fig. 15.a). Similarly, the tangential force can be described as $T_{cl} = T_{22} + T_{21} \cdot VB$.

Figure 15.b illustrates the influence of tool wear on the determined contact stresses for machining with D-Co and D-SiC tools. It can be seen that the contact stresses in both cases are reducing with the increase of VB , yet for D-SiC tool such reduction is more pronounced. This should be attributed to the larger edge radius r_β and negative clearance angle α_{VB} that develop on the D-Co tool in the course of tool wear (Fig. 8) and the associated larger forces acting on the clearance possessing similar VB .

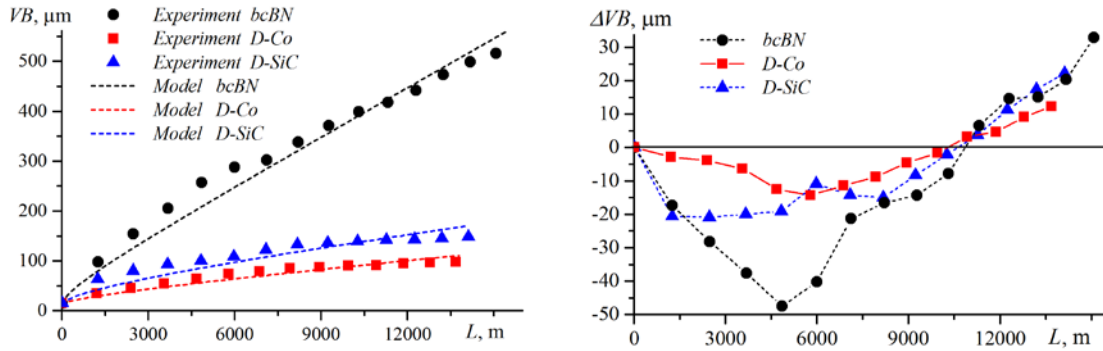
Fig. 16. (a) Modeling results for Archard wear model and (b) difference between model and experimental data for bcBN, D-Co, and D-SiC tools ($v_c = 400$ m/min).

Figure 16.a shows the results of the modelling and the experiments exemplified for several high-performing materials. Good match between the model and the machining data with the correlation coefficient of 0.96-0.99 indicates the applicability of the model for the description of the tool wear. However a slight underestimation can be observed on the initial engagement alongside with the minor overestimation at the end of tool engagement. The difference between the model and the experiments observed over the entire tool engagement is shown in detail on Fig. 16.b. Such behavior can be explained by the change in the conditions of the abrasion process during the cutting process. As mentioned earlier, the formation and retention of the TPL varies during the cutting. Initial formation of the TPL was observed during the first 500-1000 meters of engagement, while it attained the stable form after 2500-4000 meters, depending on tool material and cutting speed. More intense tool wear can be expected at the absence of TPL and therefore the model is likely to underestimate the wear rate. This means that the wear constant K used in the model changes its value as a result of variation tribologic conditions in the course of the test.

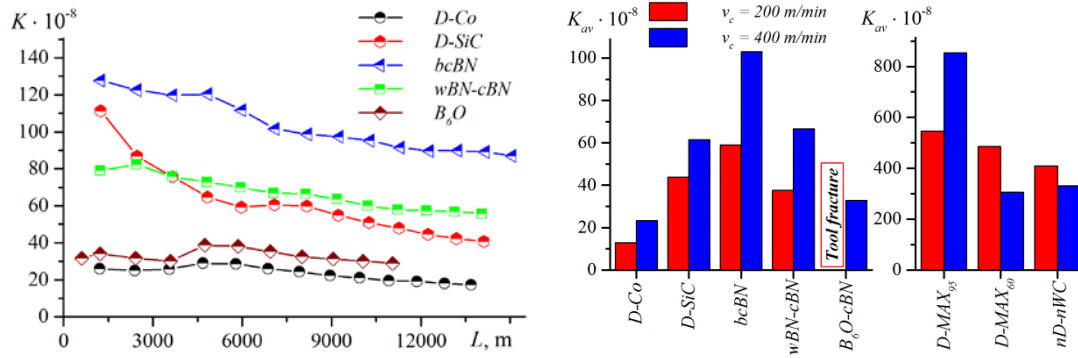
Fig. 17. (a) Variation of wear coefficient K during machining process ($v_c = 400$ m/min) and (b) average value of coefficient K for different tool materials.

Fig. 17.a shows that K value, and thus the wear resistance of the tool material, initially decreases and eventually approaches some asymptotic value upon longer tool engagement. The tool run-in and stabilization of TPL are related to this initial period. Fig. 17.b presents the average value of K over the entire cutting process. This value characterizes the tribologic wear conditions, irrespectively of the hardness of the tool material H_{tool} , and therefore can be used for judgement of the wear process itself. For example D-Co and B₆O-cBN tool materials have similar K value for tests at $v_c = 400$ m/min and in both cases the edge radius r_β (Fig. 8.b) for the worn tools and the dimensions of TPL are similar too.

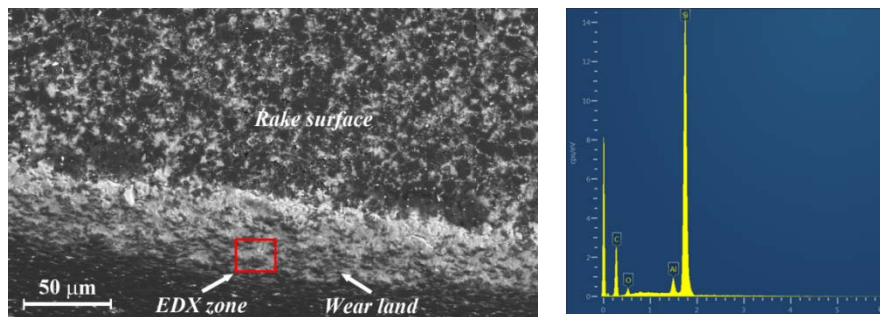
Fig. 18. (a) SEM close-up view of worn D-Co insert ($v_c = 400$ m/min) after etching, (b) EDX spectrum for layer adhered to the wear land.

Removal of the tool protection layer by etching prior to 3D optical microscopy revealed additional features of the wear process. Post-etching reevaluation of the tool wear with SEM (Fig. 18.a) have shown that for D-Co and D-SiC tools a layer remains attached to the tool surfaces, even after prolonged etching. EDX analysis of the chemical composition of this layer has shown that the main constituents are Si and C, and also contains minor quantities of Al and O (see Fig. 18.b).

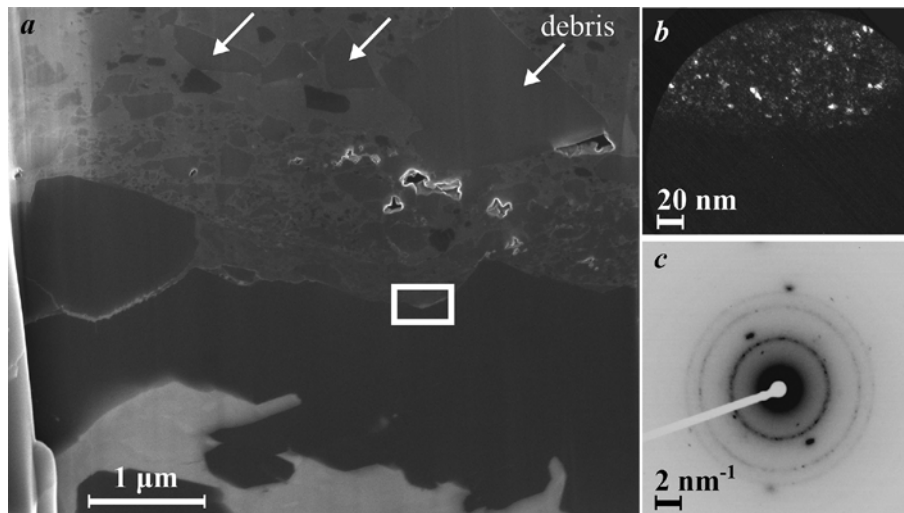
Fig. 19. (a) SEM image of the FIB prepared lamella and (b) dark field TEM image from the interface region between D-Co and TPL ($v_c = 400$ m/min). (c) SAED (inverted contrast) of the same region as in (b).

A lamella for TEM analysis was prepared using FIB lift-out in order to fully study transition from TPL, through this etch-resistant layer, to the tool material. The flank wear land of a non-etched D-Co tool was chosen for this purpose. Fig. 19 shows SEM and TEM images of the interface between D-Co and TPL, where the lower part of the image is of the tool and the top part is the TPL. Scanning TEM (STEM) EDX analysis proved that the layer mainly consists of SiC with about 1 at% of O and 2 at% Al. Dark field TEM imaging (Fig. 19.b) demonstrates nano-structuring of the layer with the typical grain size of about 2-3 nm, with an upper limit of 10 nm. The very dense diffraction rings observed in the selected area electron diffraction patterns (Fig. 19.c) support the nano-structuring. The diffraction rings match the lattice spacing of zinc blende SiC {111}, {022} and {113} -planes, respectively.

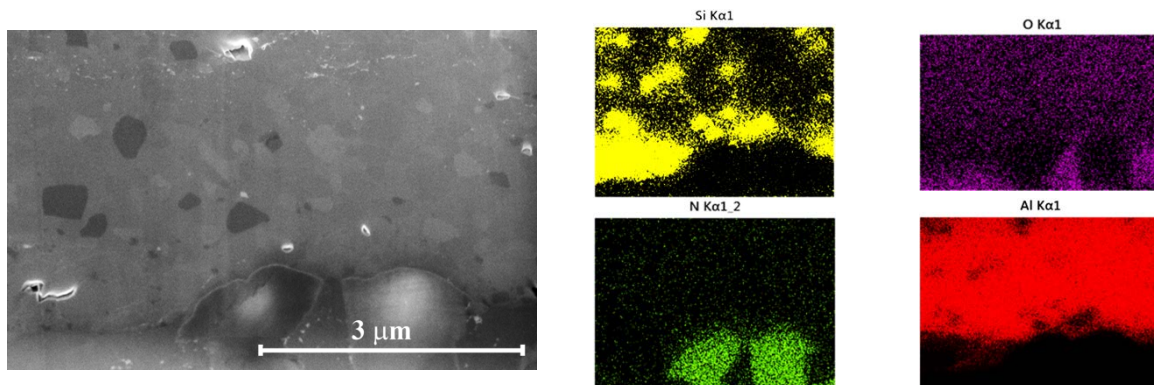
Fig. 20. EDX map of a sample FIB milled from the TPL on the crater of non-etched B₆O-cBN insert ($v_c = 200$ m/min).

Analysis of a similar FIB milled lamella extracted from the B₆O-cBN tool (Fig. 20) indicates absence of chemical interaction between tooling and MMC. In this case the TPL contains fine debris particles of eutectic Si, from the matrix of the MMC material, which are loosely located on the contact surfaces. Which is in opposition to the nano-crystalline SiC layer on D-Co that is intimately attached to the diamond. This indicates that not only the intensity of formation of the TPL is different between diamond and cBN-based tooling, but also the composition and attachment of the TPL is affected.

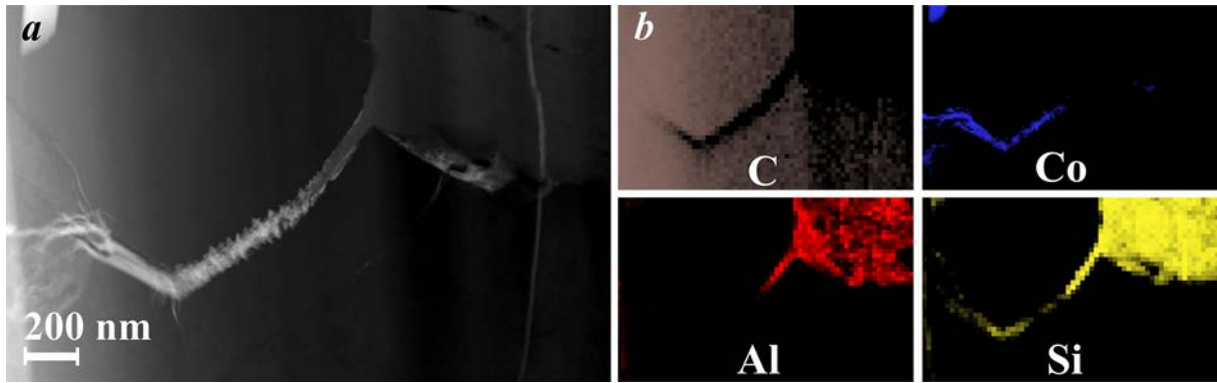
Fig. 21. (a) STEM HAADF image and (b) EDX elemental maps (C $K\alpha_{1,2}$, Co $K\alpha_1$, Al $K\alpha_1$, Si $K\alpha_1$) of a FIB lamella in the crack region of the D-Co tool ($v_c = 400$ m/min).

The evidence for diffusion wear in D-Co tooling can be seen in Fig. 21.a which is depicting high angle annular dark field (HAADF) image of a crack in the D-Co tool, also visible on Fig. 19.a. From the STEM EDX elemental maps (Fig. 21.b) it is clear that Co is present in the majority of the crack. This indicates that the crack was formed in the presence of liquid Co, i.e. during sintering of the tool material. However, an approx. 0.5 μm long region of the crack opening (close to the TPL) did not bear any Co signal, instead, Al and Si was found in this region. Si is also present, to a lesser amount, throughout the rest of the visible crack. This clearly shows the diffusional removal of Co from the tool into the workpiece material, its replacement by Si and Al from the MMC matrix, and strong ingress of Si throughout the Co phase.

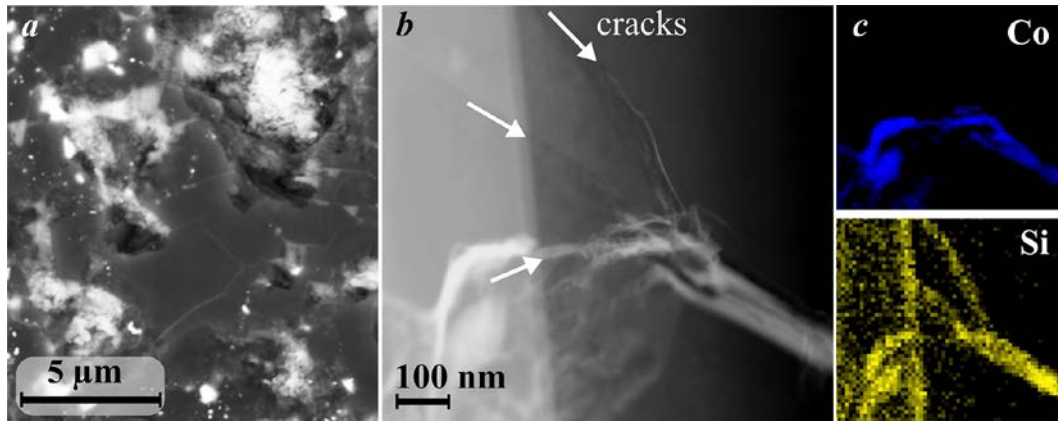
Fig. 22. (a) SEM image of cracking and fracturing of diamond grains on the rake of D-Co ($v_c = 200$ m/min), (b) STEM HAADF image of the crack network in D-Co ($v_c = 400$ m/min) and (c) EDX elemental maps (Co $K\alpha_1$, Si $K\alpha_1$) of the same region.

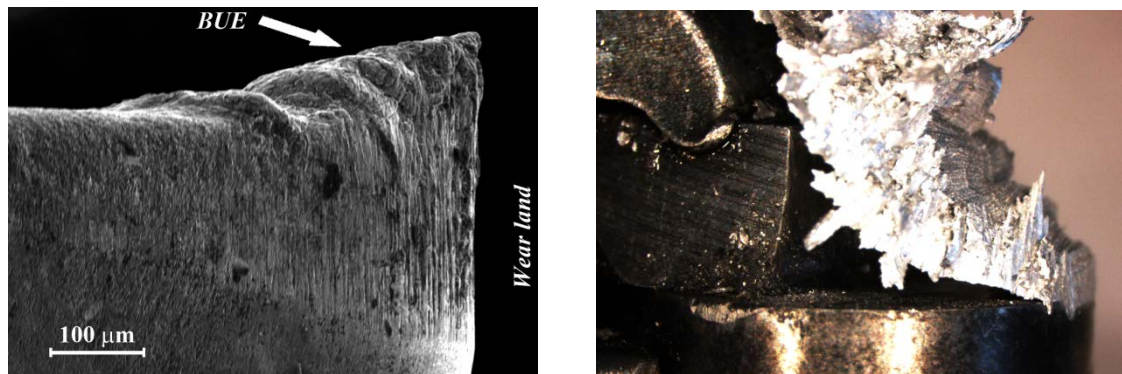
Fig. 23. (a) SEM image of build-up edge on the D-Co tool ($v_c = 200$ m/min) and (b) optical image of seizure of the chips to the rake of B_6O -cBN tool ($v_c = 200$ m/min).

Even though TPL has a positive effect on the tool life, its excessive formation is the cause of built-up edge (BUE) as shown on Fig. 23.a. In case of B_6O -cBN and wBN-cBN superhard tool materials such excessive BUE resulted in seizure of the chips to the tool (Fig. 23.b), which eventually lead to rake flaking (Fig. 4.a and Fig. 9.a) and edge chipping.

The size of BUE, as shown on Fig. 23.a, is around 100 to 150 μm while the roughness in the respective case was only $Ra = 1.1 - 1.5 \mu\text{m}$. Cross-sectional analysis of the chips and the machined surface was performed in order to identify the cause of such difference. Fig. 25.a shows that the built-up edge predominantly remains with the chips while only a small fraction of BUE remains on the machined surface. It can be assumed that flank wear land of the tool additionally smoothens the machined surface after BUE breakage (Fig. 25.b), thus reducing its negative influence on the surface quality.

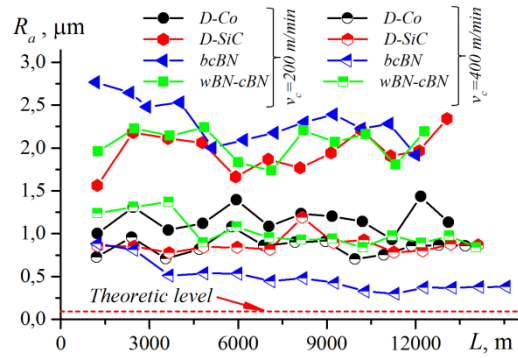
Fig. 24. Development of the surface roughness during the machining process.

Formation of BUE, apart from its direct effects on the tool life and tool wear, negatively affects the roughness and integrity of the machined surface. Fig. 24 shows that the obtained roughness in all machining cases was significantly higher than the theoretically calculated value. Only in the case of bcBN machining at speed $v_c = 400$ m/min, which is accompanied by the loss of TPL, the surface roughness approached the expected level. Machining at $v_c = 200$ m/min is characterized by surface roughness being approximately two times higher, for respective tool materials, than the surface quality at higher cutting speed. This is related to the decrease of BUE dimensions with increased cutting speed and follows previous findings [7].

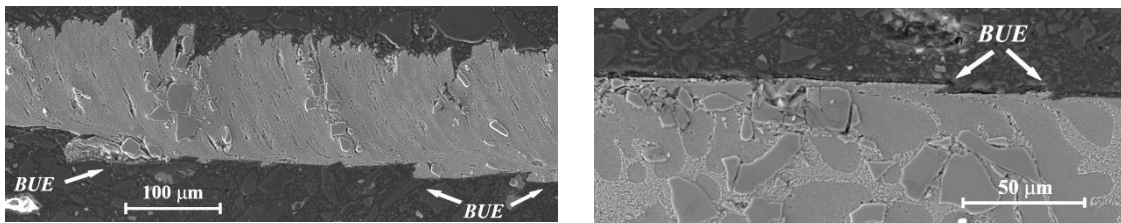
Fig. 25. SEM images of elements of build-up edge on (a) chips and (b) machined surface for D-Co tool ($v_c = 200 \text{ m/min}$).

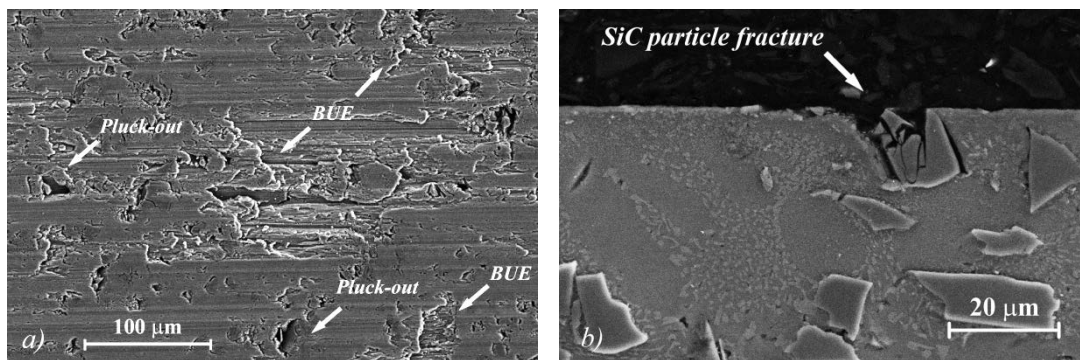
Fig. 26. SEM image of (a) machined surface and (b) subsurface with D-Co ($v_c = 200 \text{ m/min}$).

On the other hand BUE is not the only source of increased surface roughness. Fig. 26.a shows that intensive SiC particle pluck-out in the course of the cutting process deteriorates the machines surface significantly. Fig. 26.b presents the details of the machined subsurface which reveal that fracture of the SiC particles by the incoming cutting edge and subsequent pluck-out of the SiC debris by the workpiece material adhered to the tool flank leaves pores and cavities, as deep as 10-20 μm , on the machined surface. Fig. 26.a also confirms that partial smoothing of the BUE remains over the machined surface by the tool flank.
