Cleaning of ultra-high temperature milk fouling -Structural and compositionl changes

Hagsten, C. (2016). *Cleaning of ultra-high temperature milk fouling -Structural and compositionl changes*. [Doctoral Thesis (compilation), Physical Chemistry]. Department of Chemistry, Lund University.

Cleaning of ultra-high temperature milk fouling

Structural and compositional changes

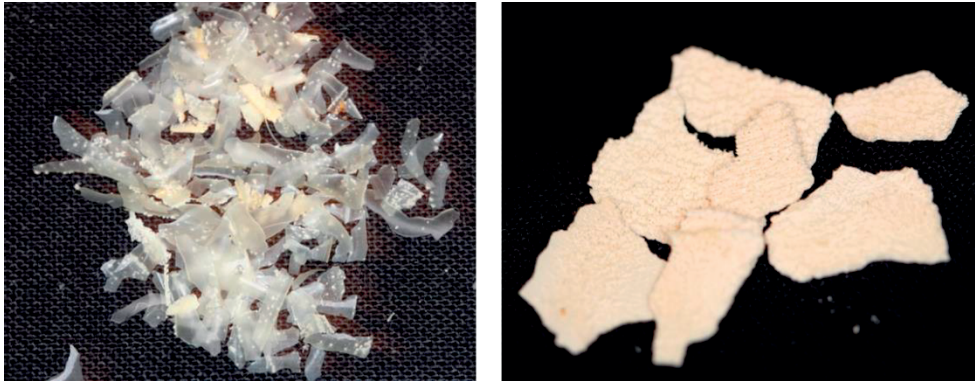
Figure 3 Image showing the low-temperature, protein-rich fouling produced in the pre-heating section (left panel). This fouling type is thin and translucent, whereas the mineral-rich UHT fouling (right panel) is thicker and has a rough surface.

Two main types of fouling occur in dairy processing equipment during heat treatment of milk: 1) low-temperature fouling, also known as type A (<100°C); and 2) high-temperature fouling, termed type B (>120°C) [14]. The two types of fouling layer are different in appearance; type A is soft and voluminous, while type B fouling has a hard, gritty surface. In the present study, in the preheating section at type A temperature, the fouling is very thin and translucent. Within the fouling, small islands of the more compact structure, similar to the fouling from the UHT section can be seen (Figure 3). The UHT fouling in this project has a rough structure, and the fouling layer is thicker and harder but becomes brittle when dried. The protein content of the low-temperature fouling is high, at around 60%, although this content is drastically decreased at higher temperatures. The mineral content has the opposite profile of temperature-dependence as compared with the protein content, and the mineral content in the high-temperature fouling is around 70% [14]. This composition is also confirmed in Paper II.
