Investigation of shallow leakage zones in a small embankment dam using repeated resistivity measurements in Internal erosion in embankment dams and their foundations

Sjödahl, Pontus; Johansson, Sam; Dahlin, Torleif

Investigation of shallow leakage zones in a small embankment dam using repeated resistivity measurements

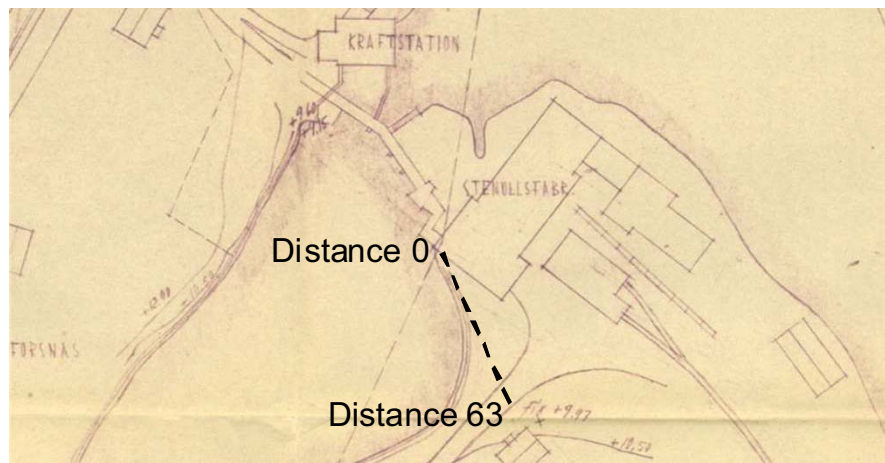
Fig. 2 Plan over the power plant and embankment dam with electrode layout.

The embankment dam was cleared of vegetation. Two lines of electrodes were installed along the dam crest. Both lines started closed to where the embankment dam connects to the spillway dam. The first line then followed the dam curvature along the upstream side of the crest, whereas the second line was placed straight across the asphalted area in front of the workshop building. After a quick first test the second line was chosen for the repeated measurements due to lower noise levels. The position of this line is shown in Fig. 2. Each electrode location was carefully positioned and levelled.

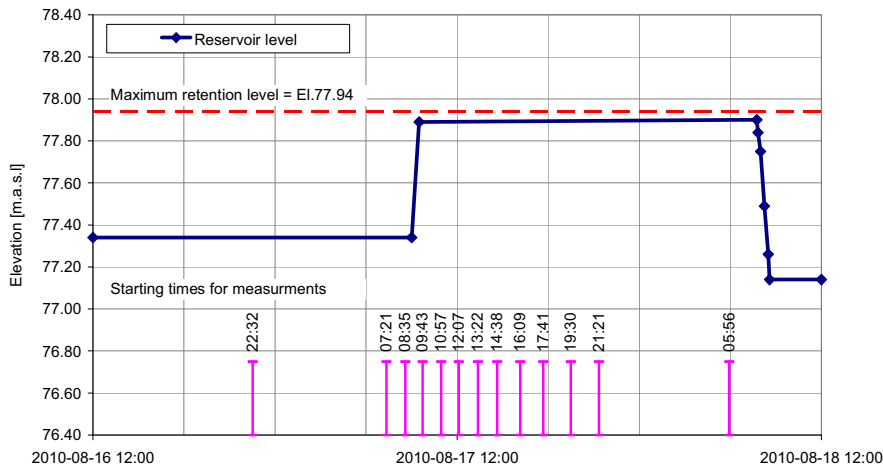
Fig. 3 Reservoir levels and starting times for measurements.

Repeated measurements were taken during a period of two days (Fig. 3). Each measurement sequence had an identical setup. Data collection time for one sequence was in the order of one hour. The first two measurements were taken with low reservoir, the third during filling and the following with high reservoir level. In total 13 measurements were taken.
