Investigation of shallow leakage zones in a small embankment dam using repeated resistivity measurements in Internal erosion in embankment dams and their foundations

Investigation of shallow leakage zones in a small embankment dam using repeated resistivity measurements

keywords: seepage, detection, resistivity, embankment dam

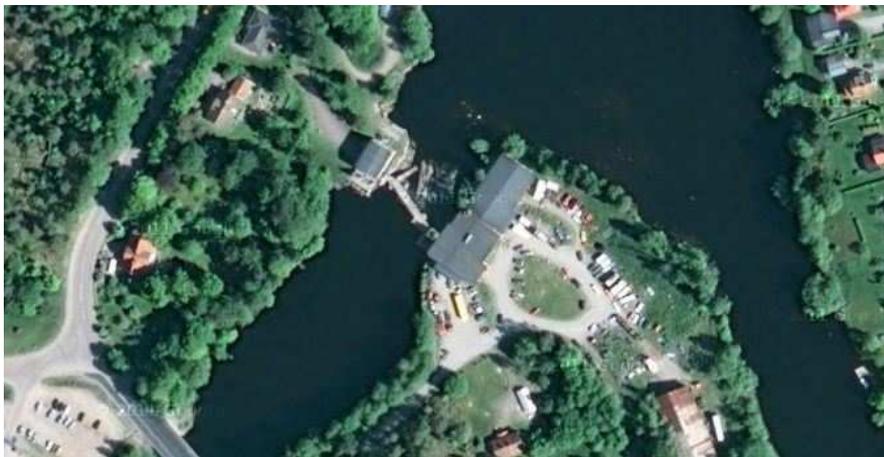
Fig. 1 Plan view over from left to right: the power plant, spillways, workshop building and embankment dam (from Google maps).

The plant is situated in central Sweden. It consists of a power plant, a concrete dam with gates, a workshop building and an embankment dam (Fig. 1). The embankment dam is less than 100 meters long and less than 10 m high.

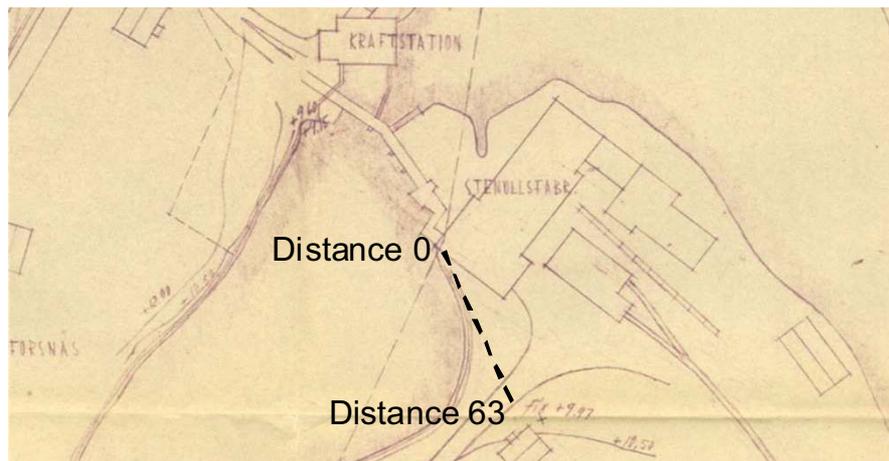
Fig. 2 Plan over the power plant and embankment dam with electrode layout.

The embankment dam was cleared of vegetation. Two lines of electrodes were installed along the dam crest. Both lines started close to where the embankment dam connects to the spillway dam. The first line then followed the dam curvature along the upstream side of the crest, whereas the second line was placed straight across the asphalted area in front of the workshop building. After a quick first test the second line was chosen for the repeated measurements due to lower noise levels. The position of this line is shown in Fig. 2. Each electrode location was carefully positioned and levelled.

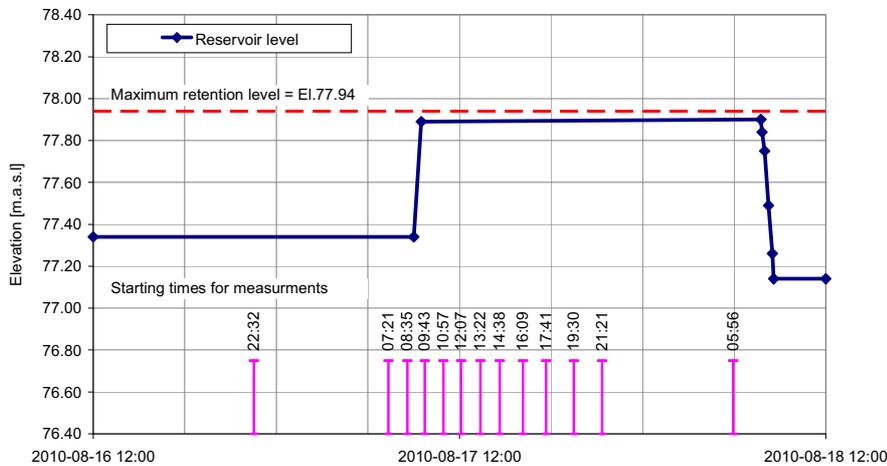
Fig. 3 Reservoir levels and starting times for measurements.

Repeated measurements were taken during a period of two days (Fig. 3). Each measurement sequence had an identical setup. Data collection time for one sequence was in the order of one hour. The first two measurements were taken with low reservoir, the third during filling and the following with high reservoir level. In total 13 measurements were taken.

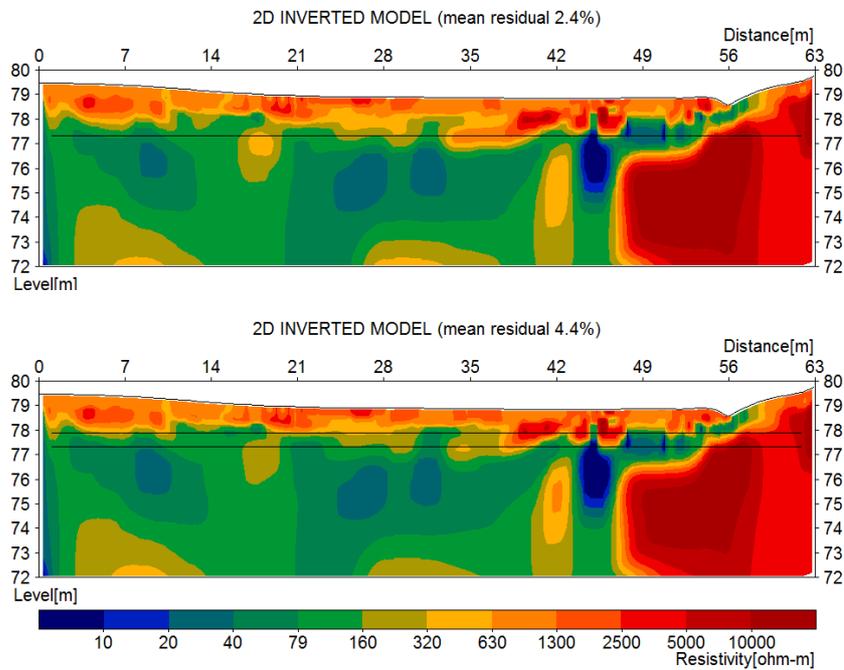
The resistivity distribution in the dam indicates homogeneous conditions along most part of the dam (Fig. 4). In the shallow parts there is an approximately 2 m deep layer with higher resistivity (ca 1000 Ω m), which most likely is representing dry earth material above the groundwater level. Due to the asphalt covering the ground this material has been protected from rainwater. Consequently, there is a rather large contrast in resistivity to the underlying material where the resistivity is significantly lower (ca 100 Ω m).

Fig. 4 Resistivity distribution in the dam from the first measurement 2010-08-16, 22:32 (above) and the last measurement 2010-08-18, 05:56 (below).

Marked lines show reservoir level at first and actual measurement.

Between distance 0 and 40 m the resistivity is uniform down to El. 72-73 m, where an increase in resistivity can be inferred. In the right part of the measured line (ca distance >46 m) there is an extensive zone with very high resistivity, which is interpreted as bedrock. At the end of the line the bedrock can be seen at the ground surface, which coincides with the interpretation as the high resistivity zone is clearly reaching the surface in this part.

At distance 44-45 m there is a small zone with very low resistivity. There are no observations or documentation to explain this zone. Rather, it is likely an artefact from the inverse modelling. In the inversion process it is often difficult to correctly map zones with large such high contrast in resistivity as is likely to appear close to a bedrock soil interface. In such zones the model may overshoot and produce resistivities lower than what would be expected. Similar tendencies can be seen in the area above the supposed bedrock level around distance 47-55 m.

Estimating the differences in modelled resistivities from the displayed sections in Fig. 4 is challenging. To emphasize on the dissimilarities of the models difference plots has been composed (Fig. 5). The first data set is used as a reference and the change in resistivity for the subsequent data sets are examined. The change in resistivity is shown after 2 hours (Fig. 5 above) and 21 hours (Fig. 5 below) respectively. Blue areas represent a decrease in resistivity and red areas represent an increase. Areas where the change is less than 20% have been blanked out as white.

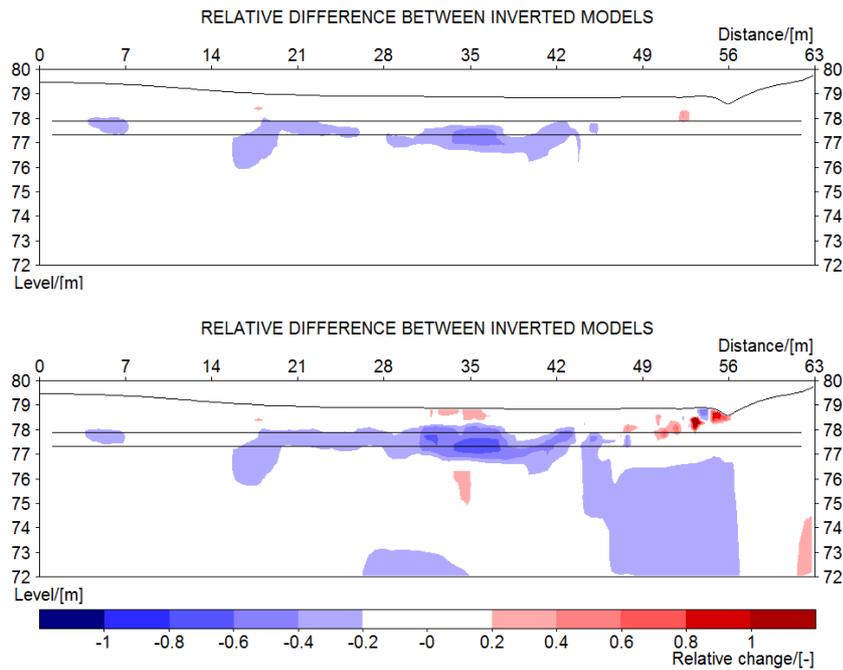
Fig. 5 Above: Difference plot between first and fifth measurement (after approx. 2 hours). Below: Difference plot between first and last measurement (after 21 hours). Marked lines show reservoir level at first and actual measurement.

Almost immediately after raising the reservoir the resistivity started to decrease along the dam at El. 77.34-77.89 m. The difference at this level, corresponding to the raise in reservoir level between the two measurements, is definitely the most apparent. This resistivity decrease corresponds well with the anticipated change in resistivity due to wetting of the soil and may be related to seepage. At this elevation the most prominent zone with decreasing resistivity is found with the centre at distance 35 m. By analysing the differences from all measurements one after another, the wetting process can be followed. A quick response is noticed at distances 5-6 m, 15-20 m and 30-40 m. The resistivity continued to decrease throughout the monitoring period in the area at distance 35, while in other areas the decrease stagnated.

The resistivity decrease in the presumed bedrock is probably caused by 3D effects, or inversion artefacts. In a few small areas a resistivity increase was noted. It might be due to drying out of shallow soil that was wetted by the intense rain that occurred in the days before the measurements started, as these areas were all situated outside the asphalt that protected most of the line from being wetted by the rain. Other possible explanations are noise or inversion artefacts in connection with the high contrast zones.
