Near Surface 2006 - 12th European Meeting of Environmental and Engineering Geophysics

Resistivity Imaging for Mapping of Groundwater Contamination at the Municipal Landfill La Chureca, Managua, Nicaragua

K. Forsberg (Engineering Geology, Lund University), A. Nilsson (Engineering Geology, Lund University), P. Flyhammar (Engineering Geology, Lund University) & L.T. Dahlin* (Lund University)

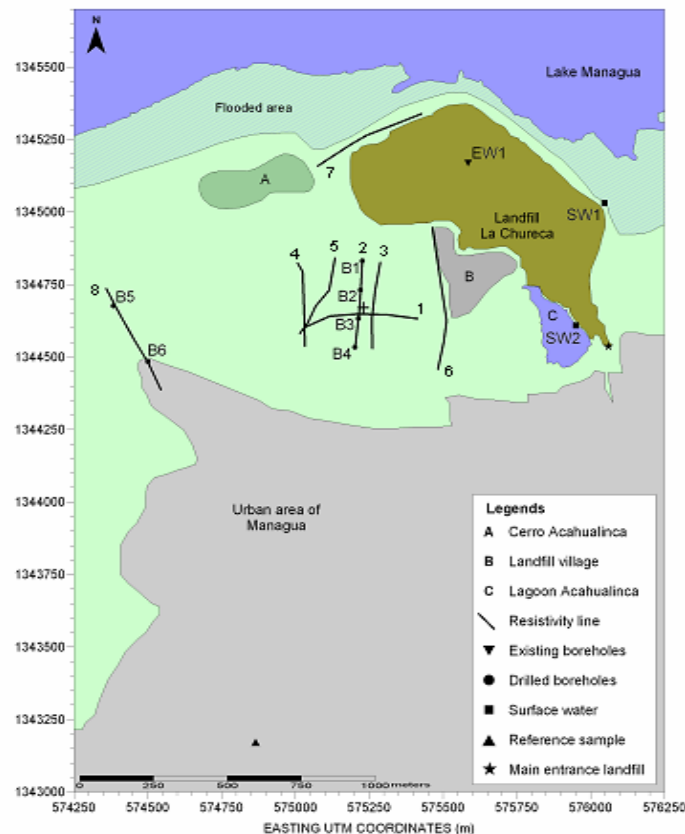
Figure 1 Map of the investigation site at the La Chureca Landfill. The position of resistivity lines (1-8), soil samples and ground water samples (B1-B6), reference ground water sample (RS), leachate water sample (EW1) and surface water samples (SW1 and SW2) are marked.

The investigation site is located in the grasslands SW-W of the La Chureca landfill (Figure 1). The landfill covers an area of approximately 40 ha and is delimited by Lake Managua to N and NE, which is situated 40 m.a.s.l.. The climate is tropic (Kogyo, 1995).

Resistivity surveys were performed with the multi channel data acquisition system ABEM Lund Imaging System. Eight lines (Figure 1), each between 300-500 m long and with a maximum investigation depth of 70 m, were measured. The inverted models were created using Res2dinv, and the results presented as 2D resistivity cross sections.

The resistivity sections were used as a base for selecting locations for drilling and sampling. Geology samples were collected during drilling along resistivity line 2 and 8 (Figure 1) to characterize different layers in the geological sequence. The drilling was performed with a geotechnical drilling track vehicle and a hand drill at 6 different locations (B1-B6), to depths between 3 and 11 meters.

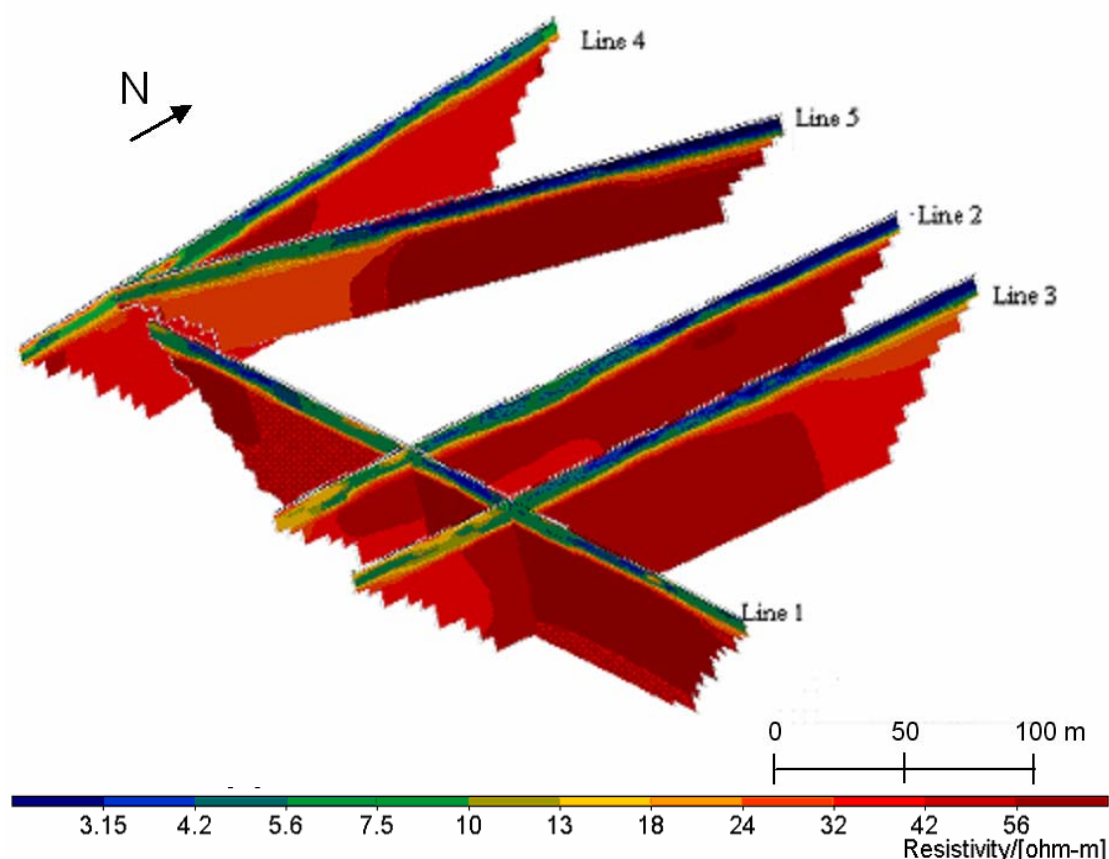
Figure 2. Fence diagram showing the inverted model sections from resistivity line 1-5.

The resistivity survey identified a general pattern of the electrical properties of the geological sequence within the investigation site, showing a zone with lower resistivity roughly within the top 10 meters (Figure 2). However, within this zone there is also a positive correlation between the resistivity and the distance to the landfill. The resistivity values are generally higher with less spatial variations along line 6 and 8 compared to line 1-5. Line 6 is located W of the oldest parts of the landfill, while line 8 is located 1000 m WSW of the landfill.

Soil samples from resistivity line 2 showed a geological sequence starting with a layer of organic soil, followed by different layers of permeable volcanic sediments of scoria and pumice. In one of the boreholes (B1), a compact layer of tuff was found at 10.4 meters. This correlates well with the increase in resistivity at that depth.
