DURABILITY AND AGEING OF SEALANTS

PER GUNNAR BURSTRÖM

REPORT TVBM-3003
LUND SWEDEN 1977

THIS REPORT REFERS TO PROJECT NUMBER 730221-4 FROM
THE SWEDISH COUNCIL FOR BUILDING RESEARCH TO THE
DIVISION OF BUILDING MATERIALS AT THE LUND INSTITUTE
OF TECHNOLOGY

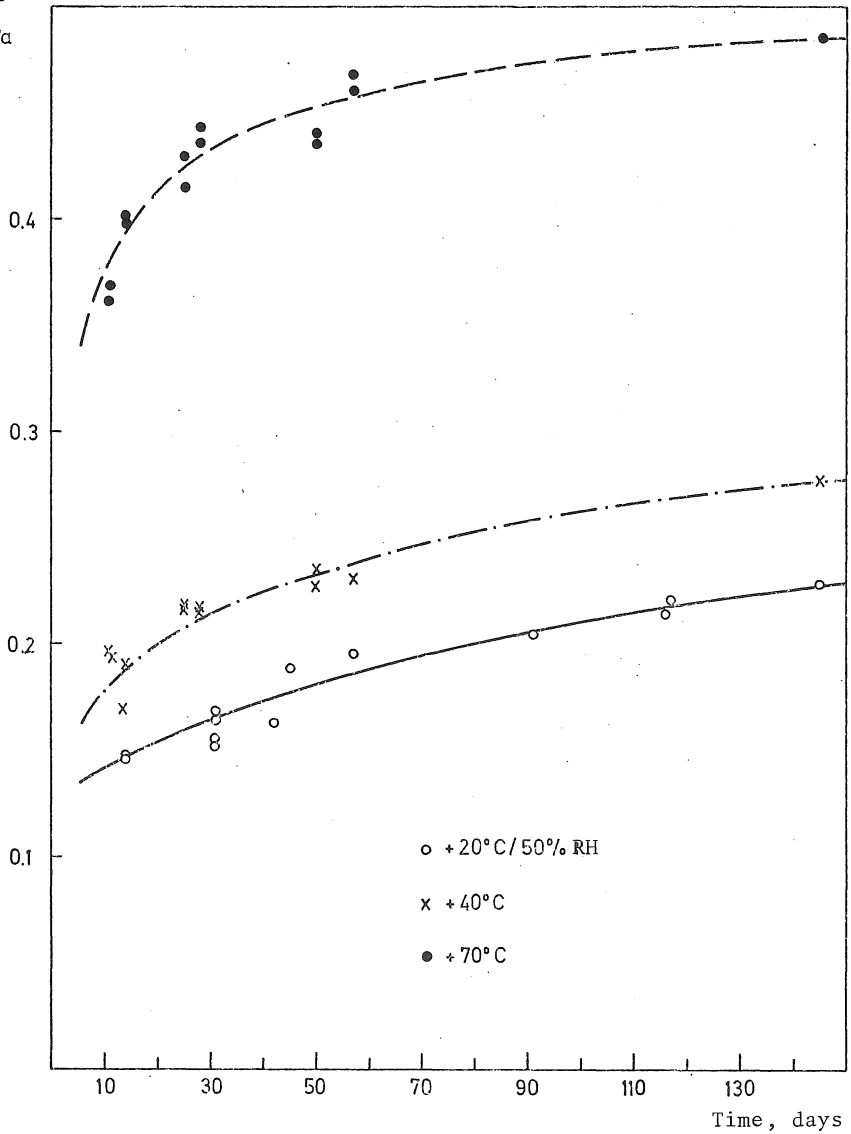
FIG 1 Stress at 50% tension ($= \sigma_{50}$) for "Material No 3" as a function of storage time at different temperatures.

The temperature is the ageing influencing factor which has been found to have the greatest effect on the deformation characteristics of the sealants. Heat ageing at $+40 - +70^{\circ}\text{C}$ usually increases the deformation resistance of the sealants to a high extent. But at the same time it is found that the heat storage affects the different materials differently. For instance the deformation resistance decreases in the soft polysulfide based sealant which has been heat aged at $+70^{\circ}\text{C}$. Experience so far has in most cases proved that heat ageing causes an increase in the hardness of polysulfide based sealants. But for most of the other types of sealants the heat ageing usually caused a definite increase in the hardness, which pretty well agrees with what happens in the case of ageing

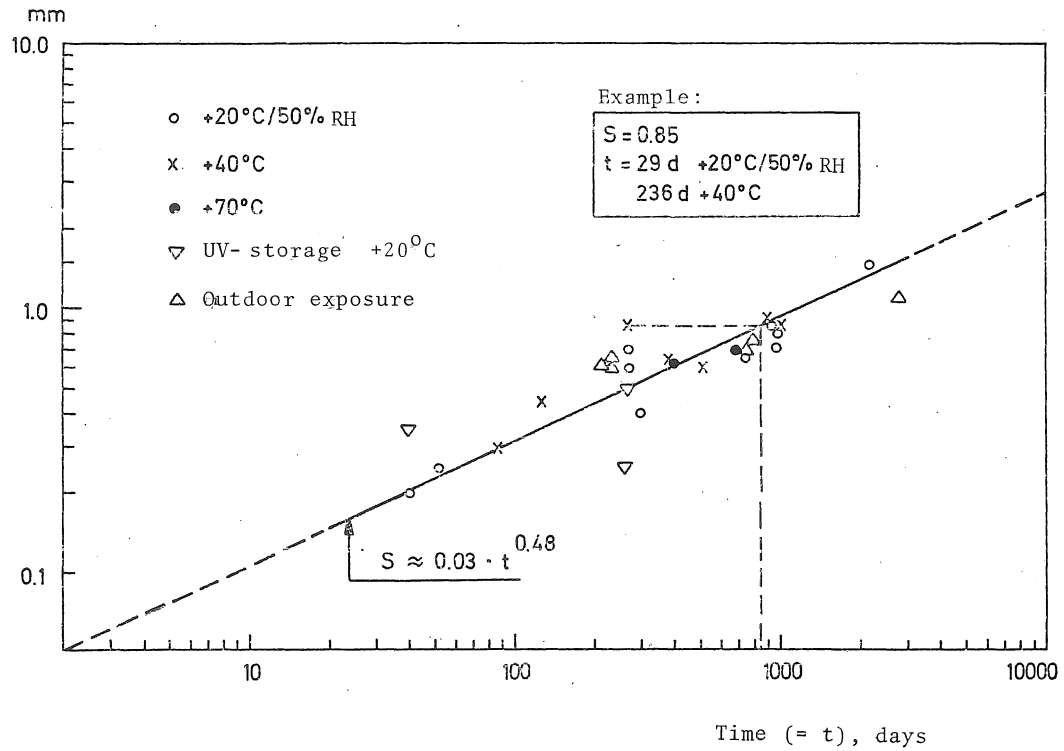
FIG 3 Skin thickness as a function of storage time at +20°C/50% RH for "Material No 8". Computing of equivalent storing time at +20°C/50% RH for material stored at +40°C and +70°C.

For the oleo resinous based sealant, whose ability to fulfill its sealing function depends to a great extent on the characteristics of the skin (toughness and growth rate), the investigation has shown a good correlation between the growth rate of the skin in a climate of $20^{\circ}\text{C}/50\%$ relative humidity and in an outdoor climate (Fig. 3). By comparing the skin growth rate at $+70^{\circ}\text{C}$ with the curve in Fig. 3 it is found that the heat ageing increases the rate with a factor about 22.

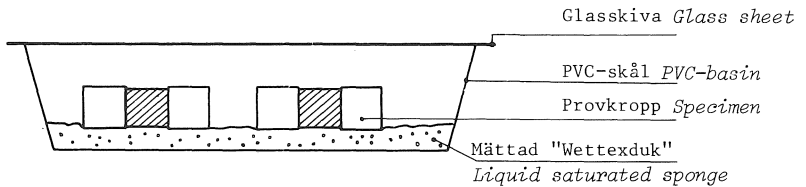
FIG 2 Fukt- respektive alkalilagring av provkroppar.

The effect of humidity has been studied by storing the specimens on a sponge saturated with de-ionized water (pH~4.0) (see Fig 2). The storage temperature was +20°C. This procedure could, for example, be similar to when a back-up material for some reason or other becomes saturated by water.

The influence of humidity and alkali was studied by storing the specimens on a sponge saturated with different media (see Fig 2). In this case "humidity" means de-ionized water with pH approx 4. The alkali solution used was a saturated Ca(OH)_2 solution diluted to pH approx 11.0. This level can be considered to be the same as the alkalinity when water is poured onto a concrete surface.

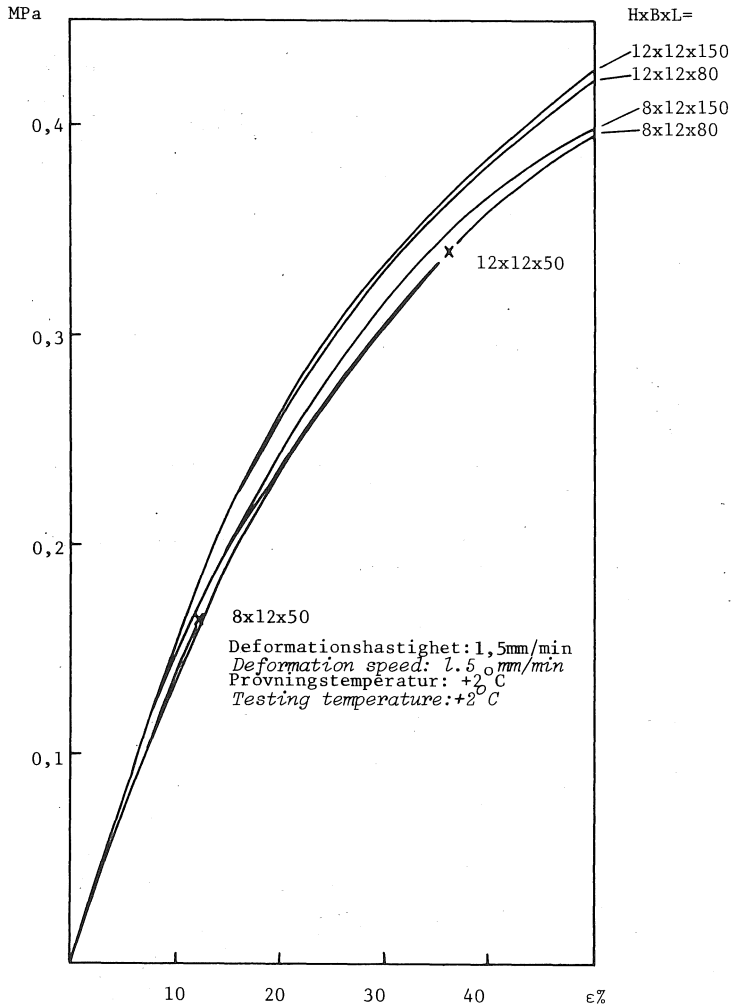
FIG 7 Arbetskurvas beroende av provkroppsdimensionen för en silikonbaserad fogmassa.

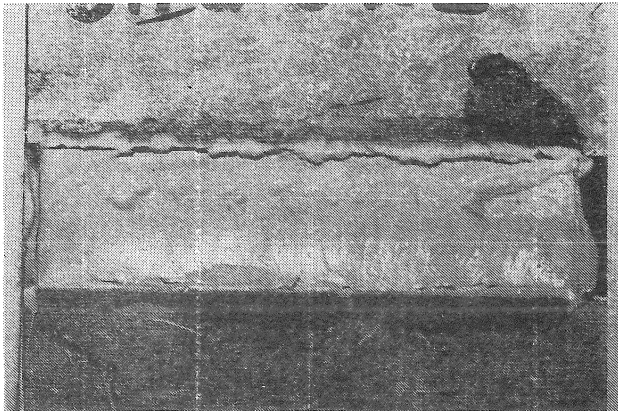
FIG 13 Yta av värmeåldrad lösningsmedelsbaserad akrylatfogmassa. Sprick- och blåsbildning p g a snabb bortgång av lösningsmedel.

Specimen surface of a heataged acrylic based (solvent release) sealant. Forming of cracks and bubbles due to a rapid release of solvents.

Storage at an increased temperature, +40°C and +70°C, started after the specimens had been stored at +20°C/50% RH for 7 or 21 days. Some undesirable effects can occur if the hot storage is started too early. This is shown in Figs 13-14, which show a solvent based acrylic sealant. In this case hot storage at +70°C was started after 7 days. The remaining solvent has evaporated from the material with blisters as a result. Consequently the rapid shrinkage also caused adhesion cracking on large surfaces. These after effects need not necessarily occur in sealants during natural ageing.

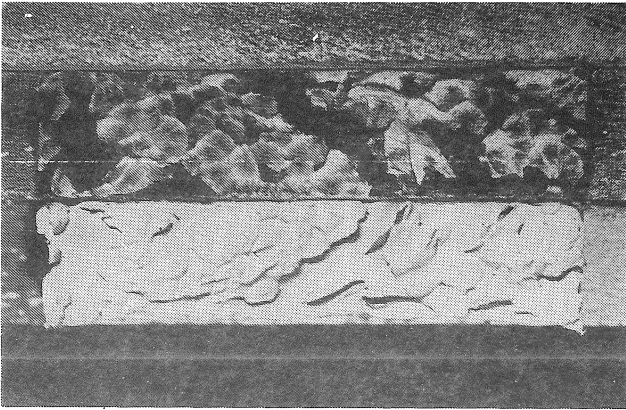
FIG 14 Brottyta av värmeåldrad lösningsmedelsbaserad akrylatfogmassa enligt fig 13.

Fracture surface of a heataged acrylic based (solvent release) sealant according to fig 13.

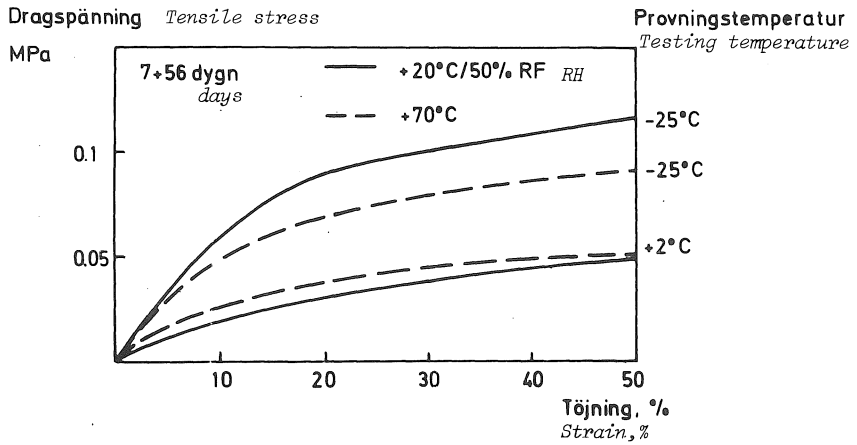
FIG 22 Arbetskurvor för "Material 1" efter värmelagring i olika klimat. Deformationshastighet: 0.001 mm/min.

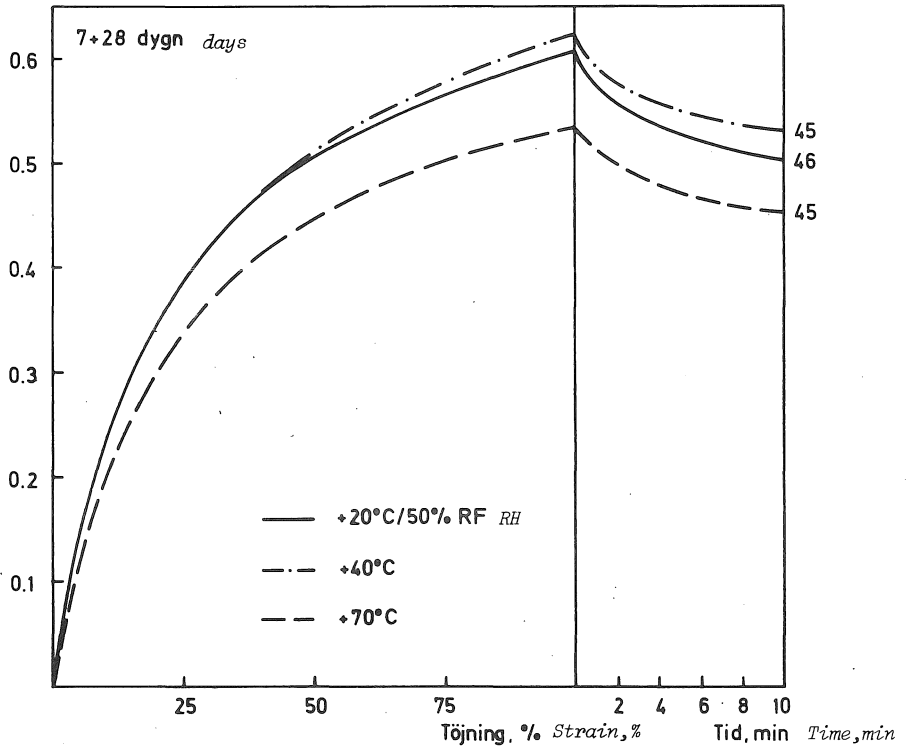
FIG 23 Arbetskurvor för "Material 2" värmeåldrat i olika temperaturer. Deformationshastighet: 1.5 mm/min. Provningsstemperatur: +20°C.

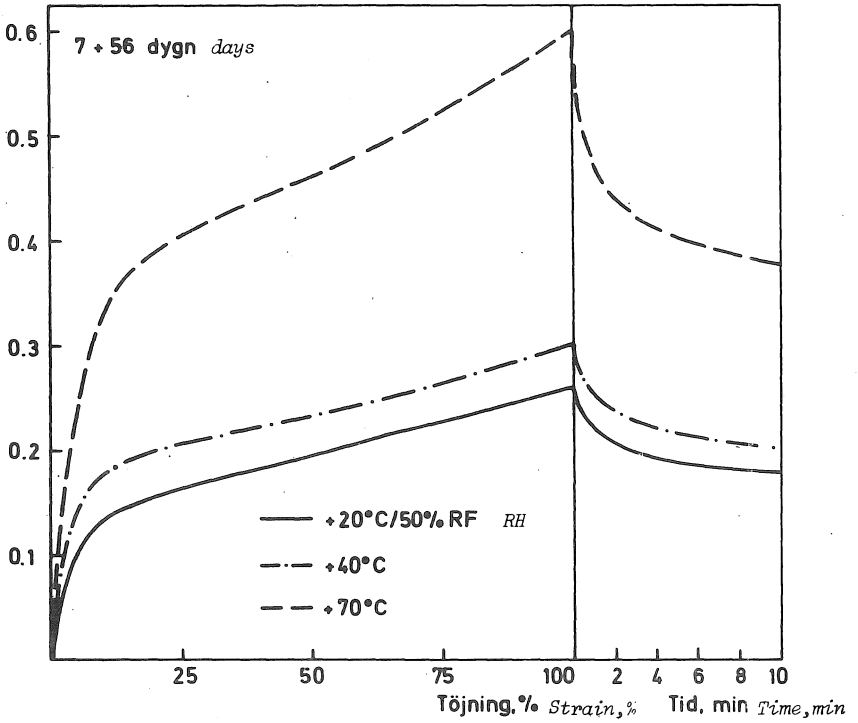
FIG 24 Arbetskurvor för "Material 3" värmeåldrat i olika temperaturer. Deformationshastighet: 1.5 mm/min. Provningsstemperatur: +2°C.

Stress-strain curves for "Material No 3" heataged at different temperatures. Deformation speed: 1.5 mm/min. Testing temperature: +2°C.

This material, a one-component polyurethane sealant, shows a great increase in hardness when exposed to heat ageing. The stress-strain curves can be seen in Fig. 24. The increase in hardness is to some extent dependent on the heat ageing having accelerated the rather slow curing mechanism at the normal climate of 20/50. This can be seen in Fig. 25 where the stress at 50% elongation is noted as a function of the storage time in different climates.

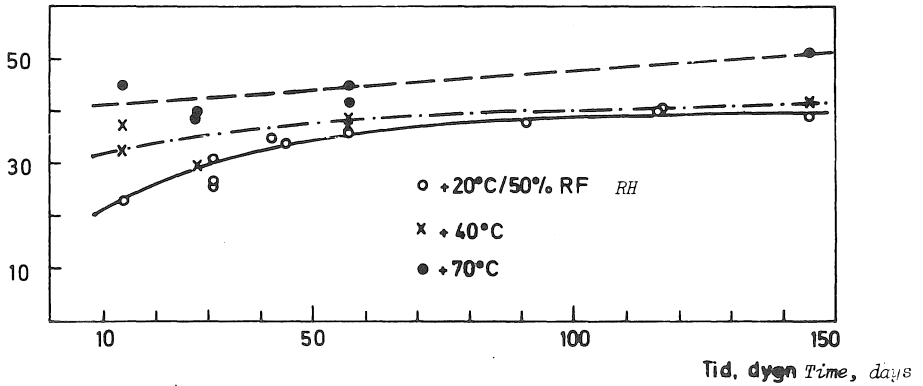
FIG 26 Hårdhet i °Shore A för "Material 3" som funktion av lagringstid i olika temperaturer. Initiallagring: 7 dygn i +20°C/50% RF.

Roughly the same tendency can be observed in Fig. 26. The hardness in °Shore A is considerably greater than the value stated by the manufacturer (25 ± 5).

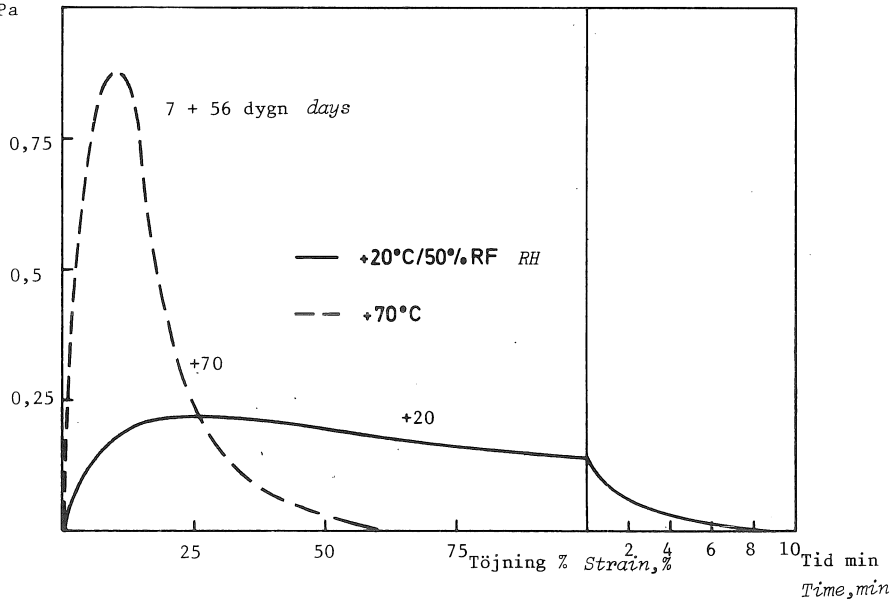
FIG 30 Arbetskurvor för "Material 5" värmeåldrat i olika temperaturer. Deformationshastighet: 1.5 mm/min. Provningsstemperatur: +2°C.

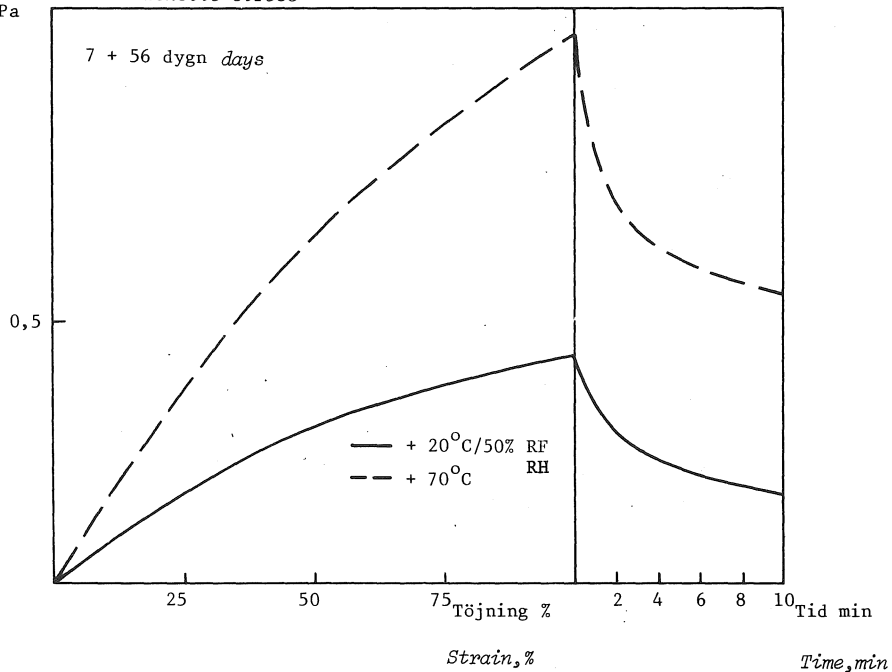
FIG 36 Arbetskurvor för "Material 7" åldrat i olika temperaturer. Deformationshastighet: 1.5 mm/min. Provningsstemperatur: +2°C.

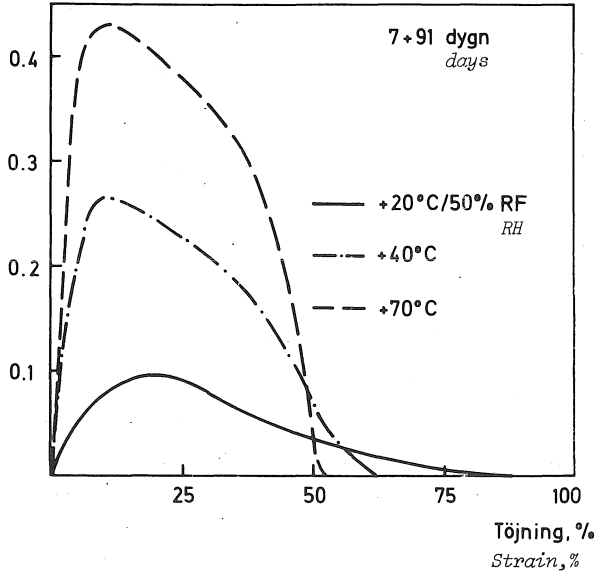
FIG 39 Arbetskurvor för "Material 8" värmeåldrat i olika temperaturer. Deformationshastighet: 1.5 mm/min. Provningsstemperatur: +2°C.

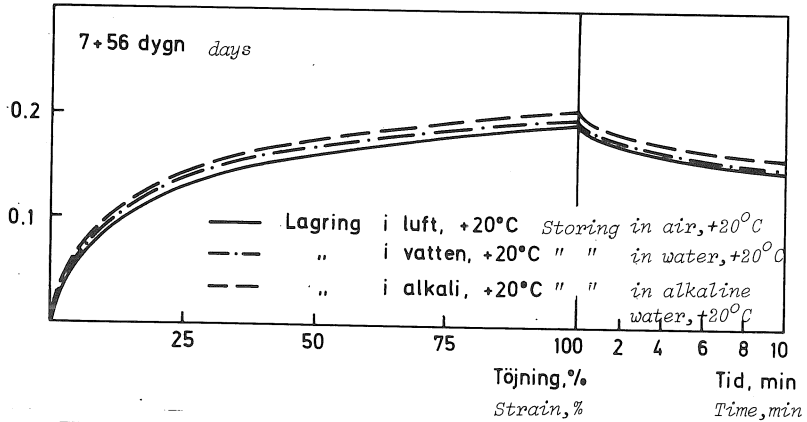
FIG 42 Arbetskurvor för "Material 1" efter lagring i luft, vatten och alkali. Deformationshastighet: 1.5 mm/min. Provningsstemperatur: +20°C.

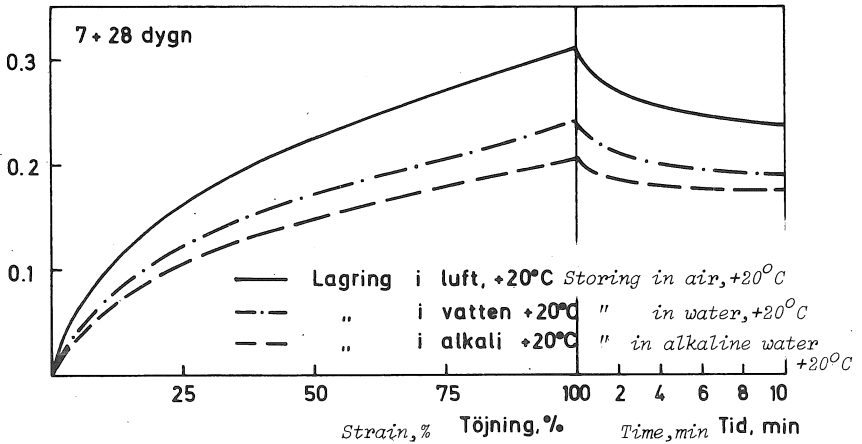
FIG 46 Arbetskurvor för "Material 4" efter lagring i luft, vatten och alkali. Deformationshastighet: 1.5 mm/min. Provningsstemperatur: +2°C.

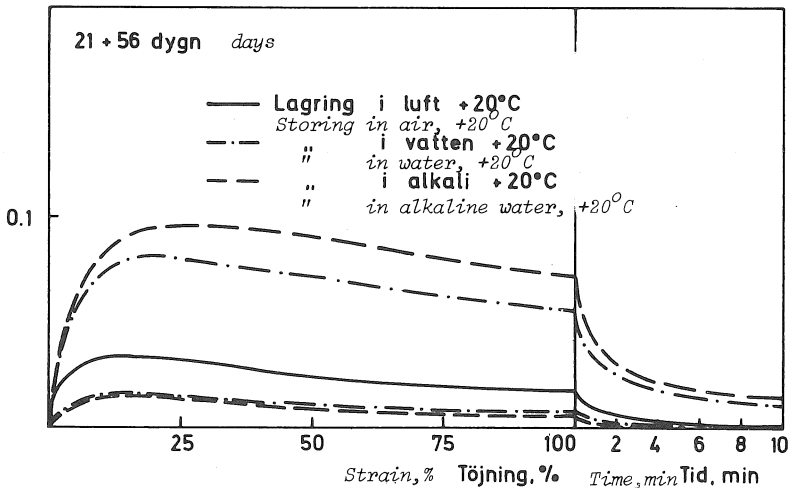
FIG 47 Arbetskurvor för "Material 6" efter lagring i luft, vatten och alkali. Deformationshastighet: 1.5 mm/min. Provningsstemperatur: +2°C.

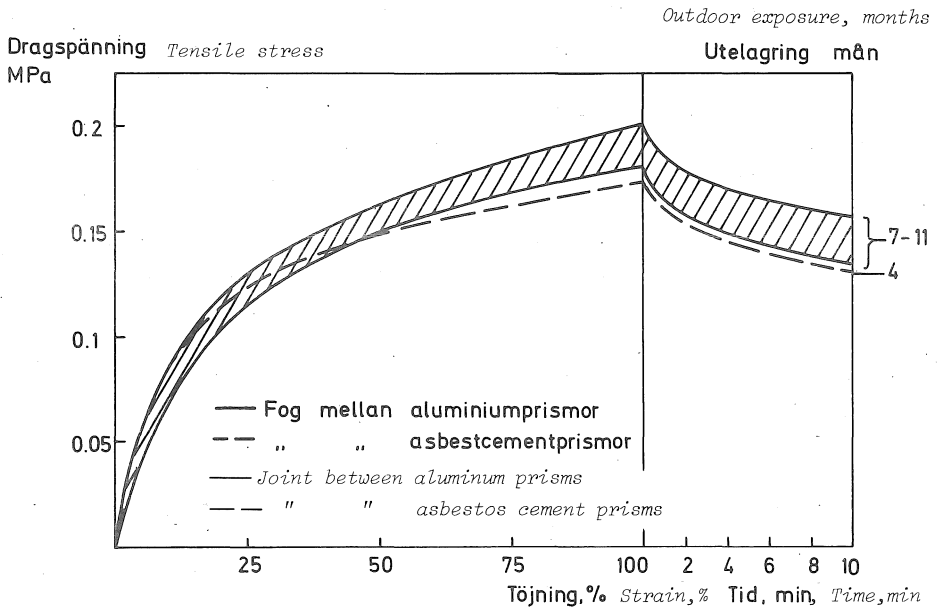
FIG 66 Arbetskurvor för "Material 1" efter olika lång tids utomhusexponering. Deformationshastighet: 1.5 mm/min. Provningsstemperatur: +2°C.

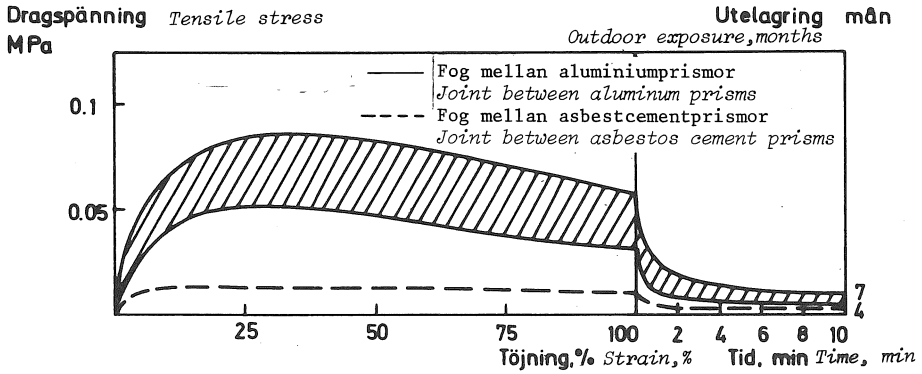
FIG 70 Arbetskurvor för "Material 5" efter olika lång tids utomhusexponering. Deformationshastighet: 1.5 mm/min. Provingstemperatur: +2°C.

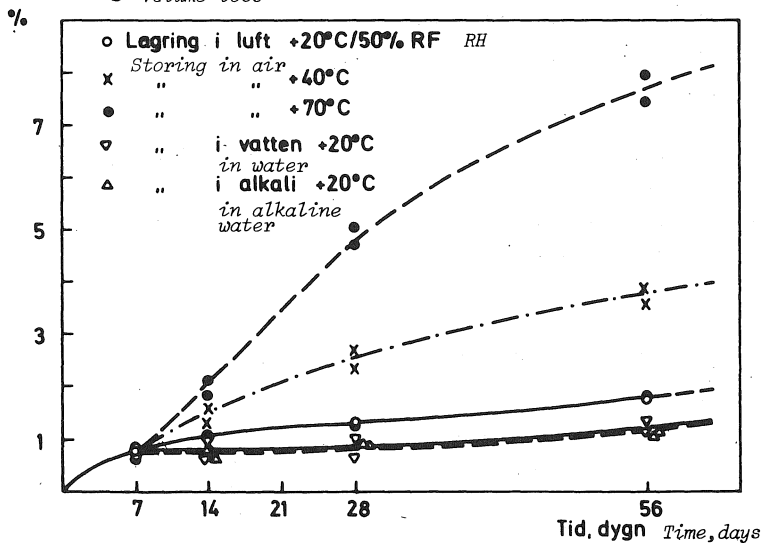
FIG 74 Volymminskning (krympning) som funktion av lagringstid i olika klimat för "Material 1".

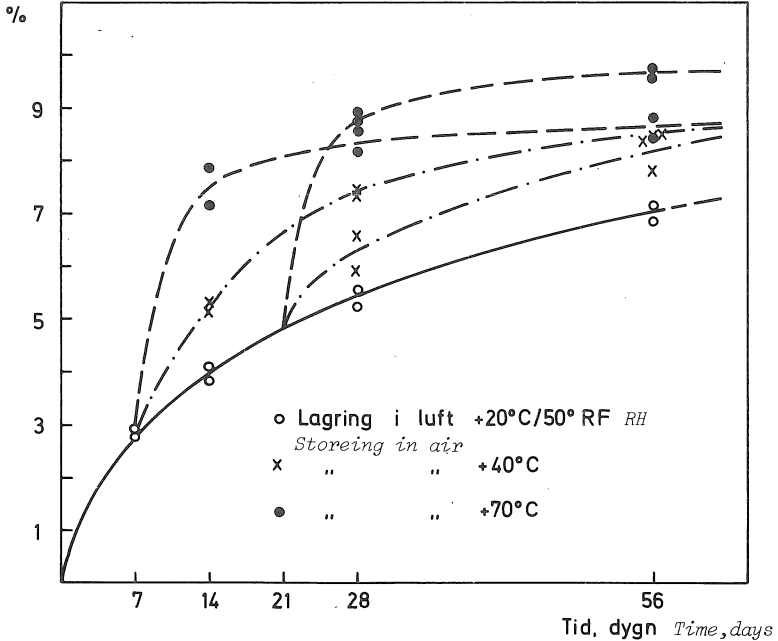
FIG 76 Volymminskning (krympning) som funktion av lagringstid i olika klimat för "Material 3".
