Ageing and deformation properties of building joint sealants

Burström, Per Gunnar

1979

Burström, P. G. (1979). *Ageing and deformation properties of building joint sealants*. [Doctoral Thesis (monograph), Division of Building Materials]. Division of Building Materials, LTH, Lund University.

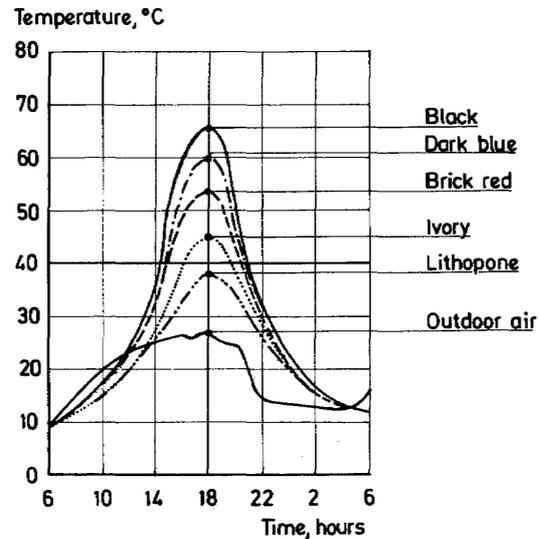
FIG. 1.2 Temperature curves, as a function of time, of differently coloured outer surfaces (west walls), measured on a highly radiating summer day (June). The walls are of identical structural design, they differ only in outer-surface colour (Künzel (1969)).

Solar radiant energy is converted into heat when it impinges upon and is absorbed by a material. On reaching the earth, the infrared part (wavelengths longer than $0.78\ \mu\text{m}$) comprises about 53% of the total radiation. The temperatures of the outside surfaces of a building (roofs and walls) depend to a great extent on the colour of the surface in question. An example of this is shown in Fig. 1.2 according to Künzel (1969).

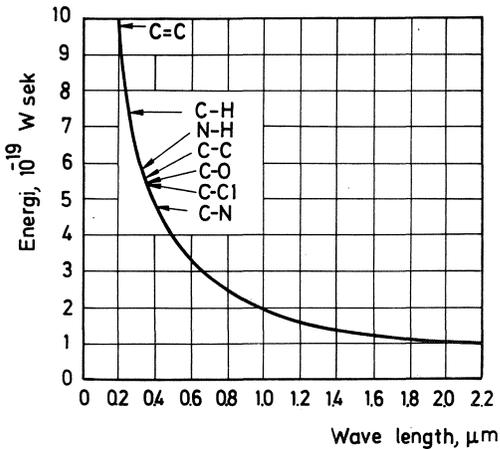
FIG. 1.3 Energy per photon and examples of dissociation energy per bond (Gjelsvik (1975)).

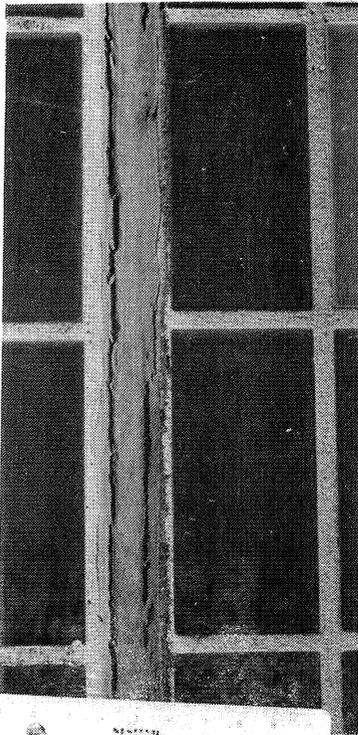
FIG. 3.1 Cohesive failure in a polysulfide sealant in a joint between concrete panels with pebble-dashed surface. This type of failures are due to large local deformations along the edges at a compression (Andersson et al (1972)).

An examination of the local deformations in a cross-section of the polysulfide sealants showed a high degree of deformation at the edges, especially at compression. In some cases these deformations caused cohesive failure along the edges, Fig. 3.1. Some surface effects were also reported and were probably due to UV- and/or ozone-attack.

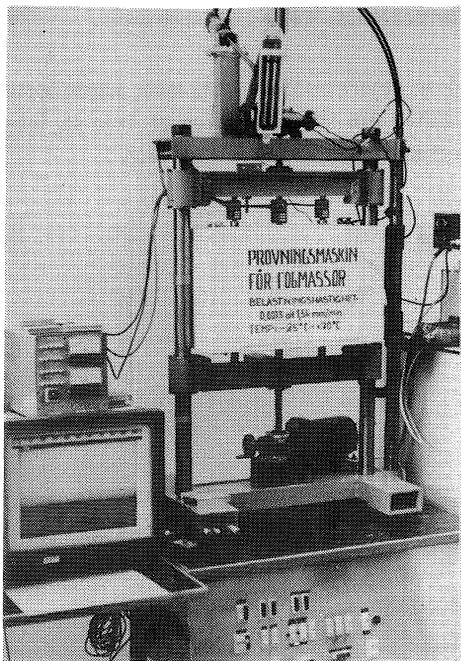
FIG. 4.1a Testing equipment for sealants. Climate chamber closed. Deformation rate 0.001-1.5 mm/min tension/compression. Testing temperature -25 - +70 °C.

The appearance and shape of the stress-strain curve supplies information regarding softening or hardening, brittleness, increased temperature dependence etc. The test equipment used for this purpose is shown in Fig. 4.1a and b.

The measurements of shrinkage stresses that might occur were made in the equipment according to Fig. 4.1 and in a specially built frame, Fig. 4.43. Measurements were carried out for Material Nos. 1, 3, 7 and 8. The temperature was $+22 \pm 1^\circ\text{C}$.

Measurements were also made with the help of the equipment shown in Fig. 4.1. The measuring accuracy was then less than 10^{-4} MPa

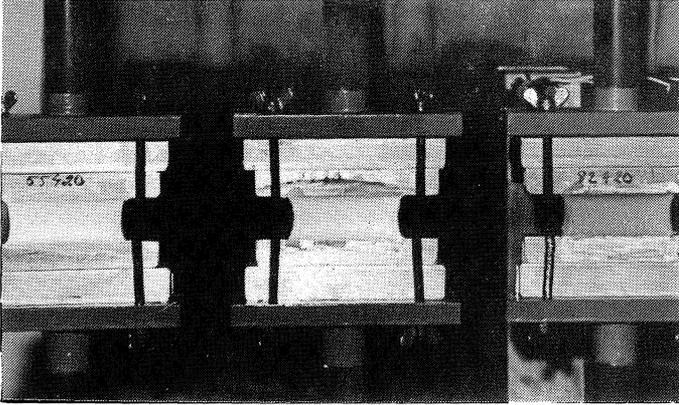
FIG. 4.1b Testing equipment for sealants. Fixing of specimens.

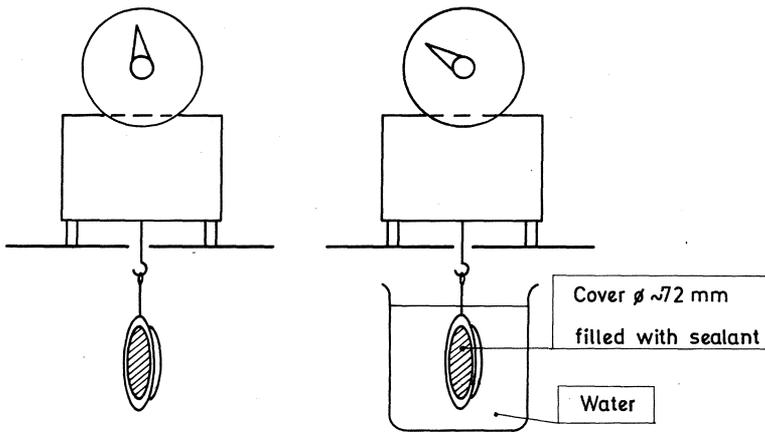
FIG. 4.2 Measuring of weight loss and shrinkage.

and the changes in density. These determinations were made approximately according to the method NT Build 015 "Determination of free shrinkage" (Gjelsvik (1976)). The methodics are shown in Fig. 4.2.

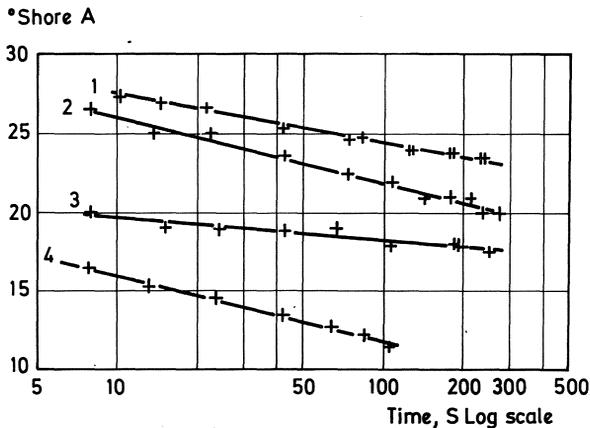
FIG. 4.3 Durometer characteristics for sealants at room temperature after storing for six months at room temperature. The level at which the curve is situated is a measure of the deformation resistance for loading times of different lengths. The inclination of the curve is a measure of the rate of creep of the compound. The curves are practically straight lines in this type of diagram.

1= Polysulfide-based sealant type 1, 2= Polysulfide-based sealant type 2, 3= Silicone-based sealant, 4= Polyurethane-based sealant (Andersson et al (1972)).

An example of how the Shore A-value depends upon the time factor is shown in Fig.4.3 when testing a couple of sealants (Andersson (1972)). The time-dependence is naturally least for the most elastic sealant, the silicone-based one.

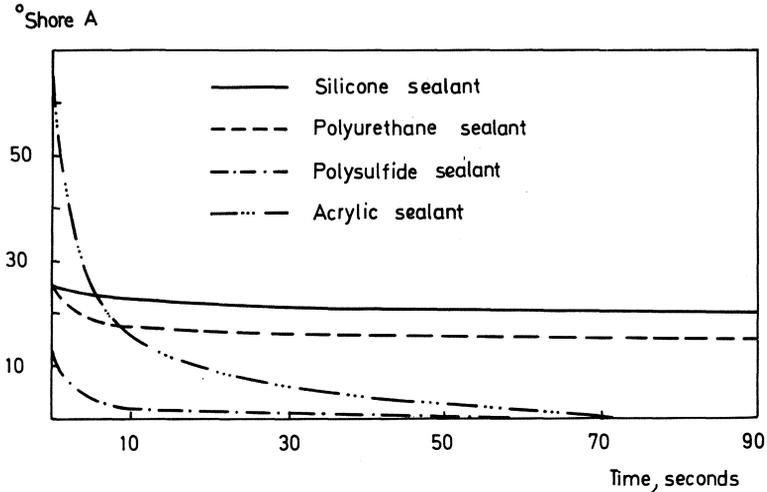
FIG. 4.4 Examples of Shore A-hardness as a function of time for four different sealants. The sealants have been stored at +20°C/50% RH five years before testing.

In Fig.4.4 the same relationship is shown for four other sealants in a linear scale and with instantaneous readings. The curves are very similar to the creep or stress-relaxation curves.

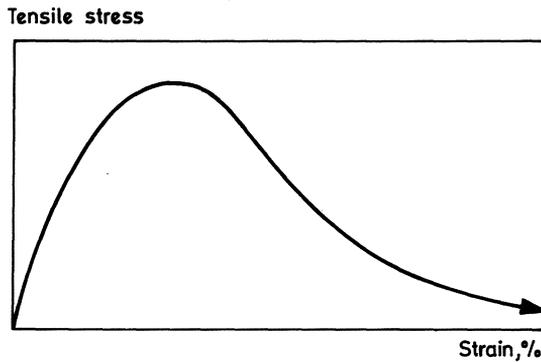
FIG. 4.5 Principle stress-strain curve of a plastic sealant.

When the stress-strain curve is determined for a more plastic sealant one obtains a principal curve as shown in Fig. 4.5. Here the stress is calculated in the usual way, i.e. by dividing the load by the original cross-section. Where the more plastic sealant is concerned the elongation is distributed unevenly along the joint width (in the direction of force). This means that most of the deformation takes place in the weakest part of the cross-section. Consequently this part gradually diminishes and thereby also the recorded load. That is the reason why the stress-strain curve produces a maximum point.

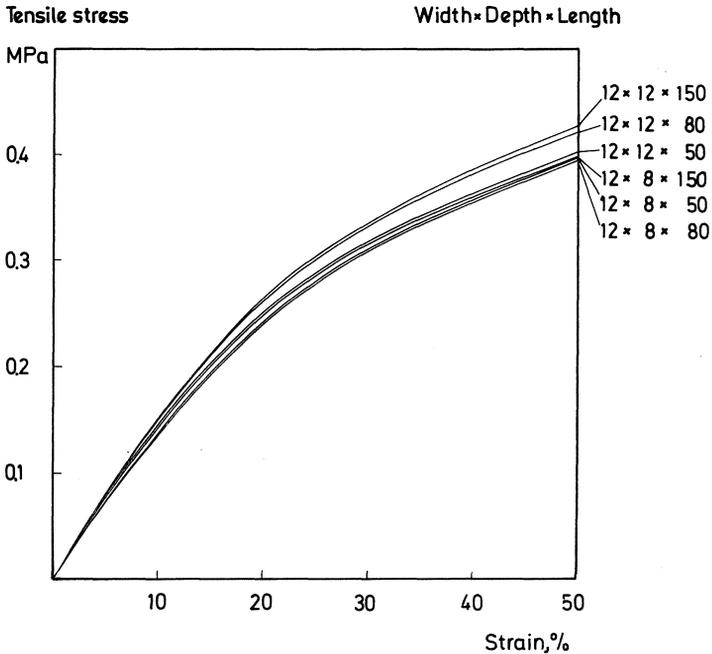
FIG. 4.6 The influence of the specimen dimension on the stress-strain curve for a silicone-based sealant of 14 months age.

mation a specimen with a length of 50 mm shows about 7% less tensile stress than one with a length of 150 mm. The difference will be somewhat larger at 50% elongation.

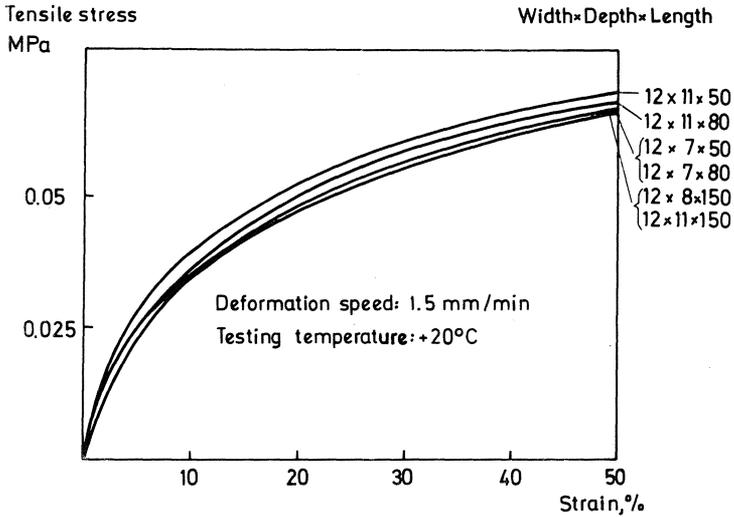
FIG. 4.7 The influence of the specimen dimension on the stress-strain curve for a polysulfide-based sealant of 14 months age.

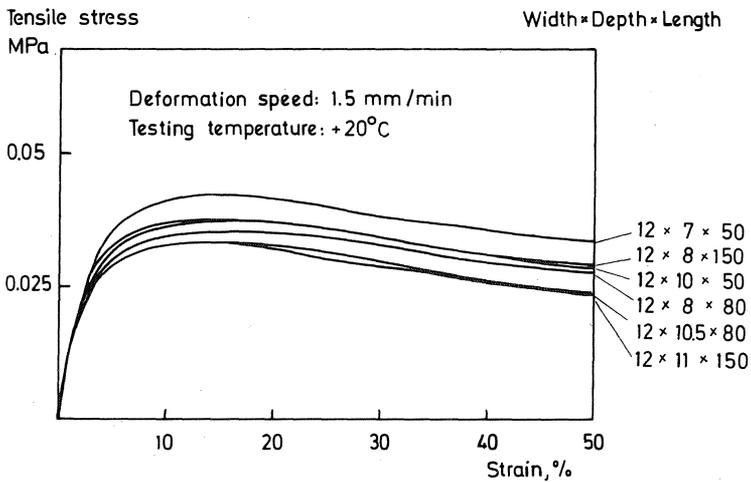
FIG. 4.8 The influence of the specimen dimension on the stress-strain curve for an acrylic-based (solvent release) sealant of 14 months age.

Where the more plastic polysulfide and acrylic sealants are concerned the distribution of the results has produced a somewhat unexpected order in the curves, Figs.4.7-4.8. The distribution of the results dominates the effect of the specimen shape. E.g., for the acrylic sealant the curve which was expected to be the highest was the lowest.

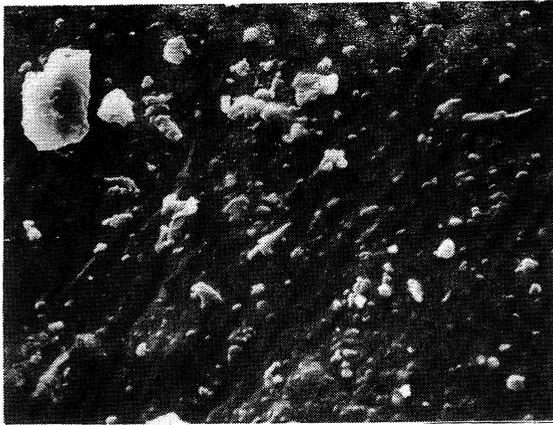
FIG. 4.9 SEM-photograph of the surface of a polysulfide-based sealant stored at +20 °C/50% RH. Enlargement 600x. Photo: The Zoological Institution of Lund University.

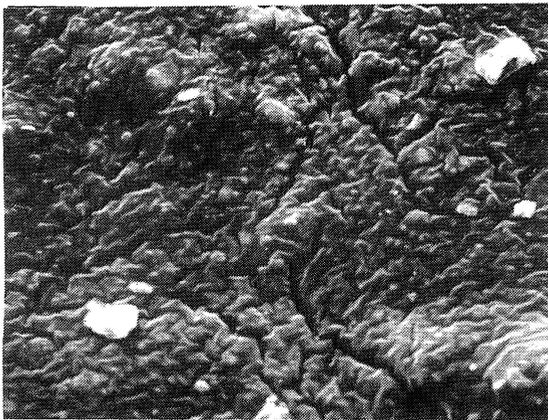
FIG. 4.10 SEM-photograph of the surface of a heat-aged (21 days at +70 °C) polysulfide-based sealant. Enlargement 600x. Photo: The Zoological Institution of Lund University.

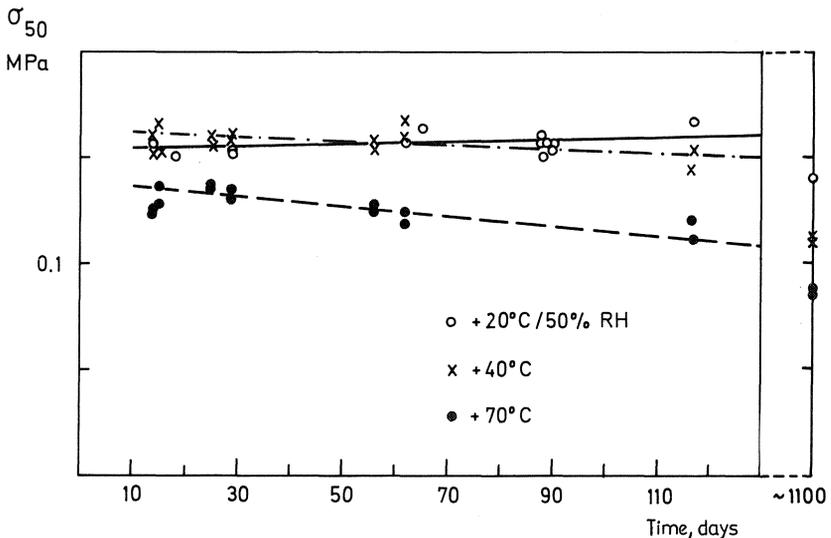
FIG. 4.11 Tensile stress at 50% elongation ($= \sigma_{50}$) for Material No. 1, as a function of storing time at different temperatures. Initial storing: 7 days at +20°C/50% RH.

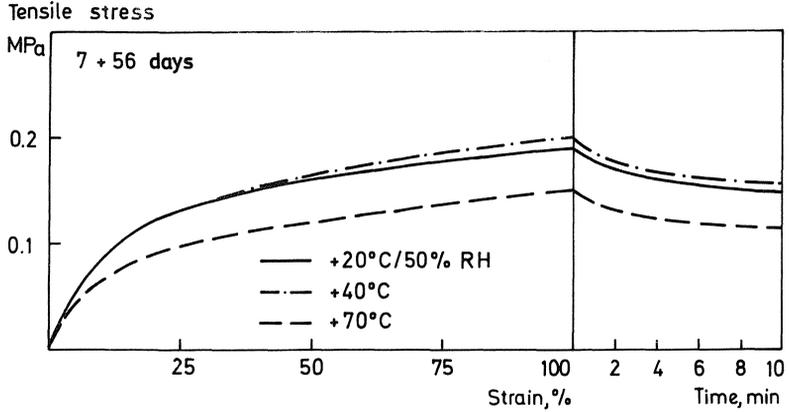
FIG. 4.12 Stress-strain curves for Material No. 1 after heat-aging at different temperatures. Deformation speed: 1.5 mm/min. Testing temperature: +2 °C.

Fig. 4.12 shows the stress-strain curves after 7+56 days. The softening after heat-ageing at +70°C is fairly evident. In Fig. 4.13, showing the stress-strain curves after almost three years at different temperatures, the softening after heat-ageing at +40°C is also evident.

In comparison to Fig. 4.12 the curve for storage in a normal climate corresponds extremely well with the curves shown in Fig. 5.12 after seven to eleven months of outdoor exposure. I.e. if there are only small changes in the sealant due to UV irradiation, for example, the deformation properties of the sealant are about the same as when the sealant is exposed outdoors or indoors.

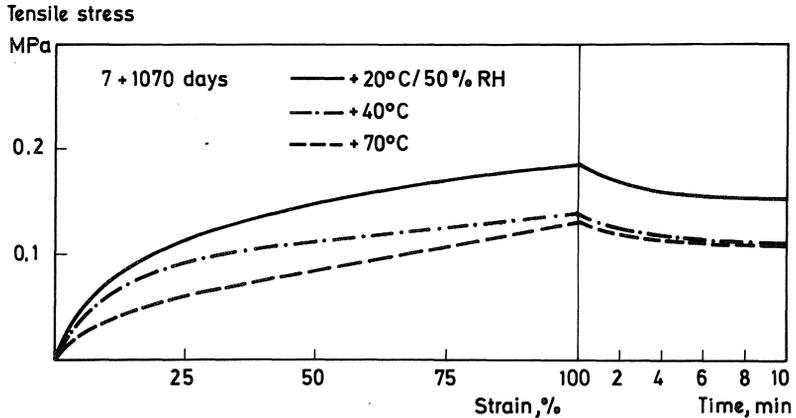
FIG. 4.13 Stress-strain curves for Material No. 1 after about three years at different temperatures. Compare Fig. 4.12! Deformation speed: 1.5 mm/min. Testing temperature: +2 °C.

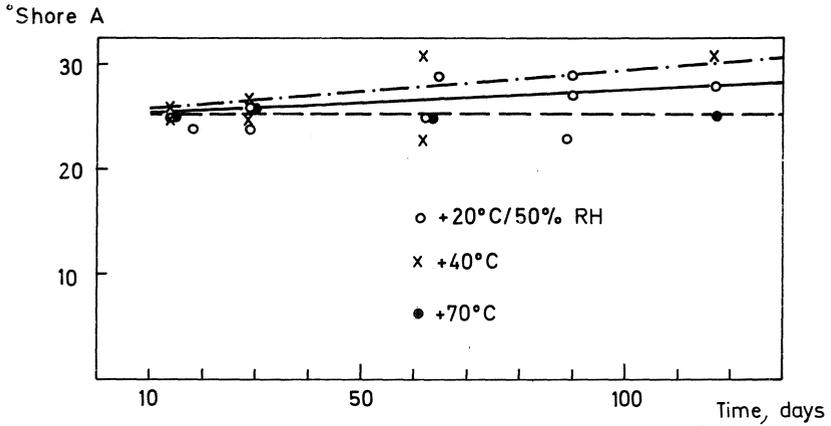
FIG. 4.14 Instantaneous Shore A-values for Material No. 1 as a function of storing time at different temperatures. Initial storing: 7 days at +20 °C/50% RH.

By means of determining the hardness in $^{\circ}$ Shore A it was almost impossible to detect the softening, Fig. 4.14. The distribution among the readings when using this method was too great. Note also that the value of 13° Shore A as stated by the manufacturer does not correspond satisfactorily with the measured values. A more accurate value is approximately 25° Shore A.

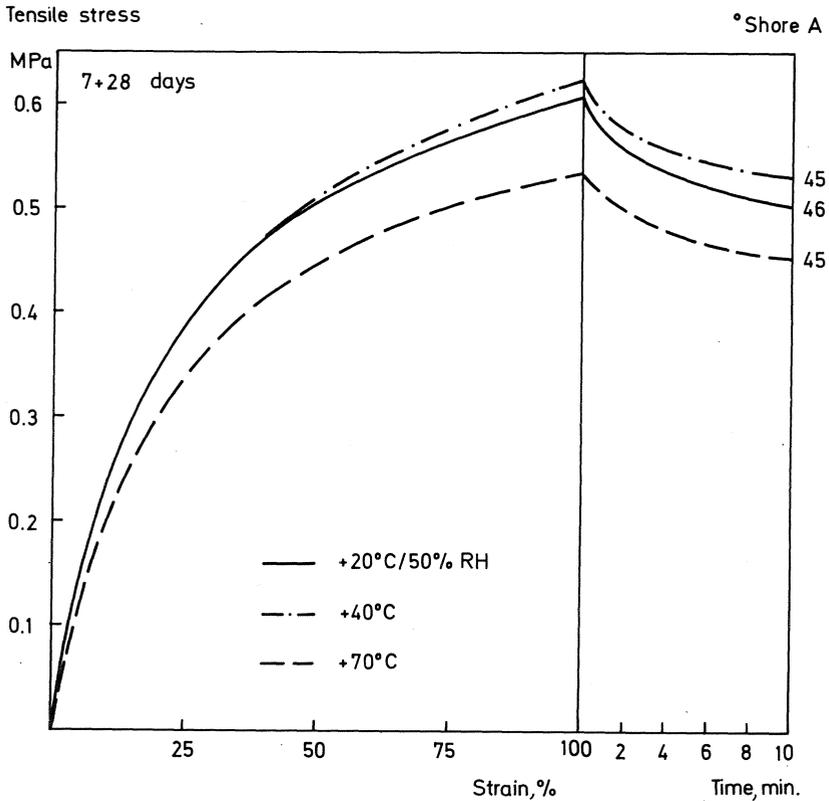
FIG. 4.15 Stress-strain curves for Material No. 2 after heat-aging at different temperatures. Deformation speed: 1.5 mm/min. Testing temperature: +2 °C.

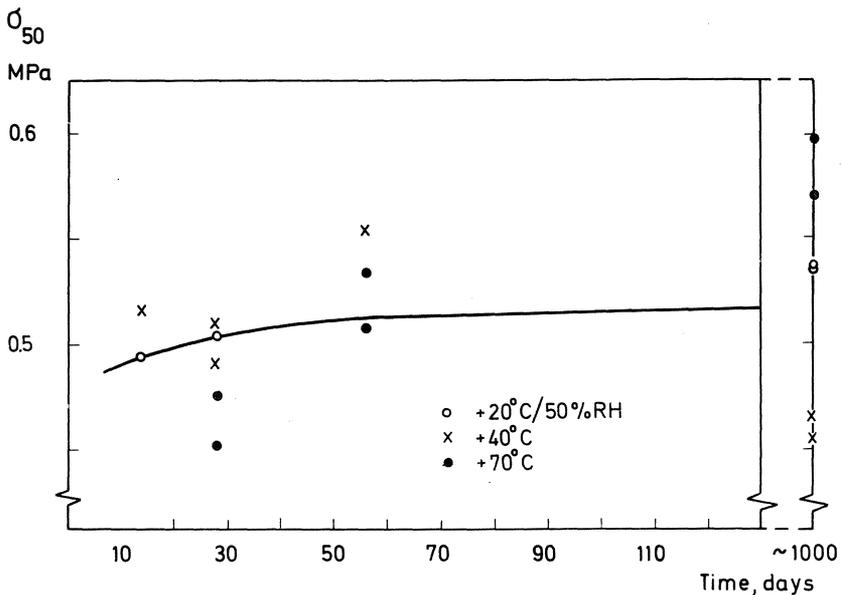
FIG. 4.16 Tensile stress at 50% elongation ($= \sigma_{50}$) for Material No. 2 as a function of storing time at different temperatures. Initial storing: 7 days at +20 °C/50% RH.

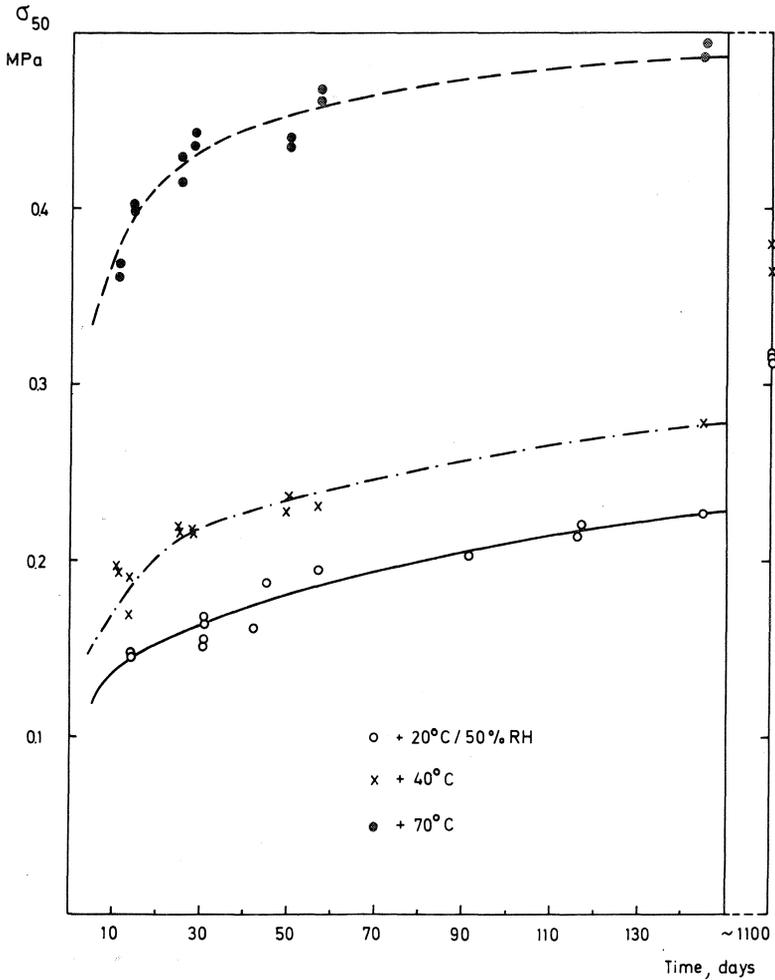
FIG. 4.17 Tensile stress at 50% elongation ($= \sigma_{50}$) for Material No. 3 as a function of storing time at different temperatures. Initial storing: 7 days at +20 °C/50% RH.

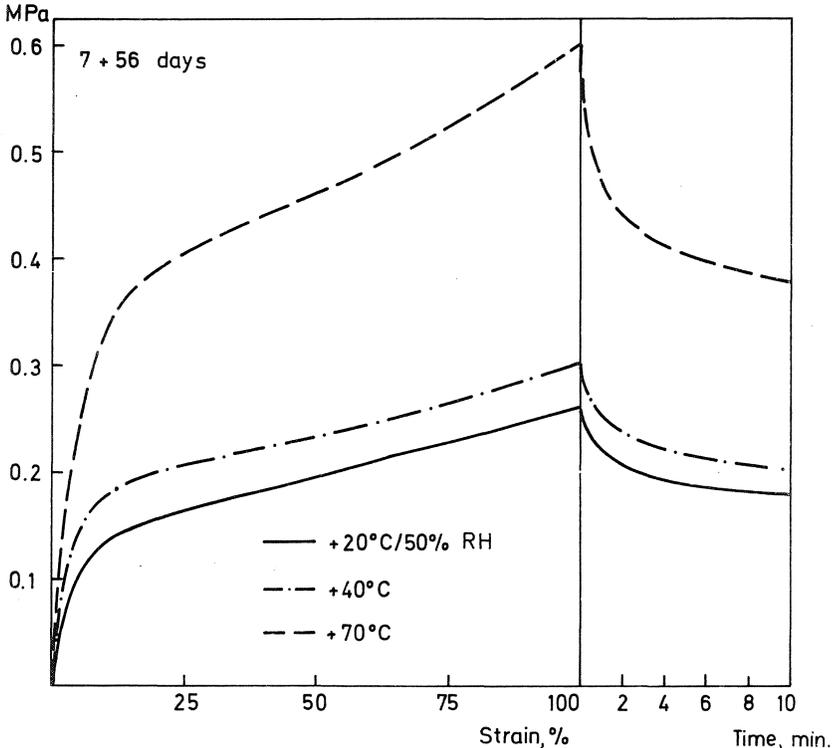
FIG. 4.18 Stress-strain curves for Material No. 3 after heat-aging at different temperatures. Deformation speed: 1.5 mm/min. Testing temperature: +2 °C.

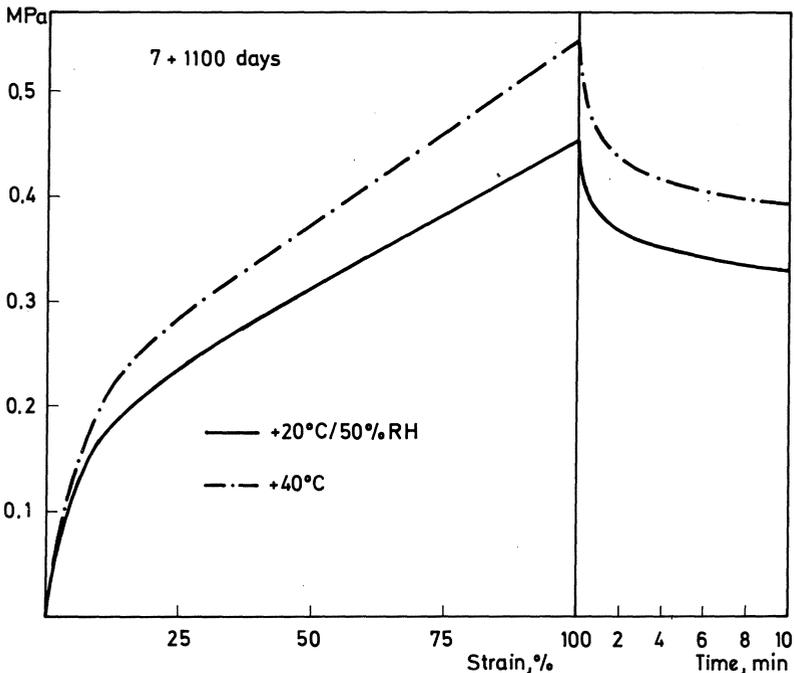
FIG. 4.19 Stress-strain curves for Material No. 3 after about three years at different temperatures. Compare Fig. 4.18! Deformation speed: 1.5 mm/min. Testing temperature: +2 °C.

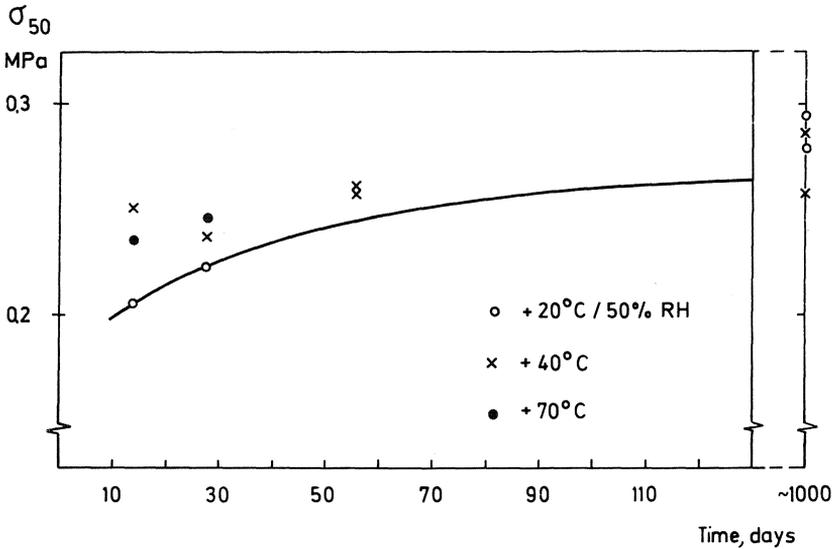
FIG. 4.20 Tensile stress at 50% elongation ($= \sigma_{50}$) for Material No. 4 as a function of storing time at different temperatures. Initial storing: 7 days at +20 °C/50% RH.

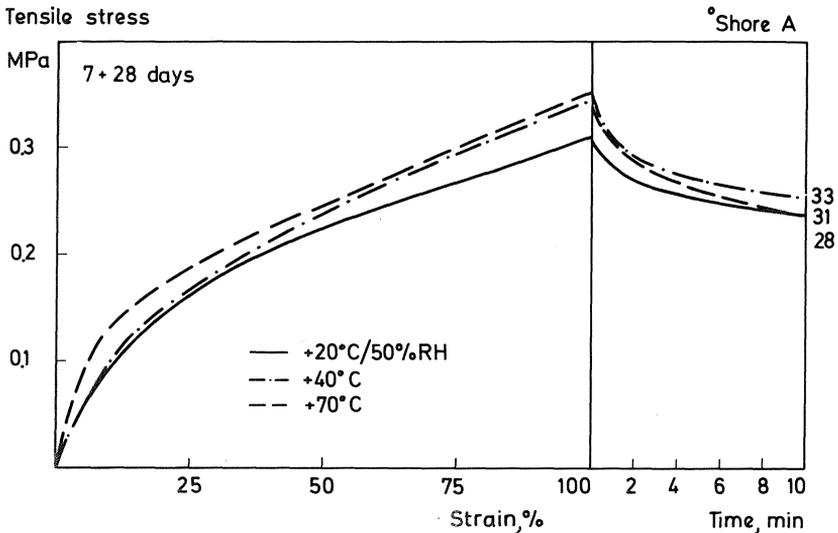
FIG. 4.21 Stress-strain curves for Material No. 4 after heat-aging at different temperatures. Deformation speed: 1.5 mm/min. Testing temperature: +2 °C.

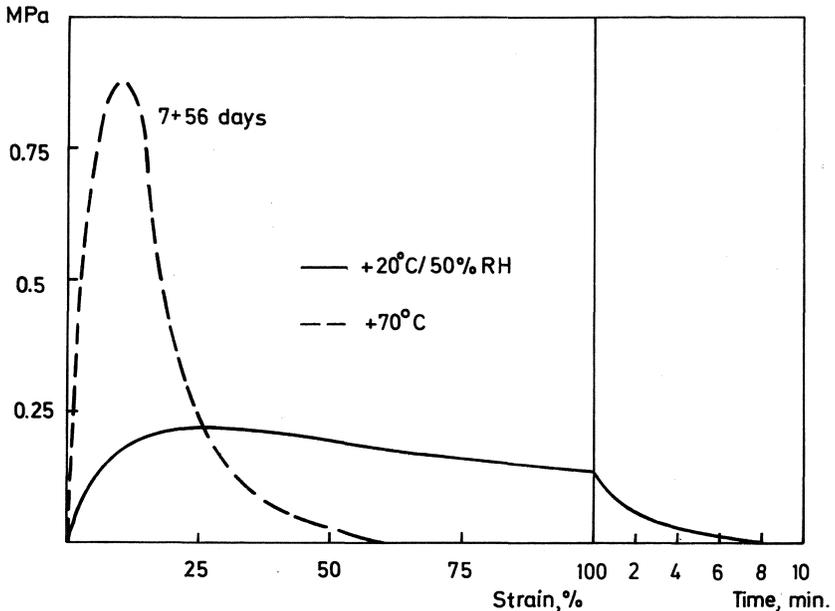
FIG. 4.22 Stress-strain curves for Material No. 5 after heat-aging at different temperatures. Deformation speed: 1.5 mm/min. Testing temperature: $+2^{\circ}\text{C}$.

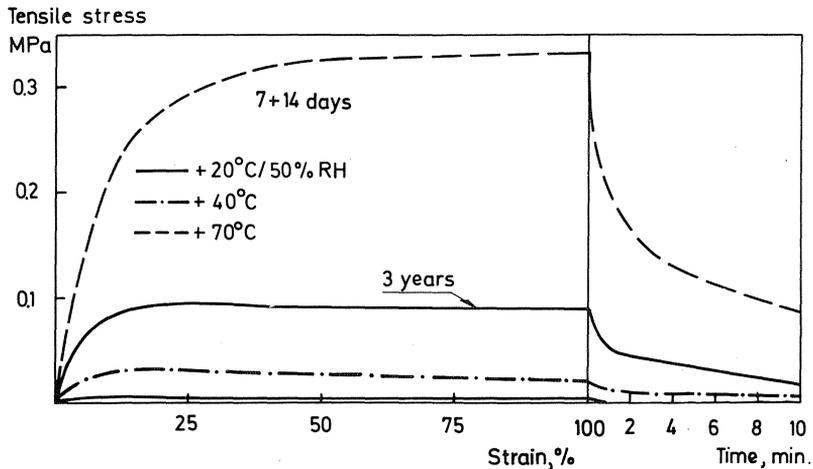
FIG. 4.25 Stress-strain curves for Material No. 6 after heat-aging at different temperatures. Deformation speed: 1.5 mm/min. Testing temperature: $+2^{\circ}\text{C}$.

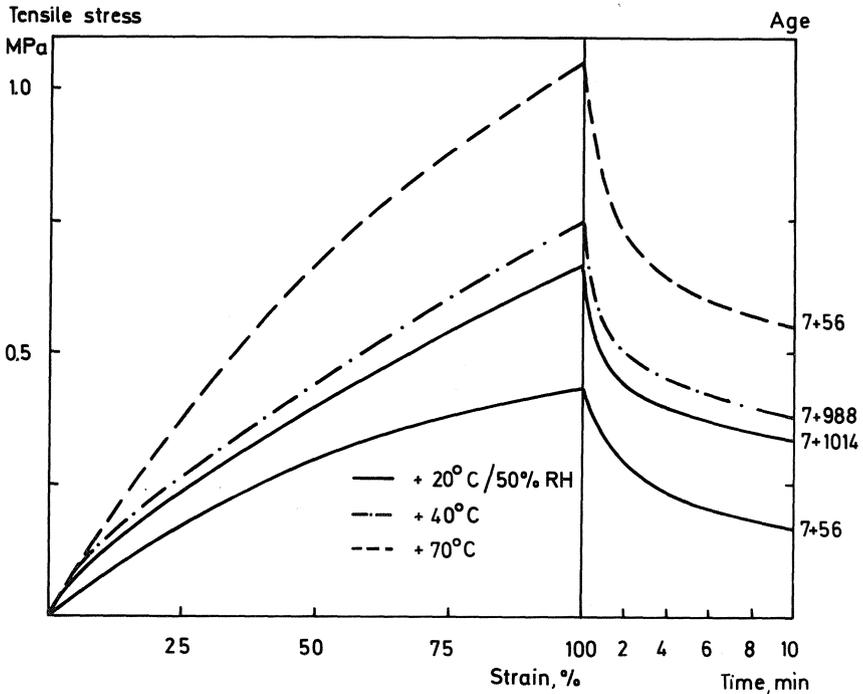
FIG. 4.26 Stress-strain curves for Material No. 7 after heat-aging at different temperatures. Deformation speed: 1.5 mm/min. Testing temperature: $+2^{\circ}\text{C}$.

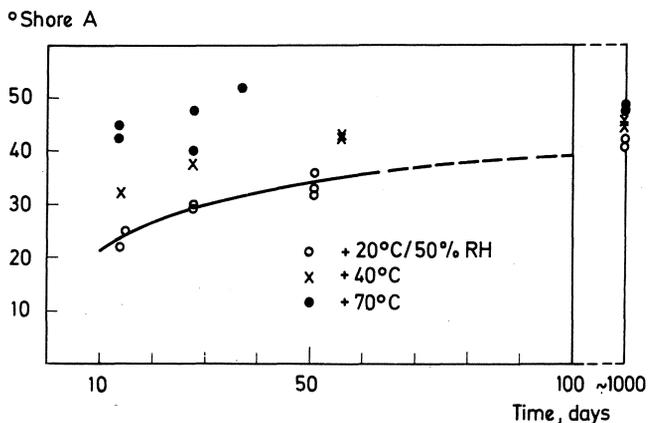
FIG. 4.27 Instantaneous Shore A-value for Material No. 7 as a function of storing time at different temperatures. Initial storing: 7 days at $+20^{\circ}\text{C}/50\% \text{RH}$.

However, this material is sufficiently elastic for the hardness values in $^{\circ}$ Shore A to be important. At the same time one can avoid the adhesion problems. Therefore, in Fig. 4.27 the Shore A values are shown after different times in a variety of climates. When stored at $+20^{\circ}\text{C}/50\% \text{RH}$ the hardness of the sealant continues to increase as the water evaporates. This increase continues for a long period of time.

When the temperature is raised, the evaporation is naturally quicker. Therefore the hardness is increased when the sealant is heat aged at $+40^{\circ}\text{C}$ or $+70^{\circ}\text{C}$. But, in the long run, an asymptotic value seems to have been reached.

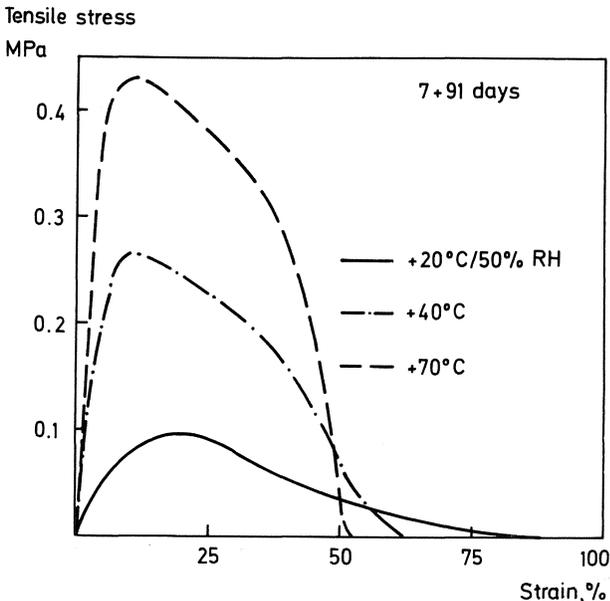
FIG. 4.28 Stress-strain curves for Material No. 8 after heat-ageing at different temperatures. Deformation speed: 1.5 mm/min. Testing temperature: +2 °C.

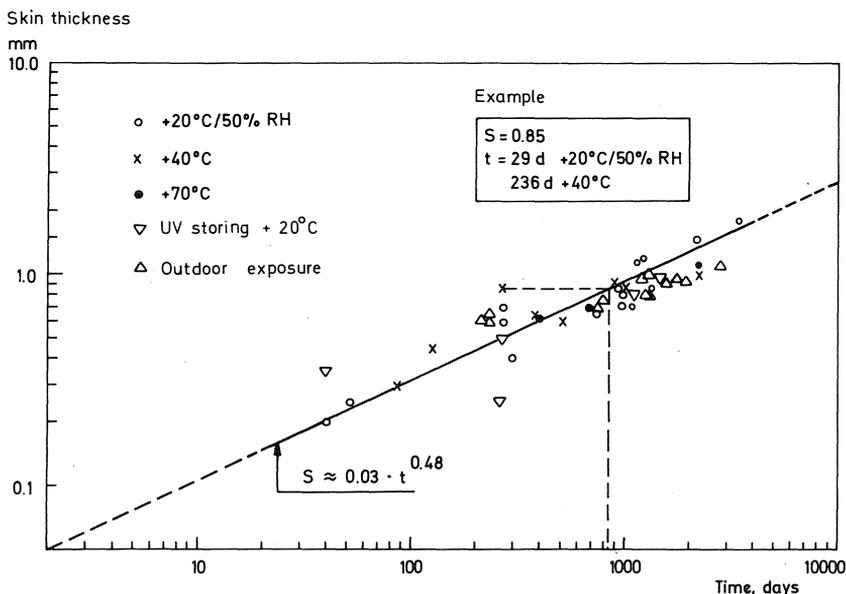
FIG. 4.29 Surface skin thickness as a function of storing time at +20 °C/50% RH for Material No. 8. Example of calculating the equivalent time at +20 °C/50% RH for material stored at +40 °C. The values of material stored at +40 and +70 °C are calculated values to equivalent times at +20 °C/50% RH according to the example in the Figure.

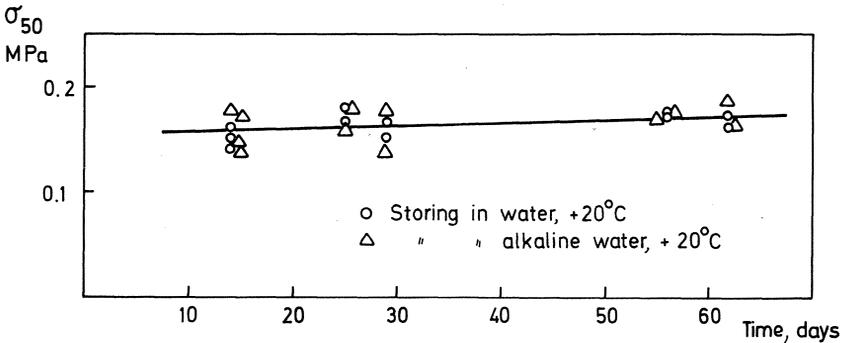
FIG. 4.30 Tensile stress at 50% elongation ($= \sigma_{50}$) for Material No. 1 as a function of storing time on water and alkaline water. Initial storing: 7 days at +20 °C/50% RH.

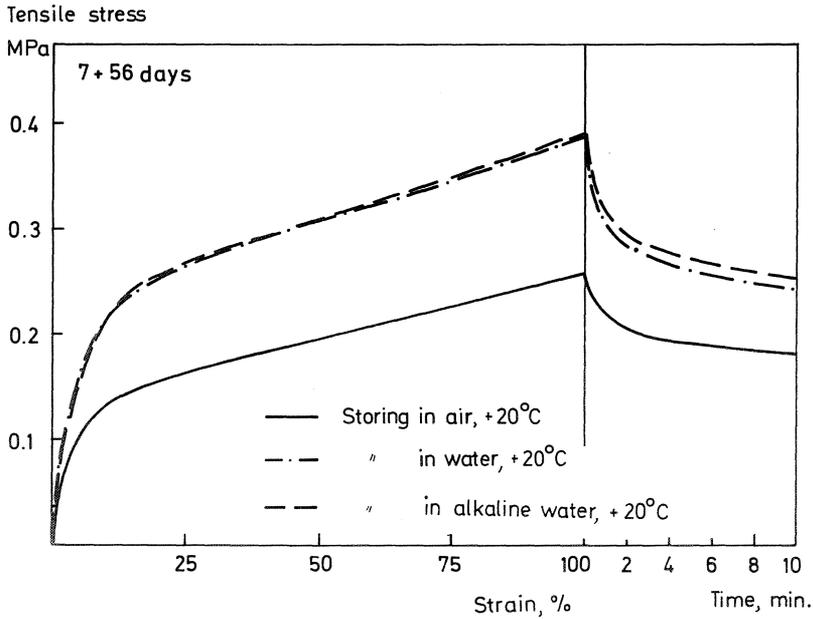
FIG. 4.31 Stress-strain curves for Material No. 3 after storing at +20 °C/50% RH, on water and alkaline water. Deformation speed: 1.5 mm/min. Testing temperature: +2 °C.

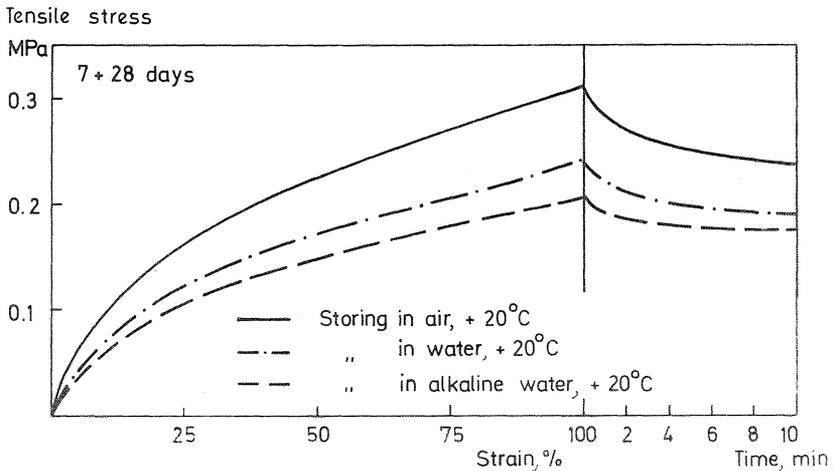
FIG. 4.32 Stress-strain curves for Material No. 4 after storing at +20 °C/50% RH, on water and alkaline water. Deformation speed: 1.5 mm/min. Testing temperature: +2 °C.

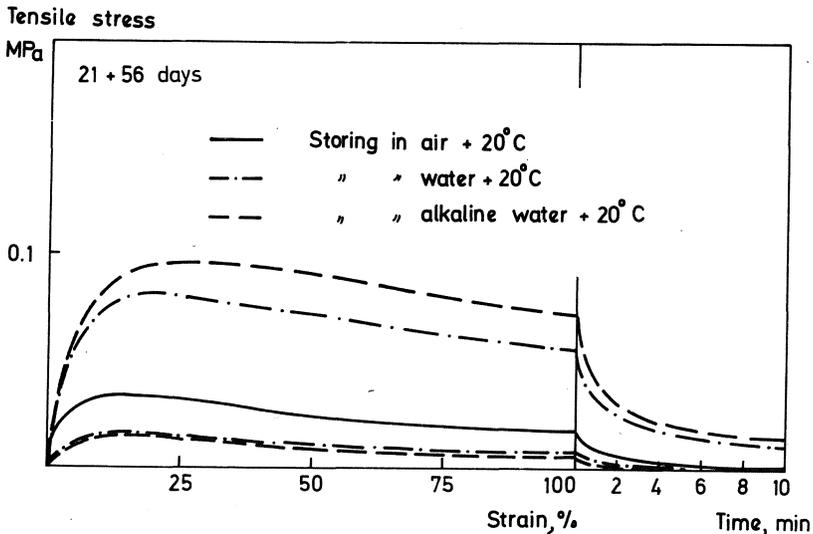
FIG. 4.33 Stress-strain curves for Material No. 6 after storing at +20 °C/50% RH, on water and alkaline water. The both upper curves are valid for specimens which were allowed to dry three weeks after the water and alkaline water storage. Deformation speed: 1.5 mm/min. Testing temperature: +2 °C.

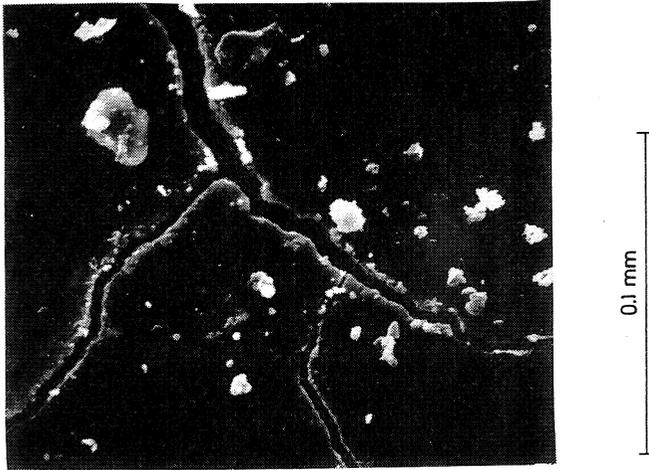
FIG. 4.34 SEM-photograph of the surface of a polysulfide-based sealant UV-irradiated for 21 days. Enlargement 600x. Photo: The Zoological Institution of Lund University.

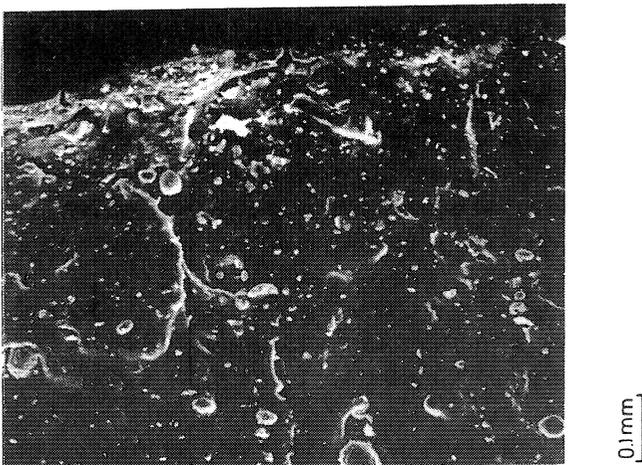
FIG. 4.35 SEM-photograph of a cut through a UV-irradiated polysulfide sealant according to Fig. 4.34. Enlargement 120x. Photo: The Zoological Institution of Lund University.

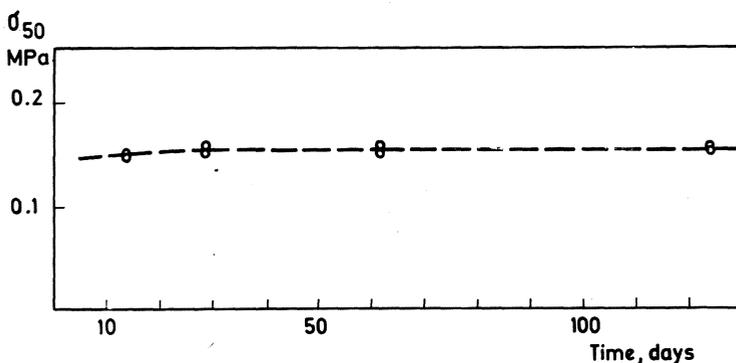
FIG. 4.36 Tensile stress at 50% elongation ($= \sigma_{50}$) for Material No. 1 as a function of storing time in UV-light. Initial storing: 7 days at +20 °C/50% RH.

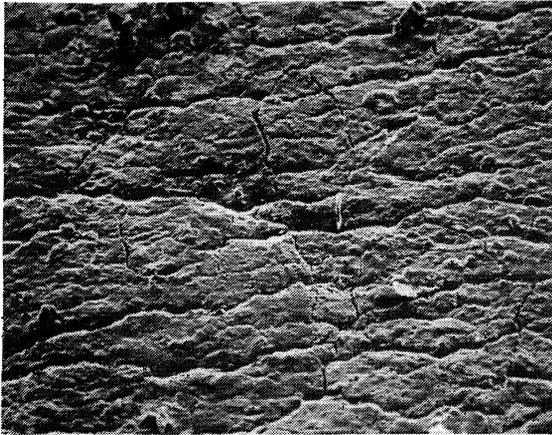
FIG. 4.37 SEM-photograph of the surface of Material No. 4 after UV-irradiation for 28 days. Initial storing: 7 days at +20 °C/50% RH. The specimen has been elongated 100% before photographing. Enlargement 240x. Photo: The Zoological Institution of Lund University.

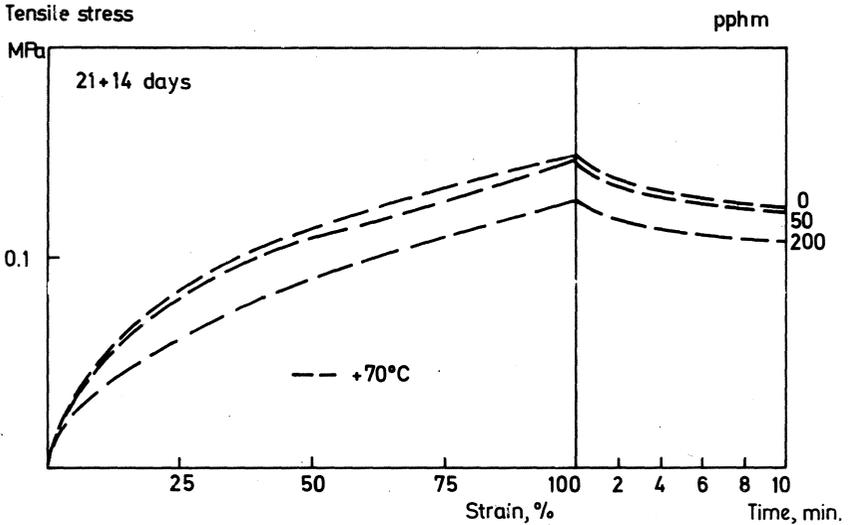
FIG. 4.38 Stress-strain curves for Material No. 1 after storing at 50% elongation and different ozone levels. Deformation speed: 1.5 mm/min. Testing temperature: +2 °C.

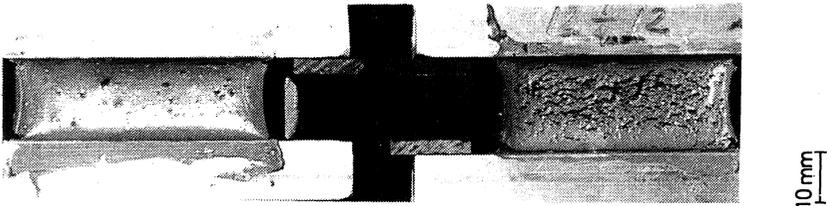
FIG. 4.39 Heat aged specimens of Material No. 1 after storing at an ozone concentration of 200 pphm. The specimen to the left elongated 25% and the specimen to the right 50% at the ozone exposure.

Fig 4.38 valid for specimens of Material No. 1 elongated 50% during the ozone exposure, shows a certain decrease in the deformation resistance to the highest ozone content. The reason for this is shown in Fig 4.39. The specimen shows typical ozone cracks oriented at right angles to the direction of the elongation.

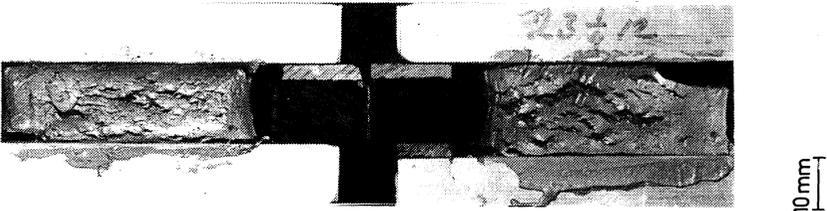
FIG. 4.40 Heat aged specimens of Material No. 2 after storing at an ozone concentration of 200 pphm. The specimen to the left elongated 25% and the specimen to the right 50% at the ozone exposure.

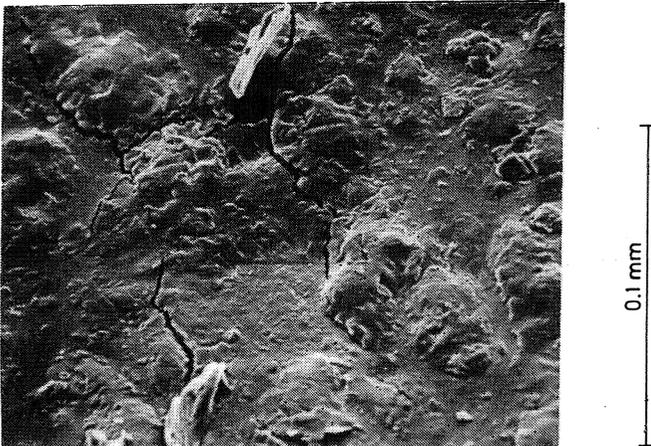
FIG. 4.41 SEM-photograph of the surface of Material No. 4 after storing at 50% elongation and an ozone concentration of 200 pphm. The specimen has been elongated 100% before photographing. Enlargement 600x. Photo: The Zoological Institution of Lund University.

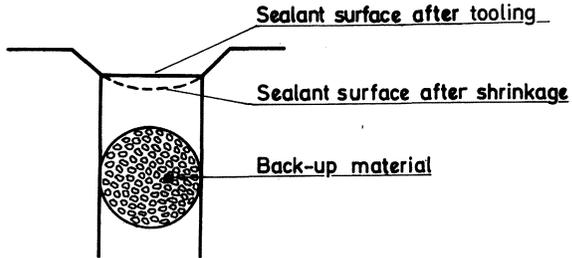
FIG. 4.42 A certain amount of shrinkage gives a better profile from the movement capability point of view.

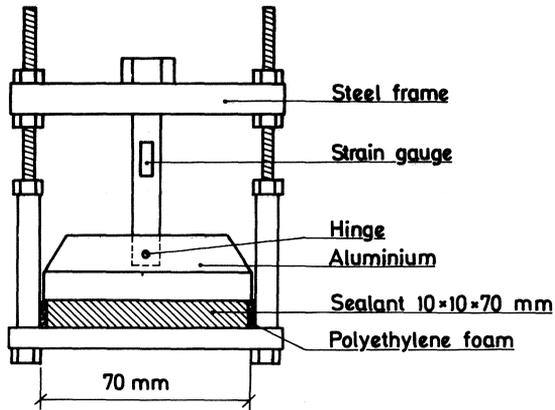
FIG. 4.43 Device for measuring of shrinkage stresses.

As it was a question of measuring very small stresses there was some uncertainty regarding the measurements. The equipment according to Fig. 4.43 is sensitive to changes in temperature etc. Therefore an approximation of the measuring accuracy was made. This resulted in a general addition ($=2 \cdot 10^{-3}$ MPa) to the measured values.

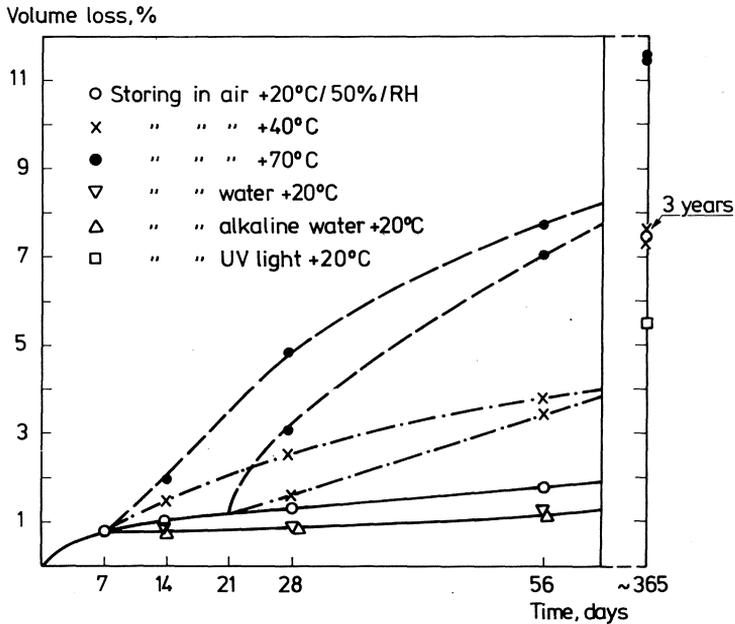
FIG. 4.44 Shrinkage as a function of storing time in different environments for Material No. 1.

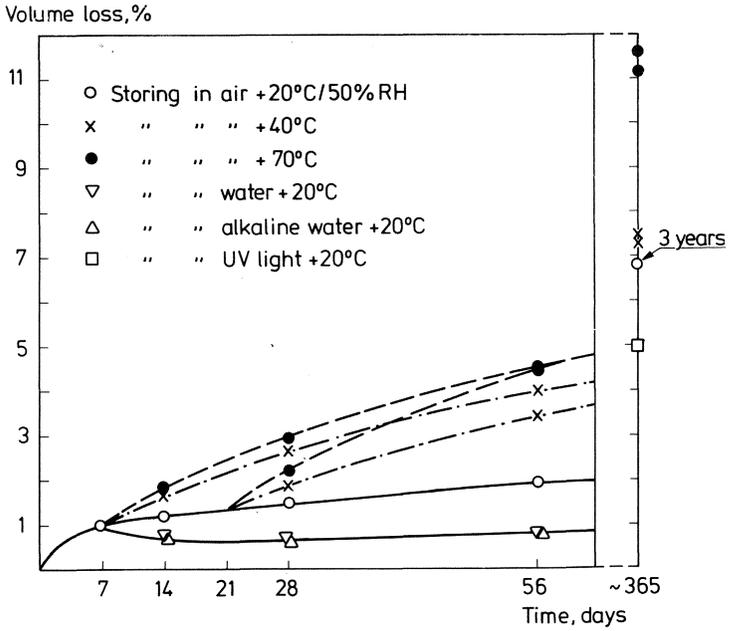
FIG. 4.45 Shrinkage as a function of storing time in different environments for Material No. 2.

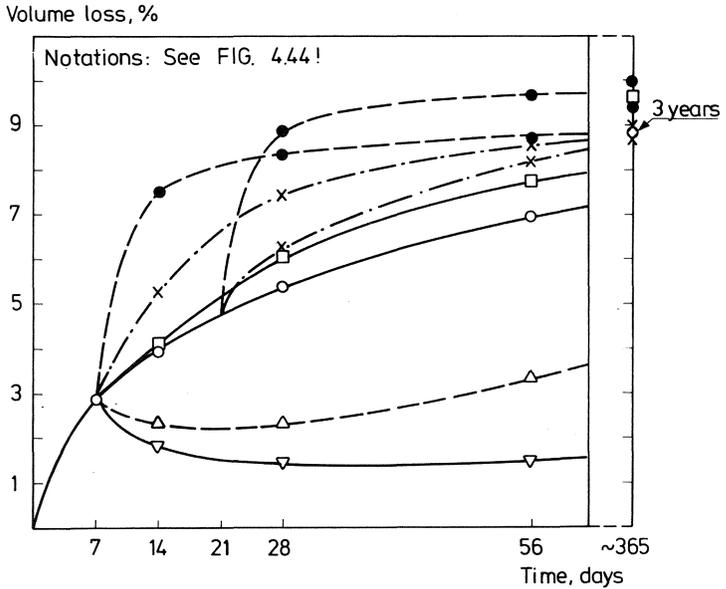
FIG. 4.46 Shrinkage as a function of storing time in different environments for Material No. 3.

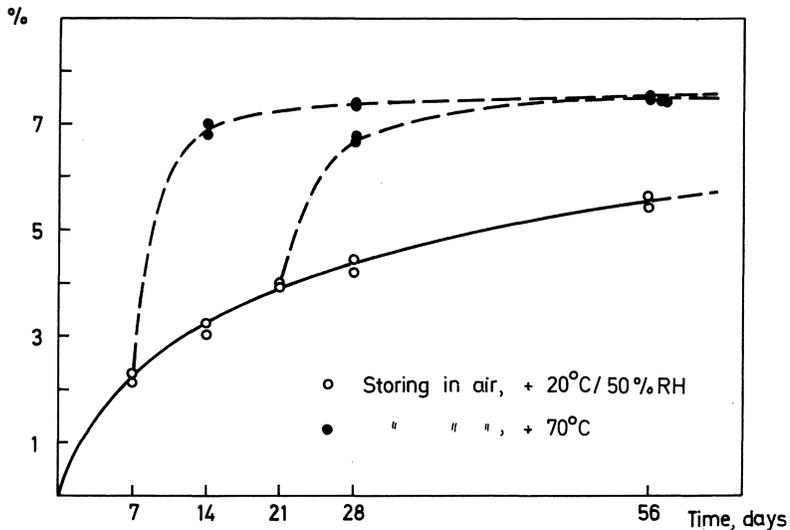
FIG. 4.47 Weight loss as a function of storing time at different temperatures for Material No. 3.

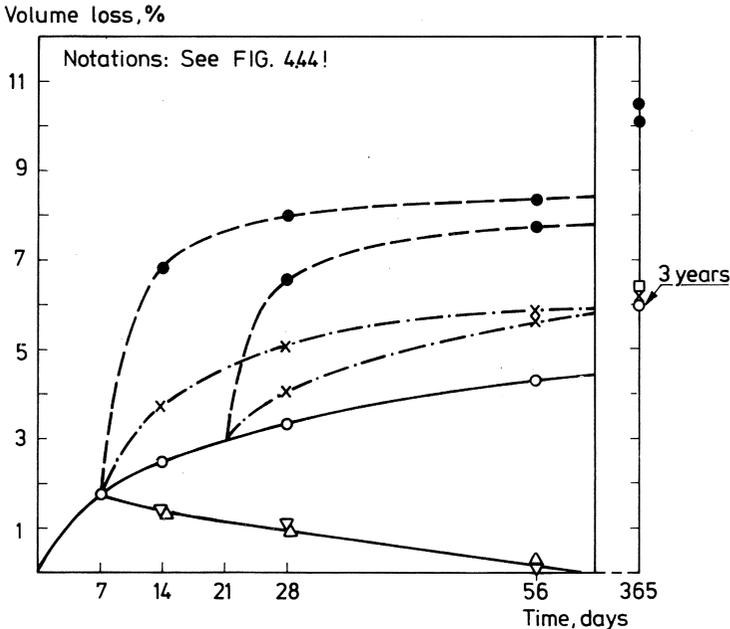
FIG. 4.48 Shrinkage as a function of storing time in different environments for Material No. 4.
