Ageing and deformation properties of building joint sealants

Burström, Per Gunnar

1979

Burström, P. G. (1979). *Ageing and deformation properties of building joint sealants*. [Doctoral Thesis (monograph), Division of Building Materials]. Division of Building Materials, LTH, Lund University.

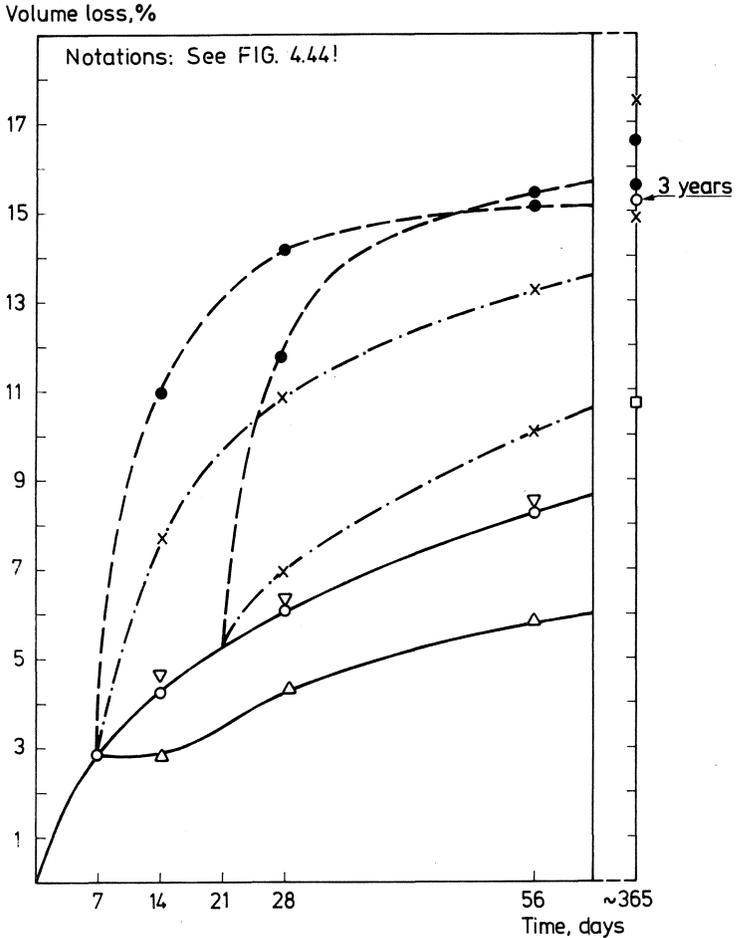
FIG. 4.49 Shrinkage as a function of storing time in different environments for Material No. 5.

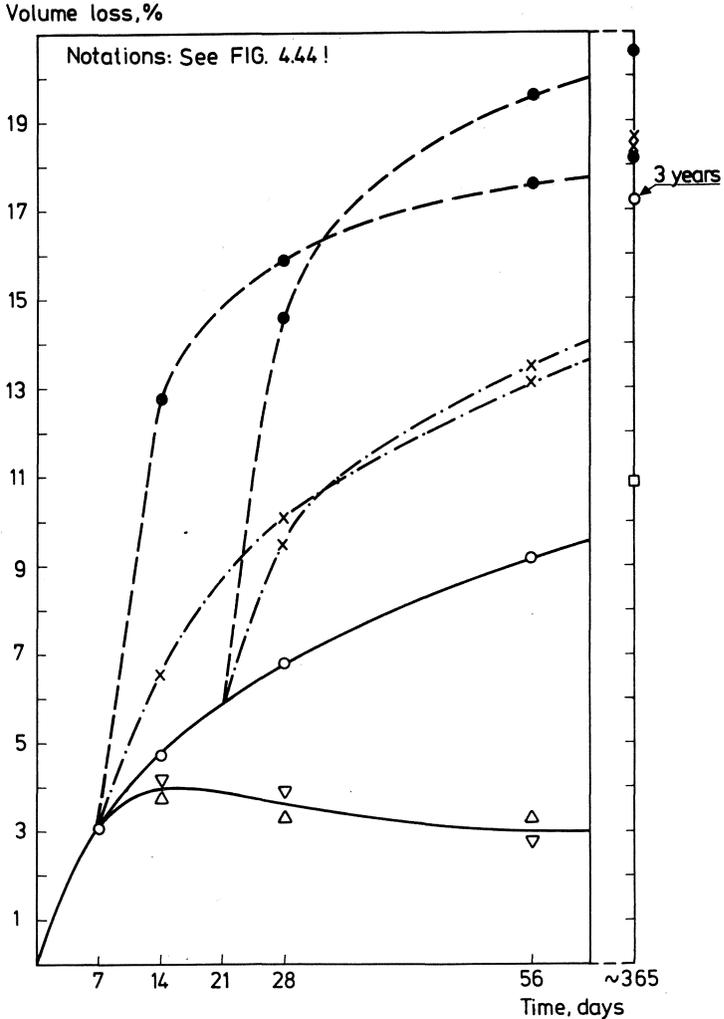
FIG. 4.50 Shrinkage as a function of storing time in different environments for Material No. 6.

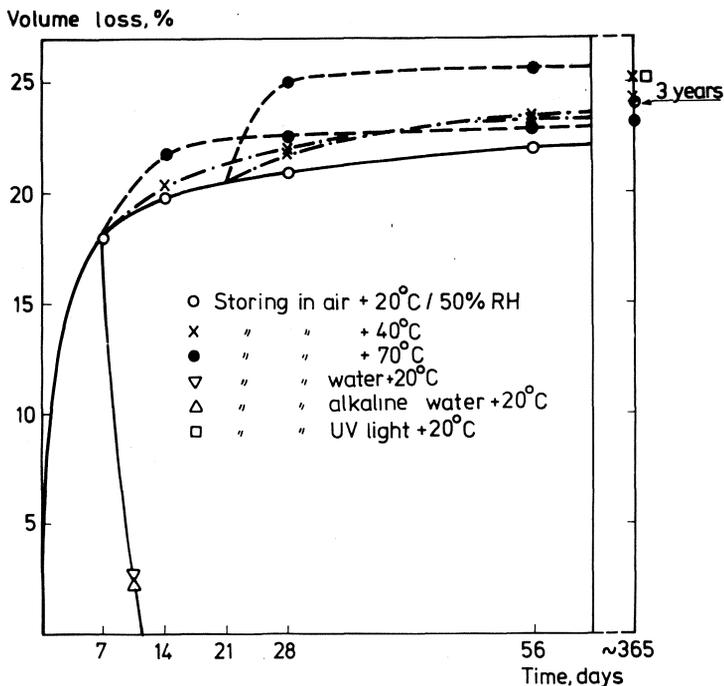
FIG. 4.51 Shrinkage as a function of storing time in different environments for Material No. 7.

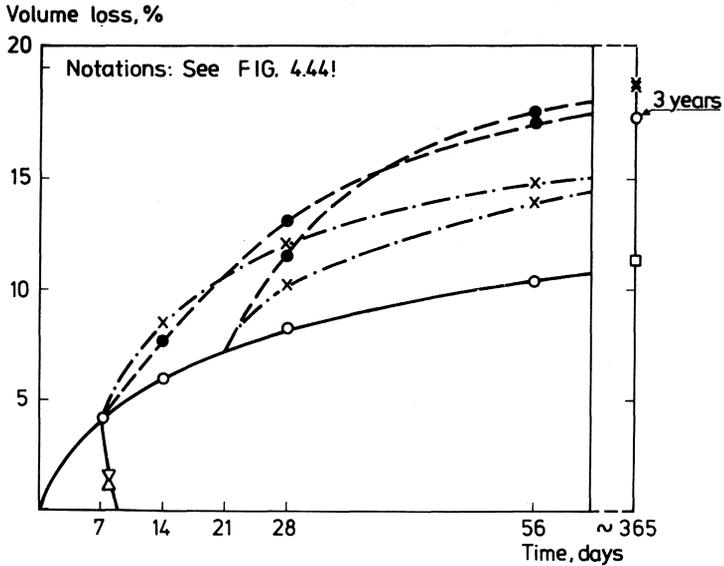
FIG. 4.52 Shrinkage as a function of storing time in different environments for Material No. 8.

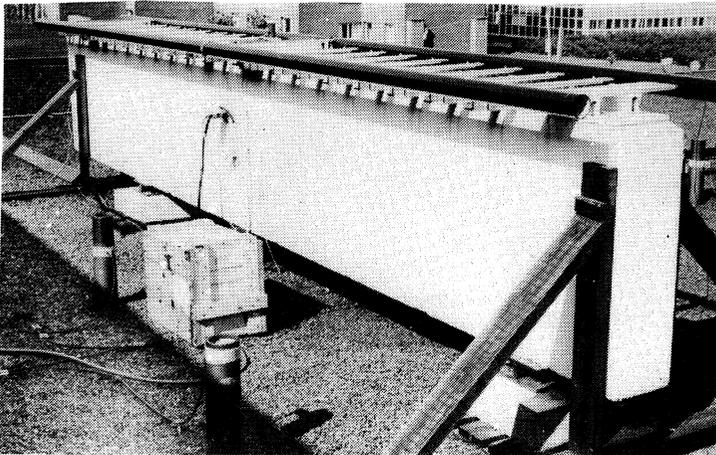
FIG. 5.1 A survey of the testing equipment for outdoor exposure of specimens.

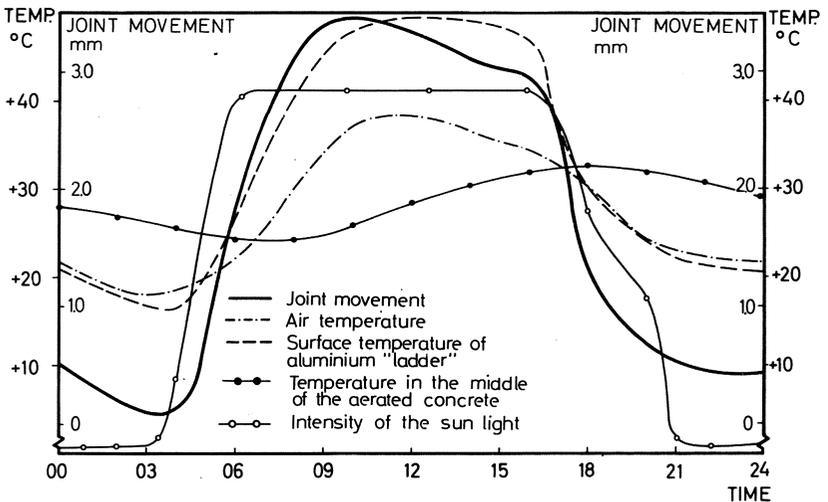
FIG. 5.2 An example of a day (750809) with large measured temperature variations and in connection to that joint movements in the outdoor equipment for exposure of specimens.

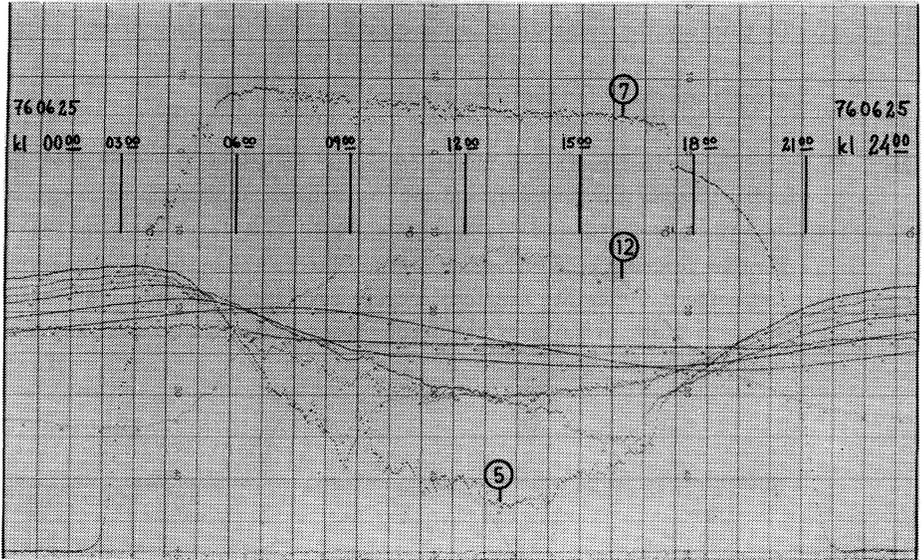
FIG. 5.3 Photo of a chart from the point recorder.

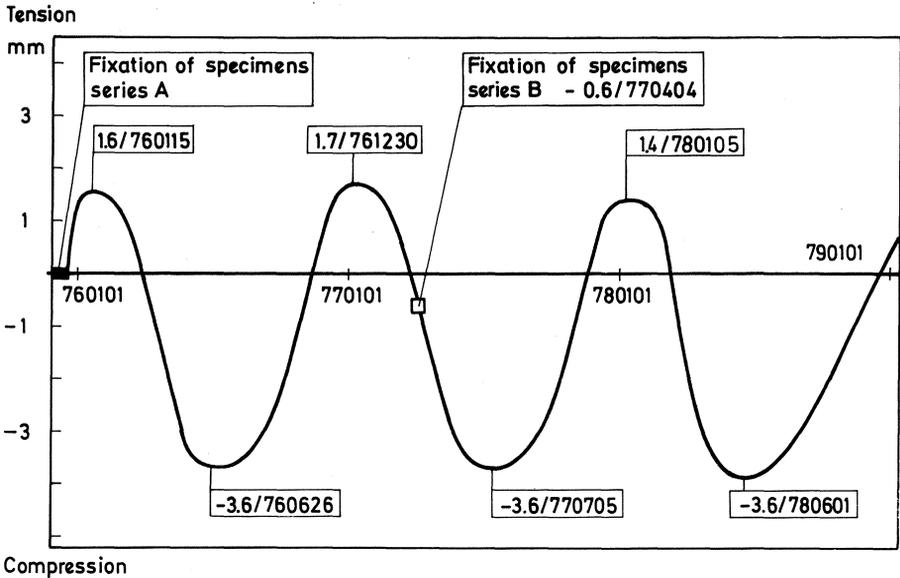
FIG. 5.4 The variations of the "joint" movements at the end of the outdoor equipment.

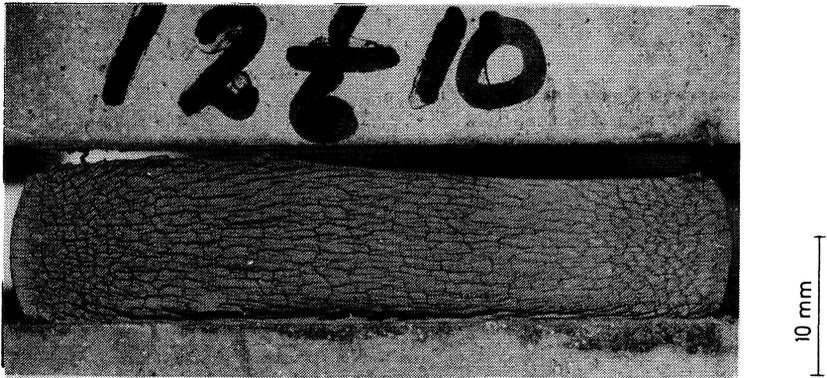
FIG. 5.5 Photo of specimen No. 12 1/2 10 after 21 months of outdoor exposure. The specimen has been elongated 11.2% and compressed 18.2% (cf. Table 5.1).

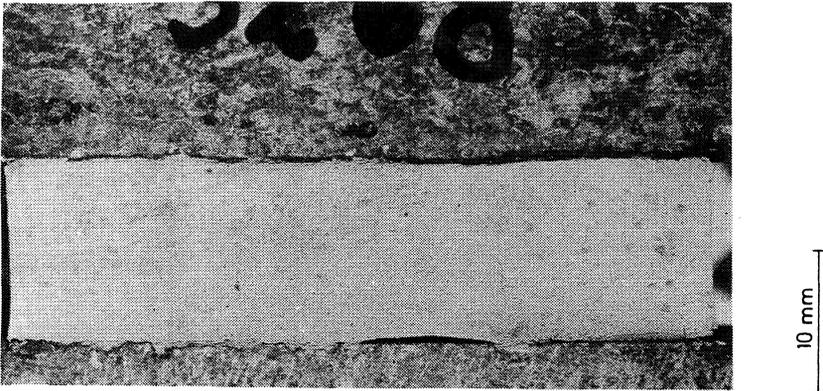
FIG. 5.6 Photo of specimen No. 3268 after 39 months of outdoor exposure. The specimen has been elongated 5.7% and compressed 12.8% (cf. Table 5.3).

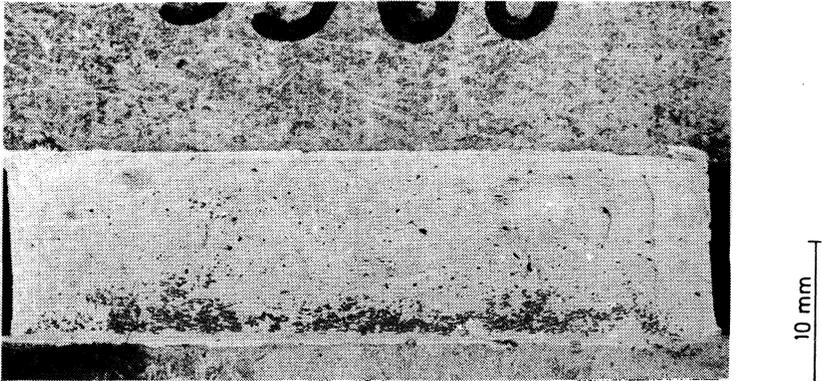
FIG. 5.7 Photo of specimen No. 5568 after 39 months of outdoor exposure. The specimen has been elongated 7.0% and compressed 15.7% (cf. Table 5.4).

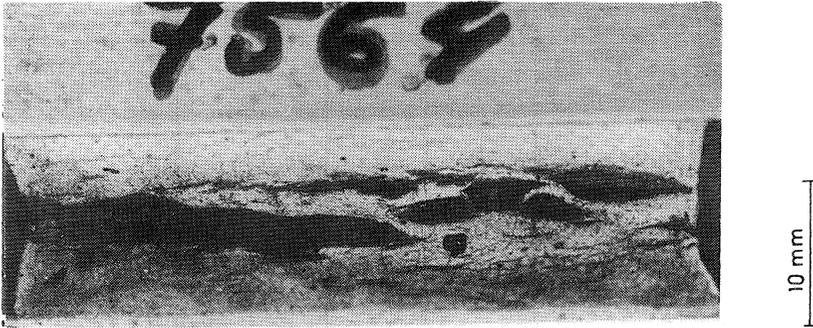
FIG. 5.8 Photo of specimen No. 7564 after 39 months of outdoor exposure. The specimen has been elongated 6.4% and compressed 14.4% (cf. Table 5.6).

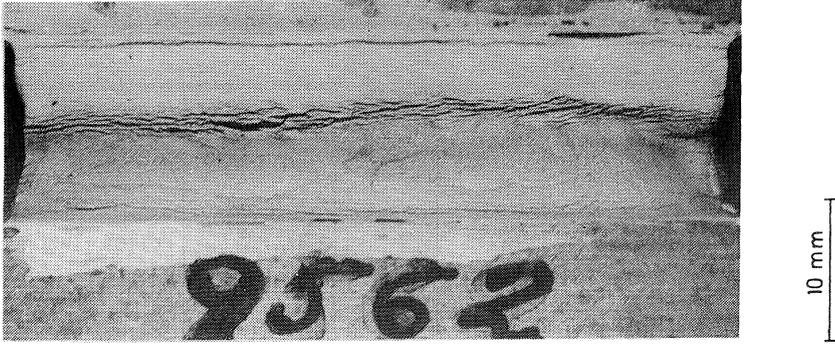
FIG. 5.9 Photo of specimen No. 9562 after 39 months of outdoor exposure. The specimen has been elongated 10.1% and compressed 22.4% (cf. Table 5.8).

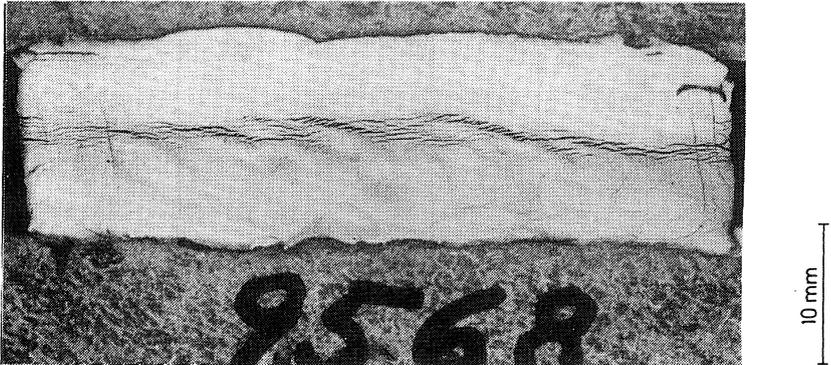
FIG. 5.10 Photo of specimen No. 9568 after 39 months of outdoor exposure. The specimen has been elongated 4.4% and compressed 9.8% (cf. Table 5.8).

Specimen No.	Curing conditions before fixation	Date of fixation	Time of exposure months	Max.tension/compression %	Observations
9561	11 days 20/50	751116	7	9.4/21.7	Folded. Testing
9562	11 days 20/50	751116	7	9.3/21.5	Folded
			14	10.1/21.5	Folded. Small surface crack
			23	10.1/21.6	"
			37	"	" "
			39	10.1/22.4	Folded. Small surface crack. Fig.5.9
9563	14 days 20/50	751119	7	4.1/9.4	Slightly folded. Testing
9564	15 days 20/50	751120	7	4.1/9.4	Slightly folded
			14	4.4/9.4	"
			23	4.4/9.5	"
			37	4.4/9.8	"
			39	"	Slightly folded. Very small surface cracks
9566	11 days 20/50	751116	7	9.2/21.3	Folded. 5A. Testing
9567	14 days 20/50	751119	7	4.1/9.4	Slightly folded. Testing
9568	14 days 20/50	751119	7	4.1/9.4	Slightly folded
			14	4.4/9.4	"
			23	4.4/9.5	Slightly folded. Very small surface cracks
			37	4.4/9.8	Slightly folded. Very small surface cracks
			39	"	Slightly folded. Very small surface cracks. Fig. 5.10

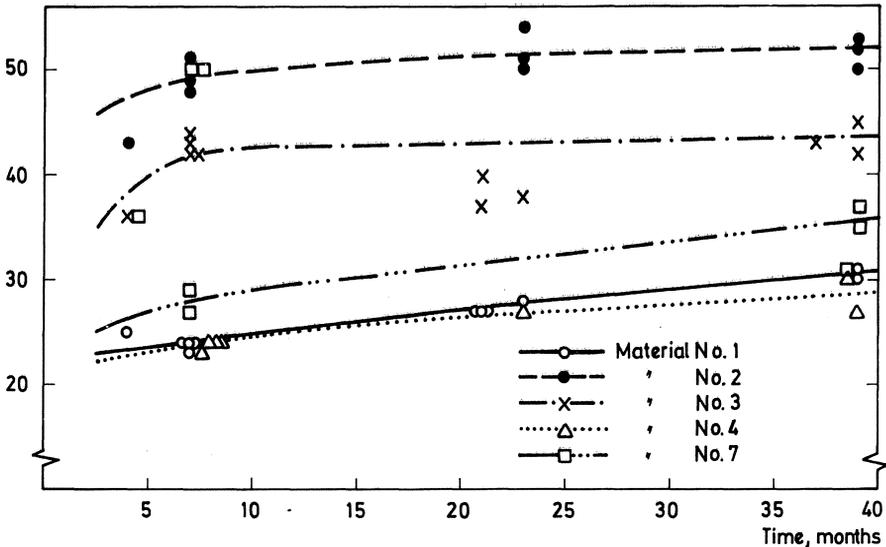
FIG. 5.11 Instantaneous Shore A-values for the mainly elastic sealants as a function of time outdoors.

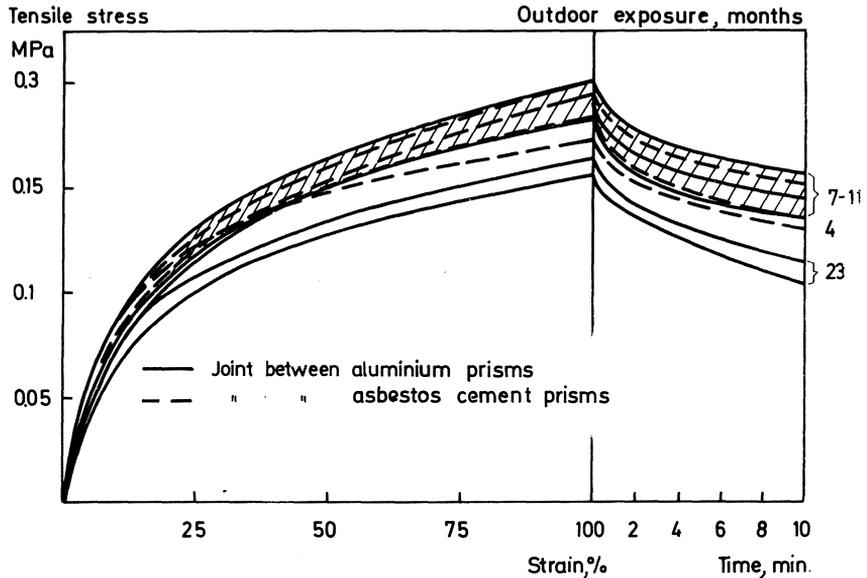
FIG. 5.12 Stress-strain curves for Material No. 1 after different times of outdoor exposure. Deformation speed: 1.5 mm/min. Testing temperature: +2 °C.

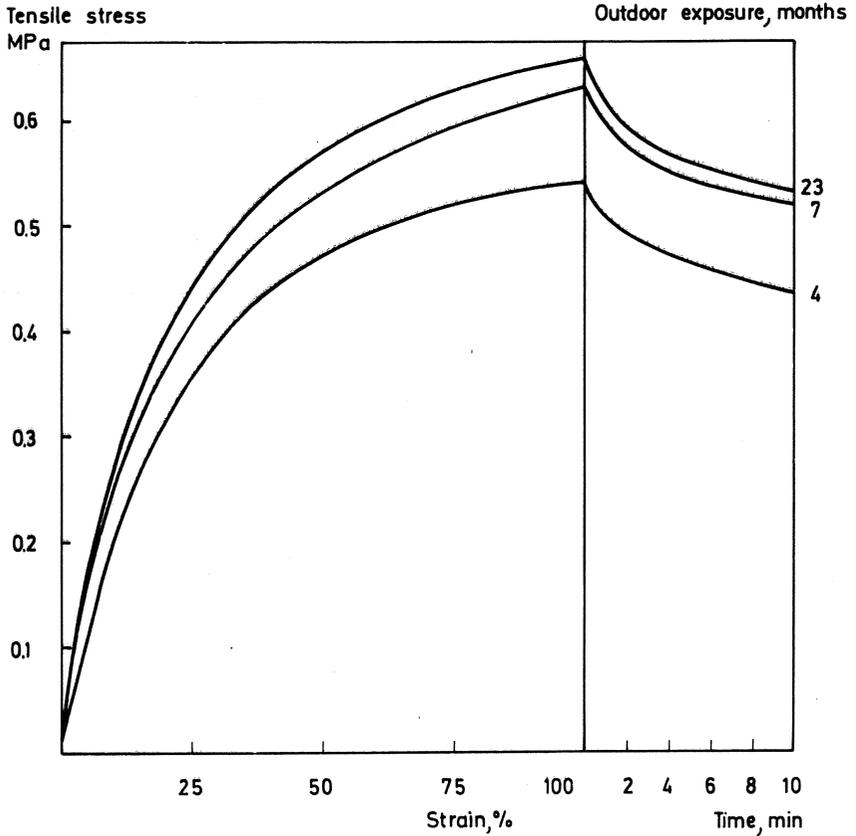
FIG. 5.13 Stress-strain curves for Material No. 2 after different times of outdoor exposure. Deformation speed: 1.5 mm/min. Testing temperature: +2 °C.

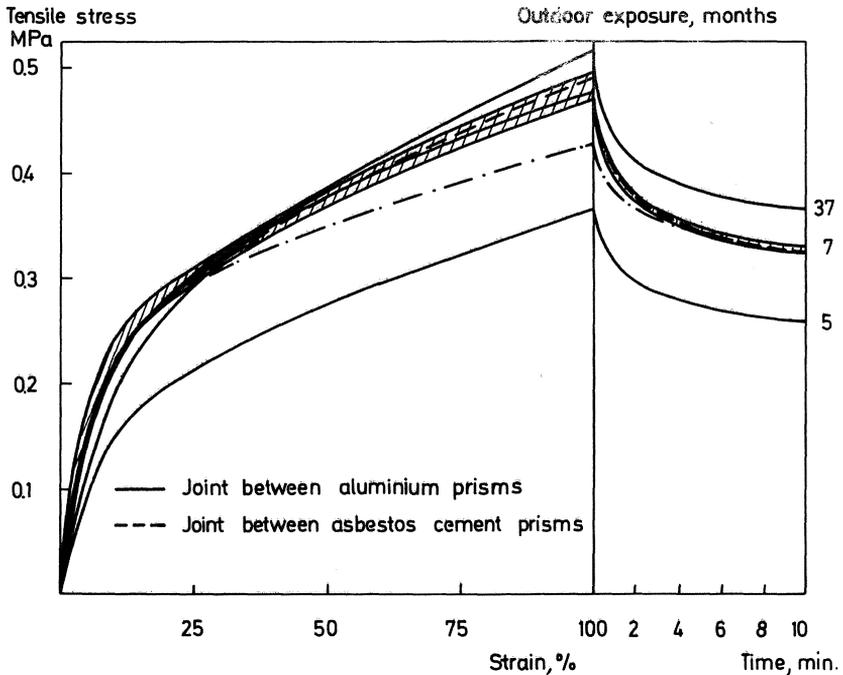
FIG. 5.14 Stress-strain curves for Material No. 3 after different times of outdoor exposure. Deformation speed: 1.5 mm/min. Testing temperature: +2 °C.

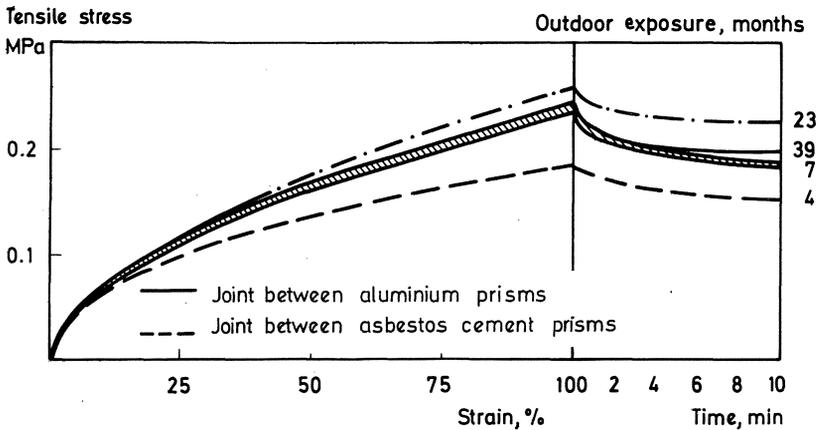
FIG. 5.15 Stress-strain curves for Material No. 4 after different times of outdoor exposure. Deformation speed: 1.5 mm/min. Testing temperature: +2 °C.

Fig. 5.15 shows the stress-strain curves for Material No. 4. The hatched surface indicates the stress-strain curves for 4 specimens (5561, 5563, 5566-7 according to Table 5.4) with an exposure time of about 7 months and with different degrees of deformation. The dispersion is very small.

The dotted line curve represents a specimen (55 1/6 9) which was well-cured before being placed outdoors. Therefore the curve is slightly steeper and the sealant shows less stress relaxation.

When comparing normal and heat stored specimens in Fig. 4.20 to the values from Fig. 5.15 it is evident that the outdoor exposed material is considerably softer! A reasonable explanation for this is that the outdoor material absorbed small amounts of water. As previously mentioned the water acts as a plasticizer.

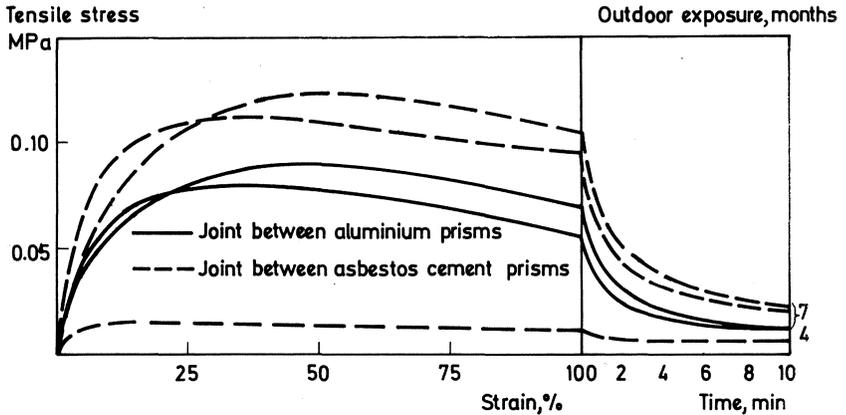
FIG. 5.16 Stress-strain curves for Material No. 6 after different times of outdoor exposure. Deformation speed: 1.5 mm/min. Testing temperature: +2 °C.

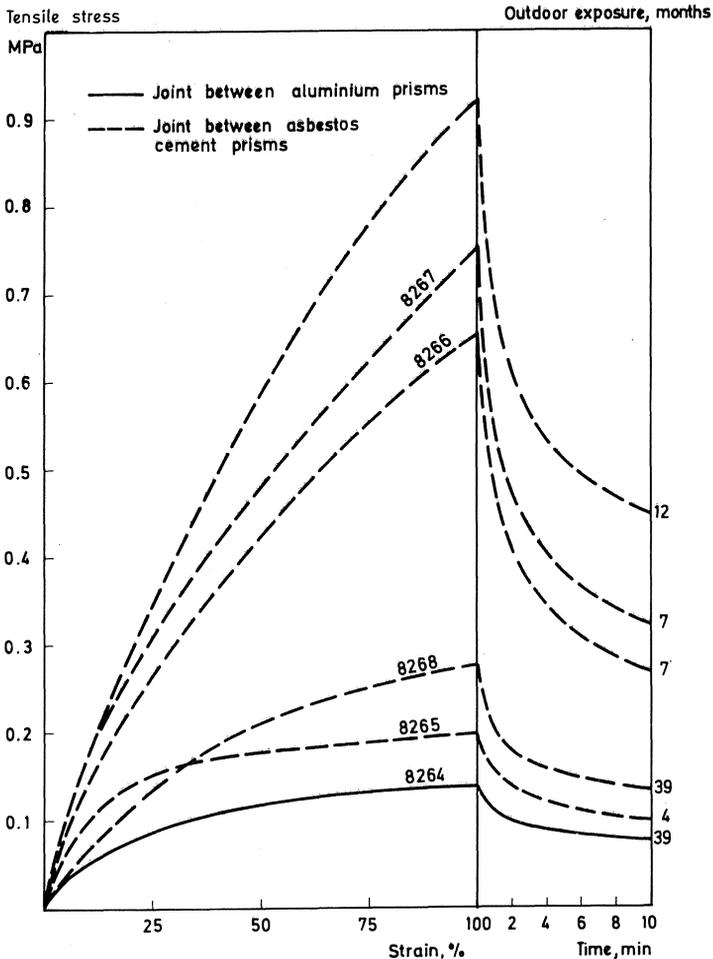
FIG. 5.17 Stress-strain curves for Material No. 7 after different times of outdoor exposure. Deformation speed: 1.5 mm/min. Testing temperature: +2 °C.

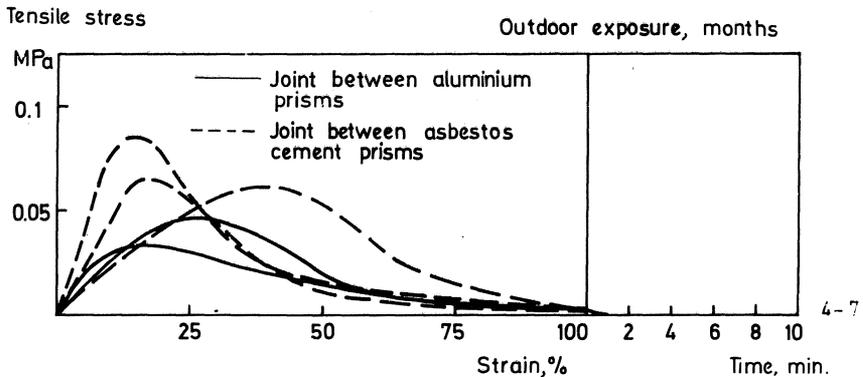
FIG. 5.18 Stress-strain curves for Material No. 8 after different times of outdoor exposure. Deformation speed: 1.5 mm/min. Testing temperature: +2 °C.

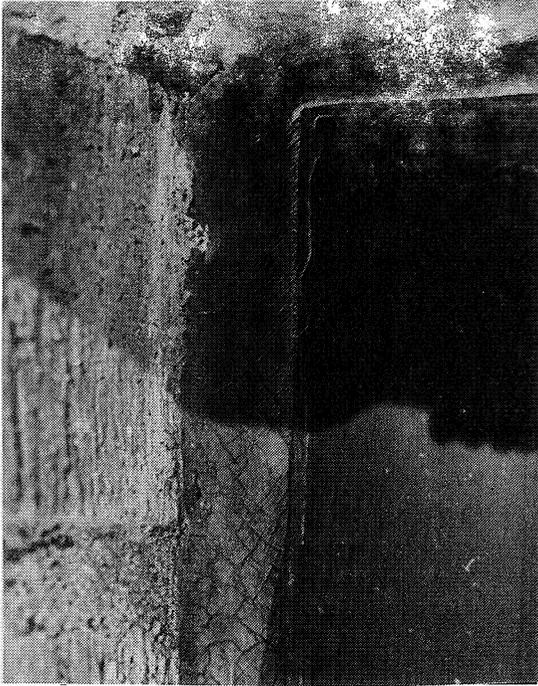
FIG. 6.1 UV-action on a two year old polysulfide-based sealant. The upper part of the joint is mostly shaded. Therefore, the UV attack is considerably lesser on this part of the sealant.

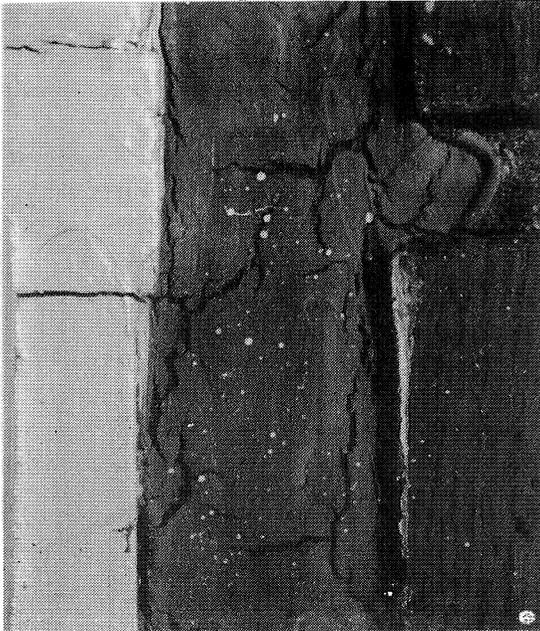
FIG. 6.2 Deep cracks in a 12 year old polysulfide-based sealant (50⁰ Shore A). The joint is located indoors at a constant temperature of about +22 °C.

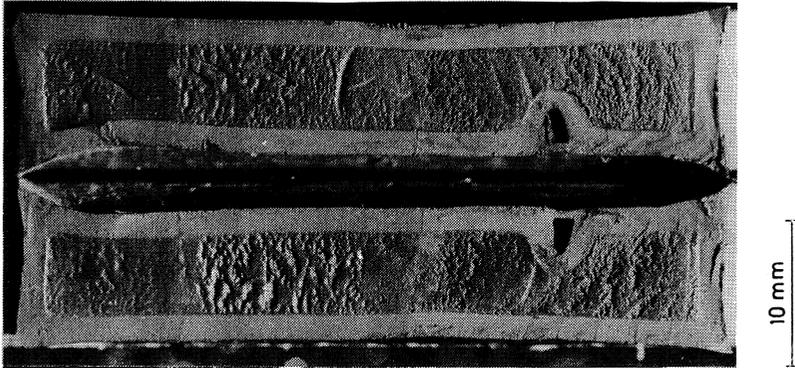
FIG. 7.1 Photo of a cut through a 9 year old specimen of Material No. 8. The specimen contains a bubble, with an outer skin which has been completely oxidized. Then the oxidation has continued within the sealant.

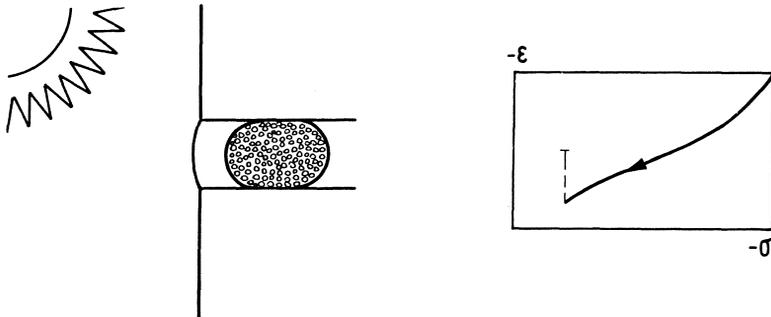
FIG. 8.1 Joint closing and a consequence of that compressive stresses in the sealant.

When a joint is closing due to increasing temperature the sealant is then consequently compressed, Fig. 8.1. The deformation properties of the sealant at that movement are to a great extent dependent upon the amplitude and the rate of the joint movement, the temperature, the duration of the movement, the age of the sealant etc. There is a complex co-operation between these variables. Stresses are induced within the sealant, and stress relaxation occurs during a resting time.

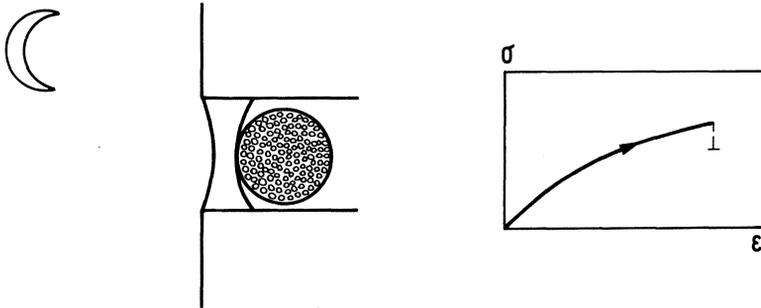
FIG. 8.2 Joint opening and tensile stresses are induced.

At a subsequent opening of the joint when the temperature drops, the sealant moves back to the original width and is later elongated to a certain amplitude. Tensile stresses are induced in the sealant, Fig. 8.2.

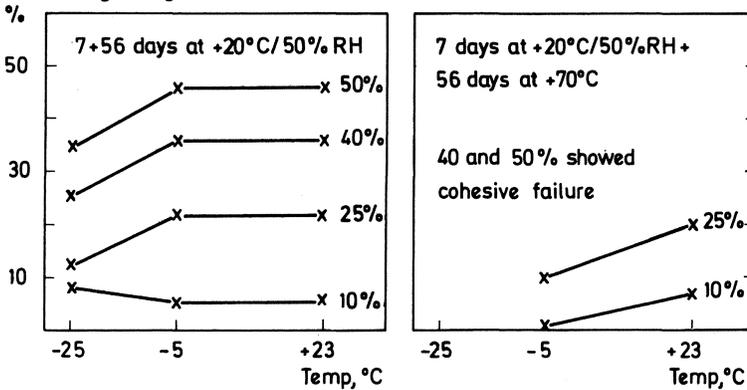
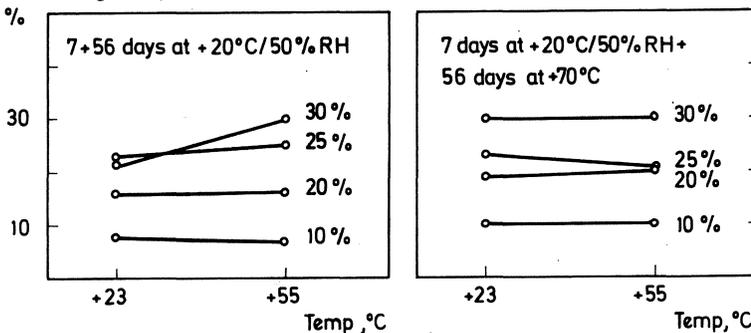
FIG. 8.3 Remaining deformations as a function of temperature for an acrylic-based sealant (solvent release). Specimens have been elongated 10%, 25%, 40% and 50% or compressed 10%, 20%, 25% and 30% at a rate of 0.001 mm/min. 7 + 56 days at +20 °C/50% RH etc. indicates the curing conditions before testing.

Figs. 8.3 - 8.5 summarize the results for the different sealants. It is evident that the lower temperatures lessened the remaining deformations for all the sealants, including the very plastic acrylic sealants.

In other words, the lower temperatures increase the elasticity of the sealants at the same time as the adhesive stresses are increased. The higher temperatures, on the other hand, increase the plastic deformations even for the highly elastic silicone-based sealant.

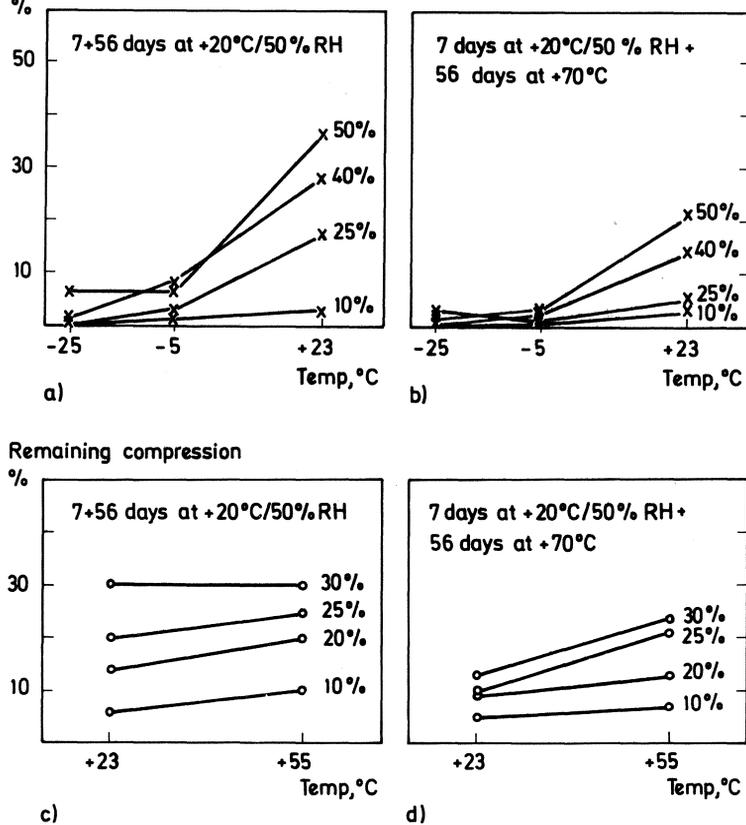
FIG. 8.4 Remaining deformations as a function of temperature for a polysulfide-based sealant (25° Shore A). Compare Fig. 8.3!

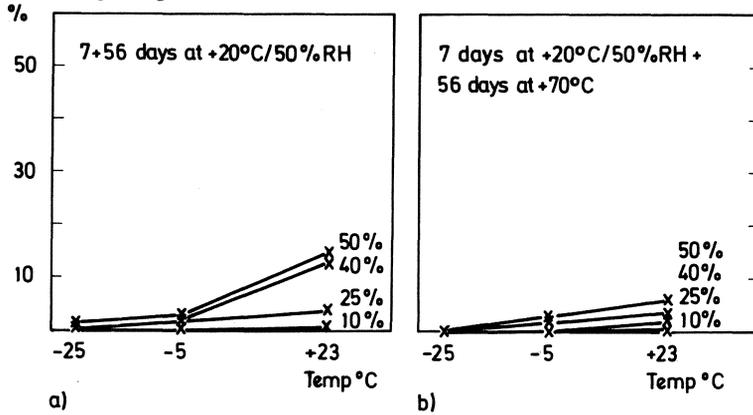
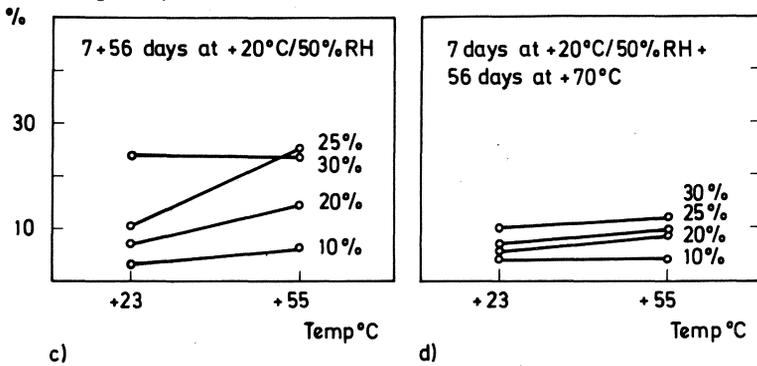
FIG. 8.5 Remaining deformations as a function of temperature for a silicone-based sealant (20° Shore A). Compare Fig. 8.3!

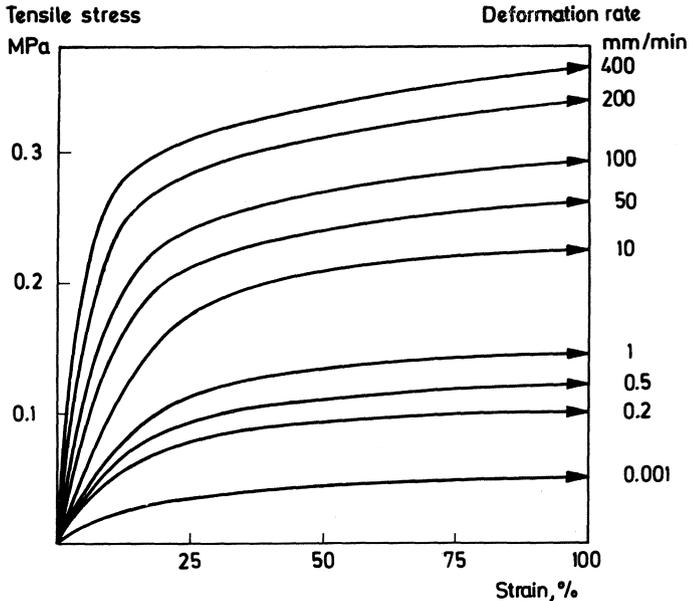
FIG. 8.6 The effect of the deformation rate upon the stress-strain curve of a polysulfide-based sealant, 22^o Shore A. Testing temperature: +20 °C.

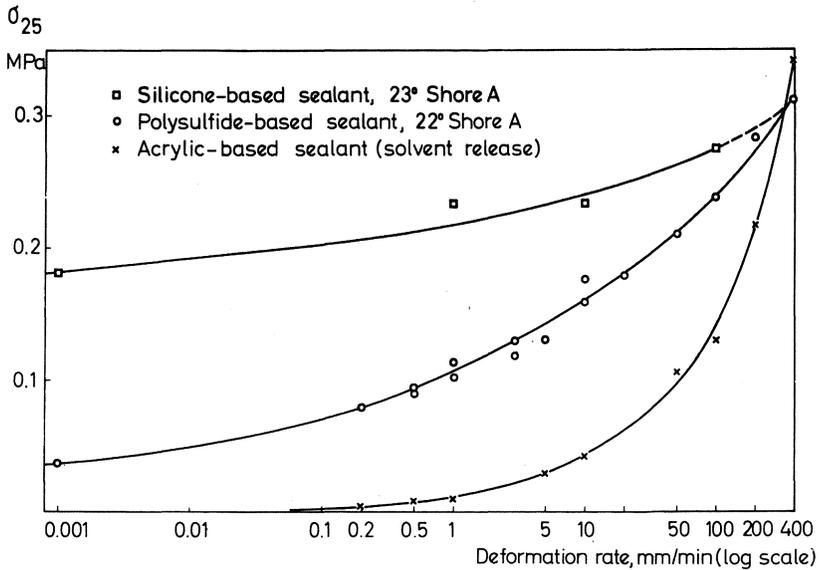
FIG. 8.7 Tensile stress at 25% elongation ($= \sigma_{25}$) as a function of deformation rate for three different types of sealants.

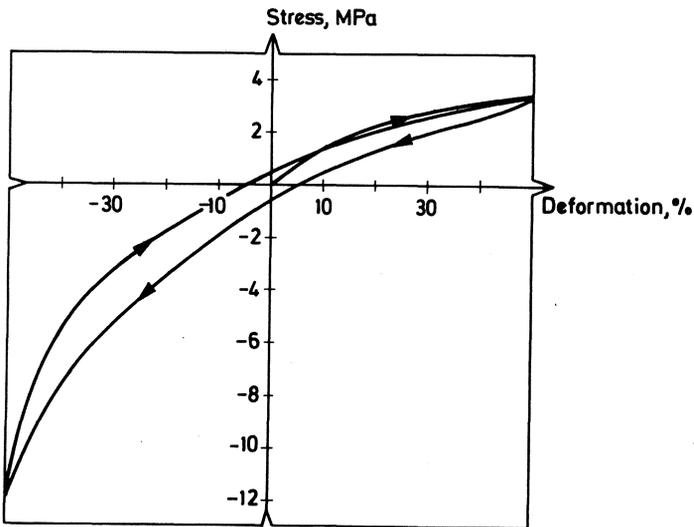
FIG. 8.8 The effect of cyclic joint movement on a polysulfide-based sealant. Deformation rate: 10 mm/min. Testing temperature: +20 °C.

In Fig. 8.8 an example of a cyclic test on a polysulfide sealant is shown. The rate is too high and therefore this kind of test is of no real value.

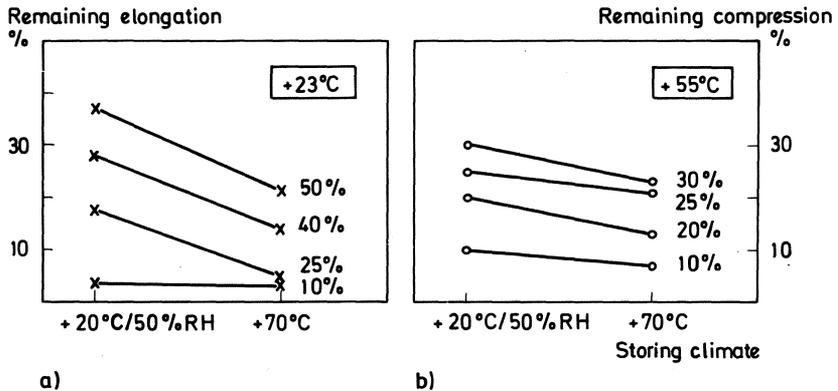
FIG. 8.9 Remaining deformation as a function of curing conditions for a polysulfide-based sealant (25° Shore A). Specimens have been elongated 10%, 25%, 40% and 50% at a temperature of $+23^{\circ}\text{C}$ (Fig. 8.9a) compressed 10%, 20%, 25% and 30% at a temperature of $+55^{\circ}\text{C}$ (Fig. 8.9b). The time at $+20^{\circ}\text{C}/50\% \text{RH}$ has been 63 days while the time at $+70^{\circ}\text{C}$ has been 56 days after 7 days at $+20^{\circ}\text{C}/50\% \text{RH}$. Deformation rate: 0.001 mm/min.

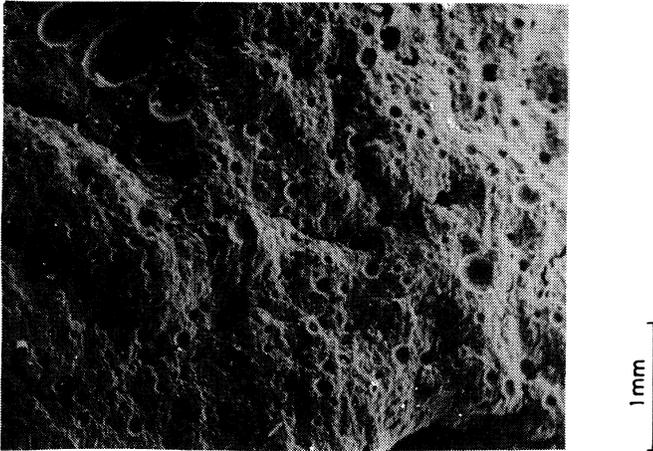
FIG. 8.10 SEM-photograph of a fracture surface of a polysulfide-based sealant for insulated glass manufacturing. Note the high amount of small pores within the sealant! Enlargement 24x. Photo: The Zoological Institution of Lund University.

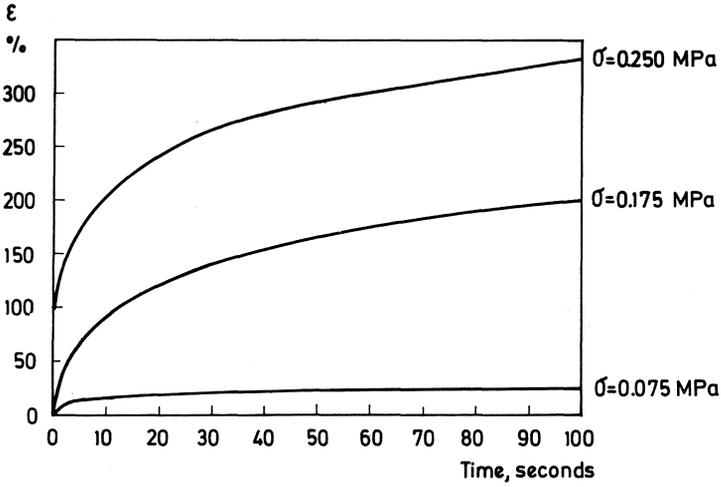
FIG. 8.11 "Creep curves" of Material No. 1 after 7 days at +20 °C/50% RH + 21 days at +70 °C. A constant deformation rate is assumed when calculating this type of creep curves. Testing temperature: +20 °C.

In Nimmermark and Olsson (1976) stress-strain curves were determined at various rates (from 0.2 - 400 mm/min). From these curves it is possible to calculate the time necessary to reach a certain stress at a certain rate. When plotting the times and the deformations connected to these a creep curve is obtained for a certain stress. Examples of such creep curves are shown in Fig. 8.11.

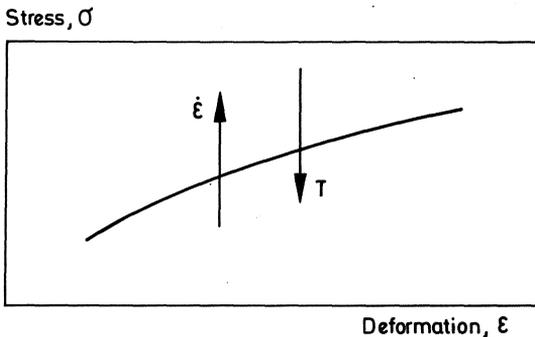
The factors depend on each other in one principal way as shown in Fig. 9.1. An increasing deformation rate raises the curve, while an increasing temperature lowers the curve.

FIG. 9.1 Principal connection between stress (σ), deformation (ϵ), time (= deformation rate, $\dot{\epsilon}$) and temperature (T).

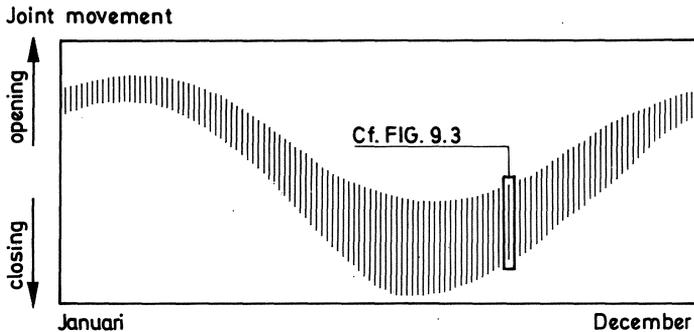
FIG. 9.2 Yearly and daily dependent movements in a joint.

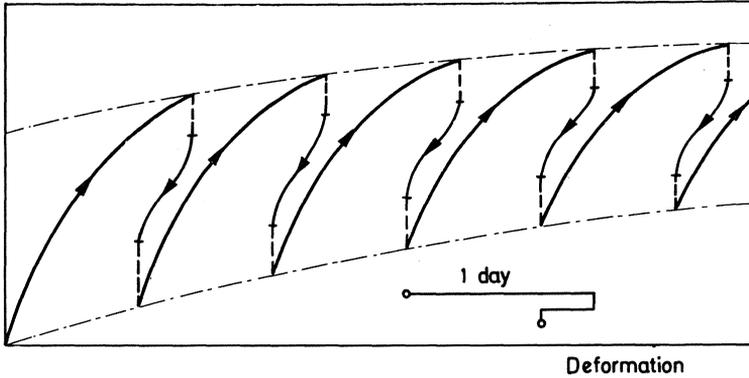
FIG. 9.3 Principal connection between stresses induced in a sealant due to daily and yearly movements. The vertical dashed lines indicate stress relaxation in the sealant.

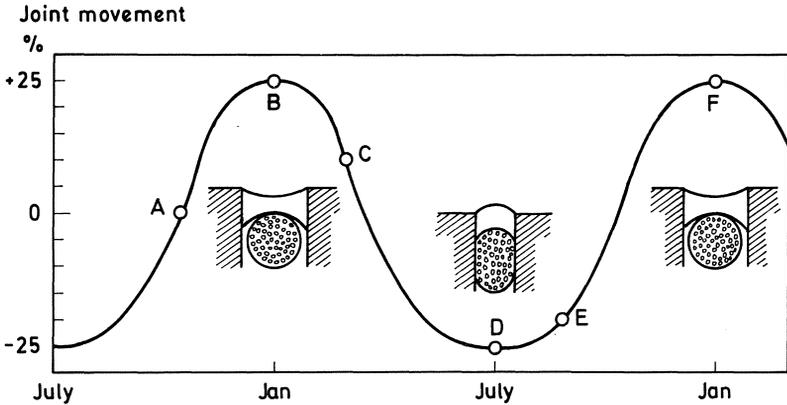
- * Take a joint where the yearly depending movements vary according to Fig. 9.5. A sealant with a movement capability of $\pm 25\%$ is chosen and applied in the autumn, point A in Fig. 9.5. To simplify matters, this point is supposed to be where equal movements occur (25%).

During a decrease in temperature the joint opens to point B where the sealant is elongated 25% (calculated according to the original sealant width = 20 mm). The joint width at this point is consequently 25 mm.

FIG. 9.5 Examples of yearly dependent joint movements. Cf. Fig. 9.6a and b.

Thus, a new sealant width is formed ($= 20 + 2 = 22$ mm). This happens in point C in Figs. 9.5 and 9.6a.

The joint continues to close and reaches its narrowest value at point D where the original joint width is compressed 25%. However, the new sealant width will now be compressed $2 + 5 = 7$ mm and the percentage compression is consequently $\frac{7}{22} \cdot 100\% = 32\%$. The corresponding "stress-strain-relaxation-curve" can be seen in Fig. 9.6b.

During the following opening of the joint the sealant is allowed to elongate, but zero stress is reached at, e.g. 20% compression (point E in Figs. 9.5 and 9.6b). Thus, the new sealant width is now $22 - \frac{20 \cdot 22}{100} = 17.6$ mm. Therefore, the elongation up to point F in Fig. 9.5 is $(20 - 17.6) + 5 = 7.4$.

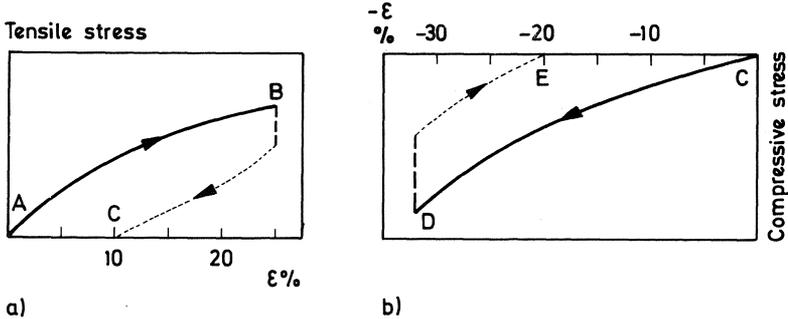
Where the "stress-strain-relaxation-curve" that has been formed during the joint movement A-B is concerned, it can be seen in Fig. 9.6a.

During an increase in temperature the joint starts to close and the sealant starts to be compressed. At a certain level, e.g. $\epsilon = 10\%$, zero stress in the sealant is reached (the dotted line in Fig. 9.6a).

FIG. 9.6 a) Tensile stresses induced in a sealant and remaining deformations according to the example in Fig. 9.5.
 b) Compressive stresses induced in a sealant and remaining deformations according to the example in Fig. 9.5.

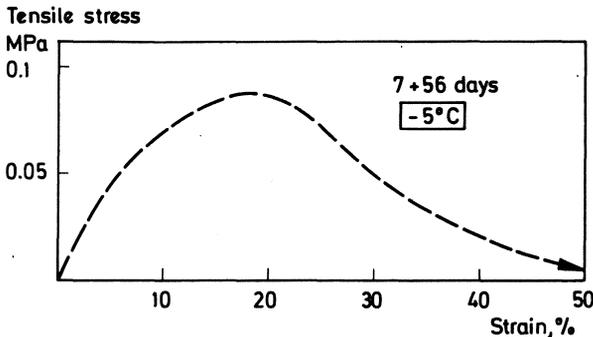
The growth of the skin thickness is found to be very low, cf. Fig. 4.2.9. The permanent strain after rupture of the skin is determined according to Chapter 9.3. The results are shown in Fig. 9.7. The maximum stress, the point where the skin cracks, occurs at a strain of about 20%, which should be the movement capability of this sealant. This movement should be calculated from the narrowest joint width, cf. the example below!

FIG. 9.7 Example of the determination of the movement capability of a oleo-resinous sealant (Material No. 8).

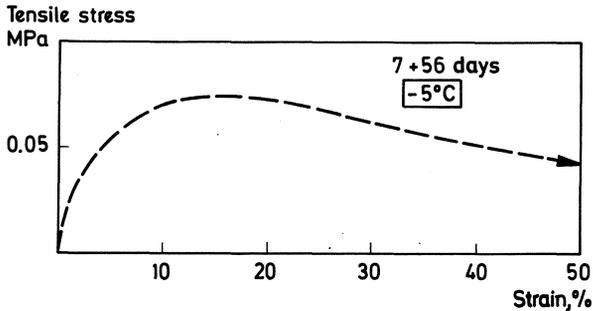
Consider Material No. 6 according to Table 4.1. This material is acrylic-based, type solvent release. The stress-strain curve is determined according to Chapter 9.3. The results are shown in Fig. 9.8. The maximum stress is reached at about 15% elongation, which is the movement capability of the sealant.

FIG. 9.8 Example of the determination of the movement capability of an acrylic-based sealant (Material No. 6).

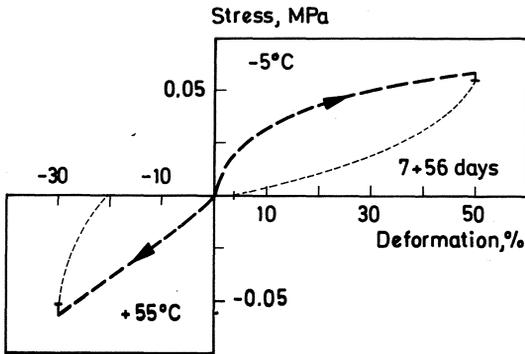
The stress-deformation curves are shown in Fig. 9.9. At this deformations, this sealant did not satisfy the demand "remaining deformation < 15%". The movement capability of the sealant is thus less than $\pm 15\%$, say $\pm 10\%$.

FIG. 9.9 Example of the determination of the movement capability of a polysulfide-based sealant (25° Shore A).
