Performance and wear mechanisms of novel superhard diamond and boron nitride based tools in machining Al-SiCp metal matrix composite

Published in:
Wear

2017

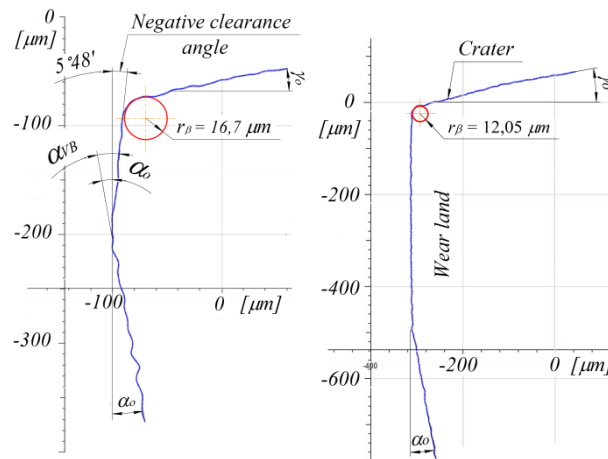
Subsequent analysis of the worn tools with the help of 3D microscopy has revealed that flank and crater wear do not completely characterize the wear topography. The original edge radius of $r_\beta = 15 \mu\text{m}$, identical for all tools, changed in the course of tool wear, as illustrated on Fig. 7. Apart from the edge radius, clearance angle α_{VB} (Fig. 7.a) was also found to deviate from its nominal value, which for the given insert and toolholder geometry should equal $\alpha_o = 9.7$ deg. [16]. Fig. 7 shows that a negative clearance angle is forming on the D-SiC tool, while bcBN grade attains the theoretical value.

Fig. 7. Cross-sectional data for the worn (a) D-SiC and (b) bcBN tools ($v_c = 400$ m/min).

Another, more conventional, mechanism of tool material softening at high cutting speed and related high tool temperature is often attributed to the abrasive tool wear. This mechanism is often observed for cemented carbide tools which exhibit strong loss of hardness at elevated temperature. However in case of superhard tooling the situation is not as pronounced. Chou and Liu [21] have shown that machining Al-SiCp composite at cutting speed of 180 m/min results in the maximum temperature of 410 °C on the tool. The room temperature hardness (Fig. 3) of cBN-based tool materials decreases significantly and in this range of cutting temperature attains values of $HV \approx 22$ GPa for bcBN [22] and $HV \approx 20$ GPa for wBN-cBN [23] materials. Therefore SiC particles in the MMC having slightly higher hardness ($HV = 25-27$ GPa) [24] can inflict mild abrasive wear to the cBN-based tooling. In the case of diamond, its hardness reduces only to $HV \approx 84$ GPa for the given process temperature [24] and thus abrasion by the much softer SiC is very unlikely. On the other hand, the chemical wear of diamond tooling, which results in nano-structured SiC (Fig. 19), enables abrasive wear since the formed SiC is softer than diamond. Therefore chemical wear followed by abrasion of its reaction products is likely to be one of the primary wear mechanisms for diamond tooling. The kinetics of the chemical reaction is linearly proportional to the process temperature. In this case, temperature gradients along the flank wear land, with the highest temperature at the edgeline, would imply the intensity of SiC formation to decrease from the tool edge towards the end of VB, thus explaining negative clearance α_{VB} found only on diamond tooling (Fig. 7.a and Fig 8.a).

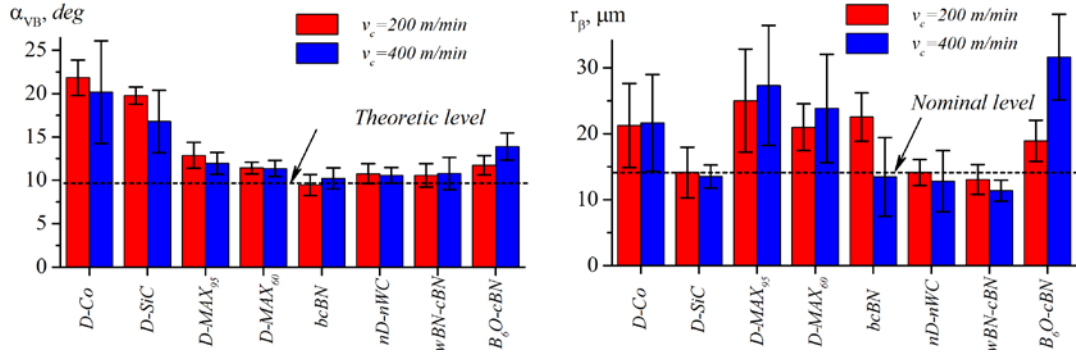
Fig. 8 summarizes the results of the measurement of edge radius r_β and clearance angle α_{VB} for different tool materials and test conditions. It shows that D-Co and D-SiC materials, which have the highest performance, form a highly negative clearance angle. This negative clearance angle is observed on the

etched tools, while the same measurement done prior to the etching indicates that the angle is on the level of the nominal one. This indicates that the workpiece material layer is adhering to the tool flank of D-Co and D-SiC tool and also acts as the tool protection layer (TPL) against the abrasion by SiC particles, which is also discussed later in the article. For other tooling materials the TPL was observed only on the rake.

Fig. 8. Measurement results of (a) clearance angle and (b) edge radius for worn tools.

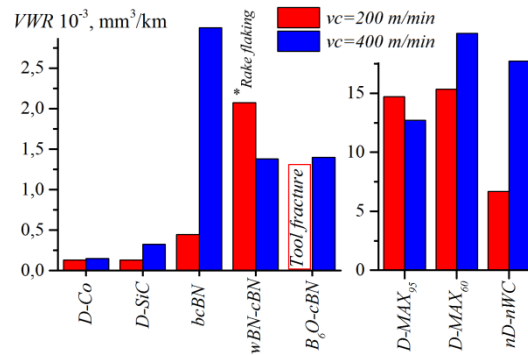
Formation of the negative clearance angle and presence of crater wear for several grades indicate that both the flank wear VB and linear wear rate LWR do not completely characterize the intensity of the wear process and that the volumetric changes should be accounted for. Volume difference measurement (VDM) module of the 3D microscope was used for such analysis. The VDM method calculates the difference between the surfaces of new and worn tool in the same location as exemplified for bcBN tool in Fig. 6. Fig. 9 summarizes the calculated results of the volumetric wear rate (VWR , mm^3/km) determined with the use of VDM method. It can be seen that diamond tool materials with MAX-phase binder have high wear rate which has minor dependence on the cutting speed. This is related to the adhesive pluck out of the diamond grains and binder (see Fig. 10.a) due to poor binding between these phases. For other materials the wear surfaces have smoothened appearance with apparent scratches due to abrasive wear, as exemplified for the D-SiC tooling shown on Fig. 10.b. Fig. 10.b also shows that diamond phase attained minimal abrasive damage while the softer SiC binder has been preferentially abraded from the tool rake.

Fig. 9. Volumetric wear rate (VWR) for different tool materials.

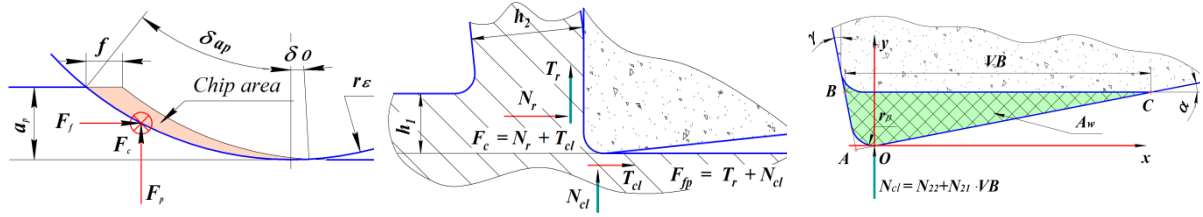
where A_w – cross-sectional wear area (Fig. 12.c), b – active length of the cutting edge (Fig. 12.a), H_{tool} – hardness of the tool material (Fig. 3), N_{cl} – normal force acting on the clearance (Fig. 12.b), and e – tool engagement distance.

Fig. 12. Schematic of (a) cutting forces acting on a tool, (b) decomposition of forces acting on the rake and clearance for a new tool, (c) normal force N_{cl} on the worn clearance and respective wear area A_w .

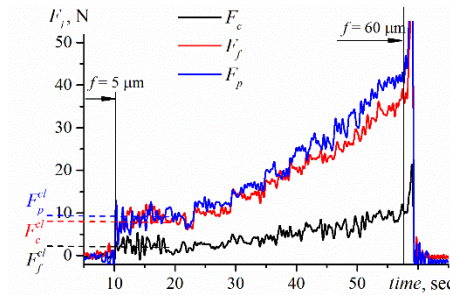
The normal force on the clearance N_{cl} for a new cutting tool can be identified by extrapolation of the F_f and F_p forces to the zero chip thickness [19], i.e. the moment when the tangential component T_r equals zero. Figure 13 shows an example of recorded cutting forces for machining MMC with the new D-Co tool at cutting speed $v_c = 200$ m/min when the feed was continuously increased from 5 to 60 $\mu\text{m}/\text{rev}$. The Figure 13 indicates that up to the feed of $f \approx 15$ $\mu\text{m}/\text{rev}$, which corresponds in our case [20] to the maximum theoretical chip thickness of $h_{lmax} = 4.9$ μm , the force components remain constant and represent the actual cutting forces acting only on the tool clearance.

Fig. 13. Development of cutting forces while continuously increasing feed ($f = 5 - 60$ $\mu\text{m}/\text{rev}$) for new D-Co tool ($v_c = 200$ m/min).

while the force component F_c^{cl} (Fig. 13) represents the tangential force on the clearance T_{cl} .

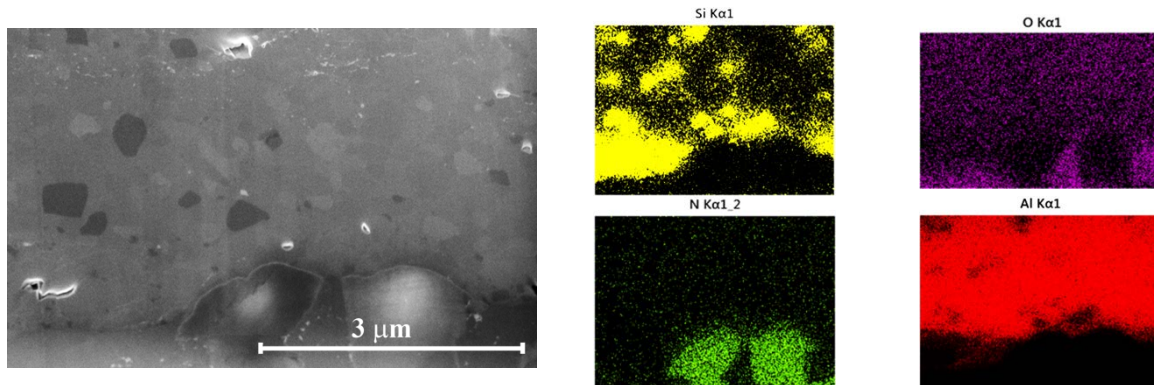
Analysis of a similar FIB milled lamella extracted from the B₆O-cBN tool (Fig. 20) indicates absence of chemical interaction between tooling and MMC. In this case the TPL contains fine debris particles of eutectic Si, from the matrix of the MMC material, which are loosely located on the contact surfaces. Which is in opposition to the nano-crystalline SiC layer on D-Co that is intimately attached to the diamond. This indicates that not only the intensity of formation of the TPL is different between diamond and cBN-based tooling, but also the composition and attachment of the TPL is affected.

Fig. 20. EDX map of a sample FIB milled from the TPL on the crater of non-etched B₆O-cBN insert ($v_c = 200$ m/min).

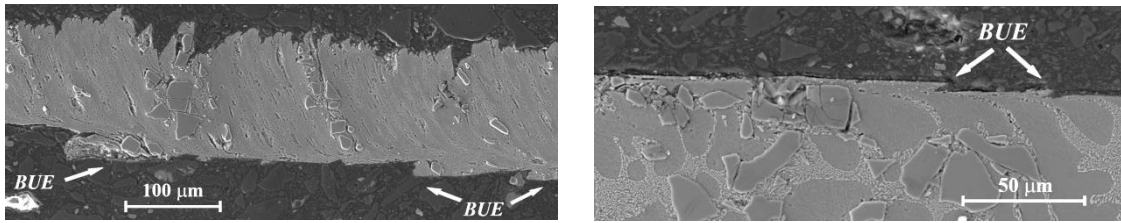
The size of BUE, as shown on Fig. 23.a, is around 100 to 150 μm while the roughness in the respective case was only $Ra = 1.1 - 1.5 \mu\text{m}$. Cross-sectional analysis of the chips and the machined surface was performed in order to identify the cause of such difference. Fig. 25.a shows that the built-up edge predominantly remains with the chips while only a small fraction of BUE remains on the machined surface. It can be assumed that flank wear land of the tool additionally smoothens the machined surface after BUE breakage (Fig. 25.b), thus reducing its negative influence on the surface quality.

Fig. 25. SEM images of elements of build-up edge on (a) chips and (b) machined surface for D-Co tool ($v_c = 200$ m/min).
