Published in:
European Corrosion Congress 2011 (EUROCORR 2011)

Sheet Pile Corrosion in Swedish Harbours – An inventory of Corrosion Surveys along the Swedish Coast

Henrik Wall & Lars Wadsö, Div. of Building Materials, Lund University, Sweden

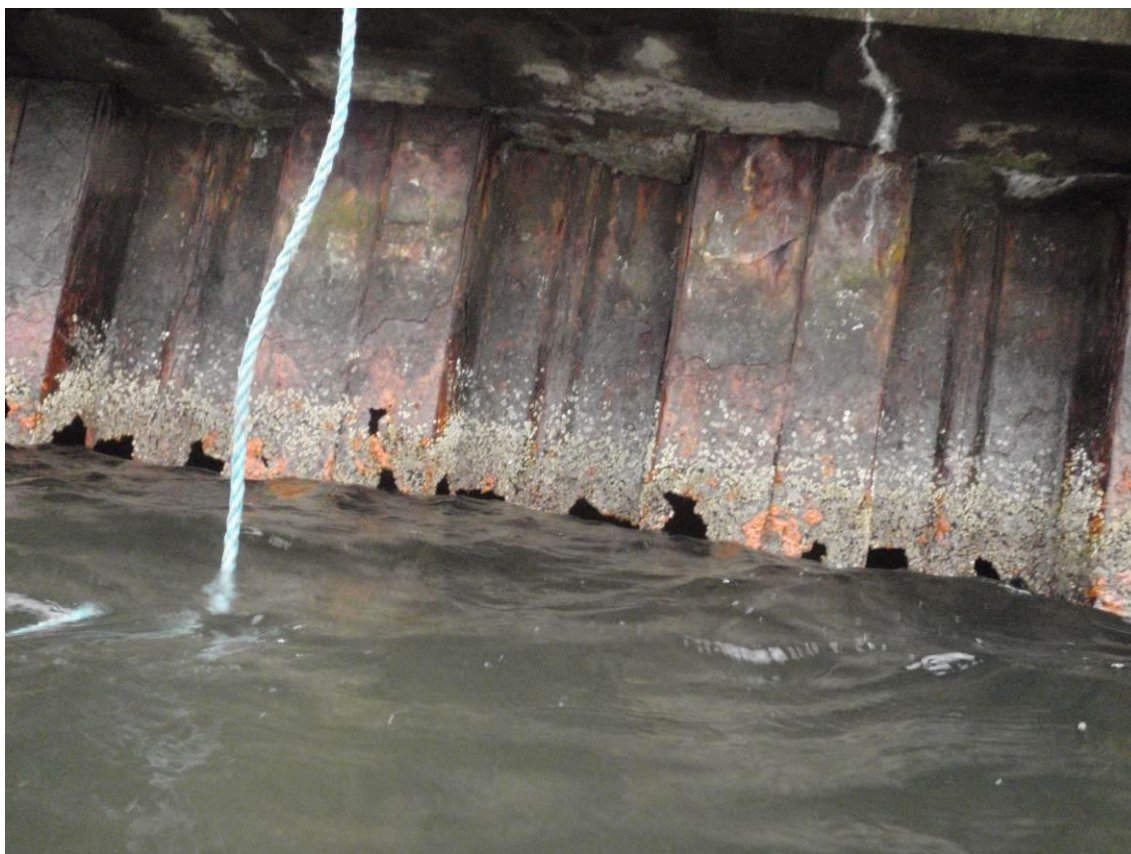
Figure 1: Sheet pile wall on the Swedish east coast suffering from severe corrosion
(Joakim Brogstam, MarCon Teknik AB)

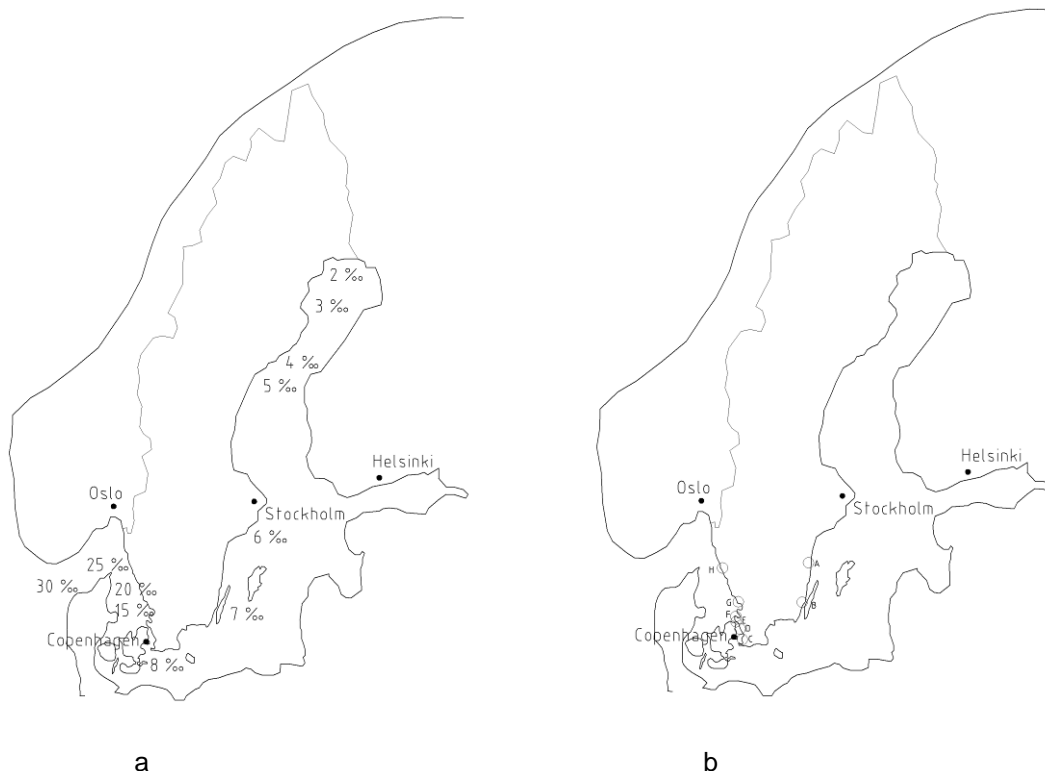
Figure 5: The salinity (‰) in sea water along the coast of Sweden (5 a) and locations of investigated harbors (5 b)

the north east coast, to around 3.0% at the north west coast (Fig. 5a). In the Northern Baltic sea the ice loads can be rather heavy on the sheet pile structures as the number of ice days can be as high as 130 [2].

The measurements presented in this paper are from investigations performed by divers in Swedish harbors. The clients are either the port authorities themselves or consultants who are hired for the purpose of determining the status of a specific quay structure. The data has been collected from steel sheet quays starting south of the city of Stockholm on the east coast down to the south coast of Sweden and up along the southern half of the east coast (Fig. 5b).
