## Unfortified elite buildings in 13th century Sweden

Hansson, Martin

*Published in:*  
Vivre au Château

## UNFORTIFIED ELITE BUILDINGS IN 13<sup>th</sup>-CENTURY SWEDEN

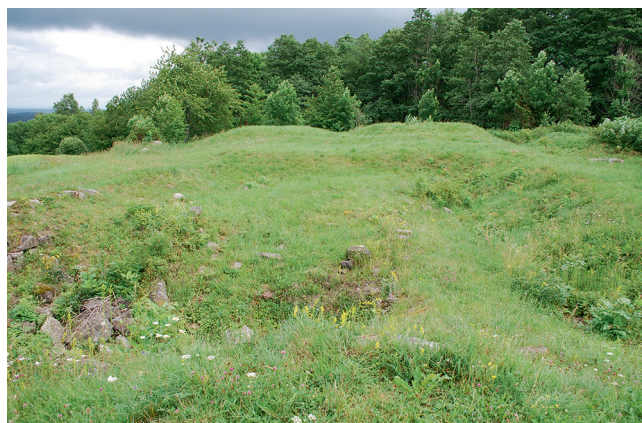
Fig. 3 Today the appearance of the palace in Lena is dominated by the foundations and the cellar of the building. Photograph M. Hansson.

The building complex is c. 120 m x 95 m in area and consists of the foundations of the palace and four other houses, as well as three terraces. The palace itself seems to have measured c. 32 m by 18 m, making it a substantial building of stone, which was divided into between four and six rooms. Just east of this building, two almost quadrangular house remains can be seen (fig. 3). They are connected with each other by a wall and have been seen by some to have been some kind of towers, but this is an uncertain interpretation. Further south, two more houses can be found, one 21 m in length, the other 13 m long, both being 8 m in width. About 30 m east of the palace a wall dams a small stream.

The lower parts of the palace walls were of fieldstone in mortar; higher up the walls were a mix of fieldstones and bricks. The palace seems to have had an internal axial partition wall, slightly offset to the south, which possibly indicates that the upper floor had a gallery facing south, on the backside of the building in relation to the position of the church. In a cellar northwest of the palace, a natural well occurs and the water led in a stone lined culvert. Everything indicates that this was a very luxurious building<sup>11</sup>.

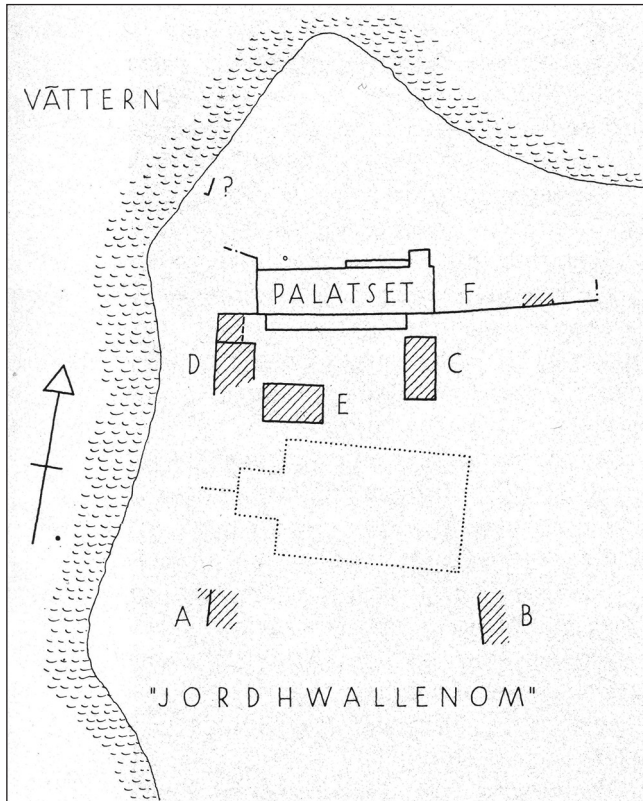
Fig. 4 Schematic plan of palace complex in Vadstena, with contemporary buildings marked. Palatset = the Palace. A-E = ancillary buildings. "Jordhwallenom" = tentative location of the earthen wall mentioned in the 14<sup>th</sup> century. After ANDERSON 1972, fig. 64 (p. 53).

Investigations made during the 1950s and 1960s revealed that parts of the preserved nunnery were indeed a medieval palace. The palace complex, apart from a large brick building, seems to have consisted of at least five other brick and/or limestone buildings. Two of them were placed as wings in relation to the palace, and a third one was placed to the south, but parallel to the palace. These ancillary buildings formed an open courtyard, in front of the palace (fig. 4). Yet two other minor stone buildings

further south are probably contemporary with the palace. These ancillary buildings were probably used for cooking, storage and the like.

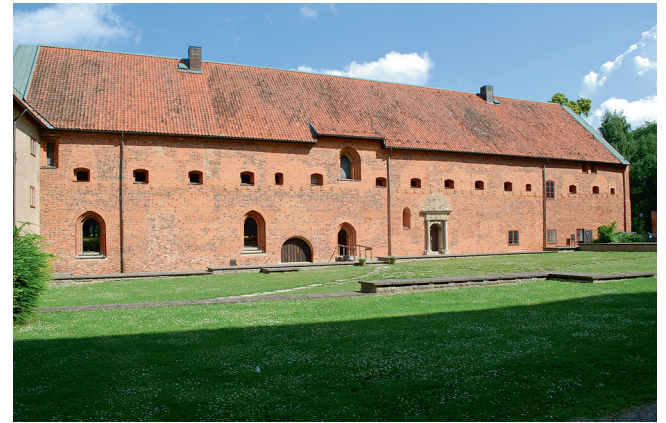
Fig. 5 The present appearance of the palace in Vadstena. Photograph M. Hansson.

The palace, a brick building, was built in monk bond and was c. 56 m long, 14.5 m wide and at least 14 m high<sup>17</sup>. It had two floors and a basement under the western part of the building<sup>18</sup>. The ground floor consisted of three rooms, one larger one to the west and two smaller ones to the east (fig. 5). The first floor was reached *via* an external stairway and gallery that seems to have been present along the southern side of the building. It is possible that the gallery could have functioned at some stage as some form of balcony<sup>19</sup>. From the gallery people could enter the rooms on the upper floor, but also view and be viewed

from the courtyard. The great hall in the western part had a large fireplace and pointed arched windows. The outer sides of the windows were decorated with round mouldings. In the eastern part, another large hall could have functioned as a meeting place / throne hall for the king or as a chapel. The exclusivity and high status of the building is evident<sup>20</sup>.

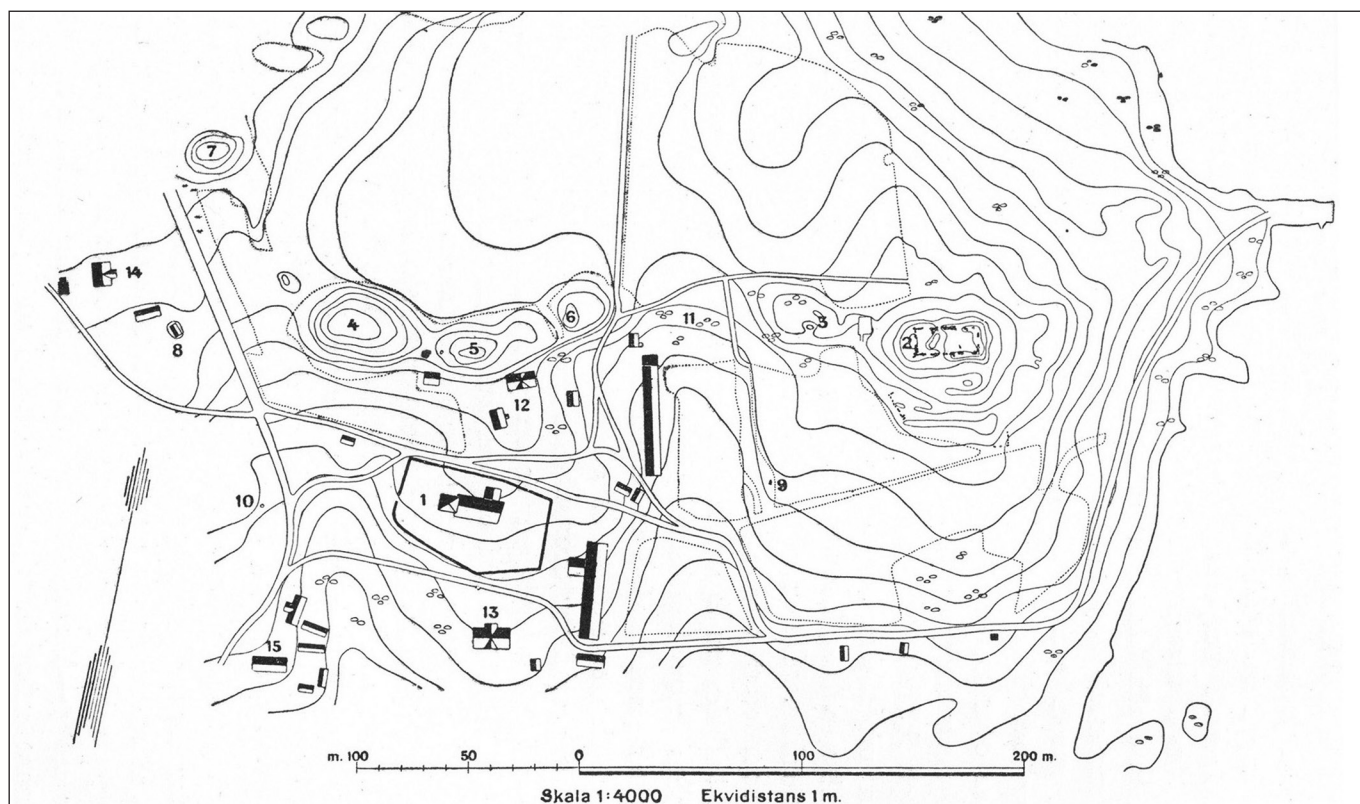
Fig. 6 The palace complex and ancient monuments at Alsnö. Some of the monuments marked on the plan: 1) parish church; 2) palace; 3) cellar; 4-6) grave mounds; 9) runic inscription. After THORDEMAN 1920, fig. 1 (p. 3).

The palace lies on small height on a relative flat plateau somewhat elevated in comparison to the surrounding ground level (fig. 6). The complex must have been visually dominant for anyone approaching on water<sup>26</sup>. Apart from the palace, a number of timber buildings seem to have existed as well<sup>27</sup>. The palace itself was in a secondary phase surrounded by a dry, shallow moat and a low earthen wall. On the inside of the moat, traces of a weak palisade were found. However, the site cannot be regarded as being originally defended militarily, since the palisade is stratigraphically a later addition<sup>28</sup>.

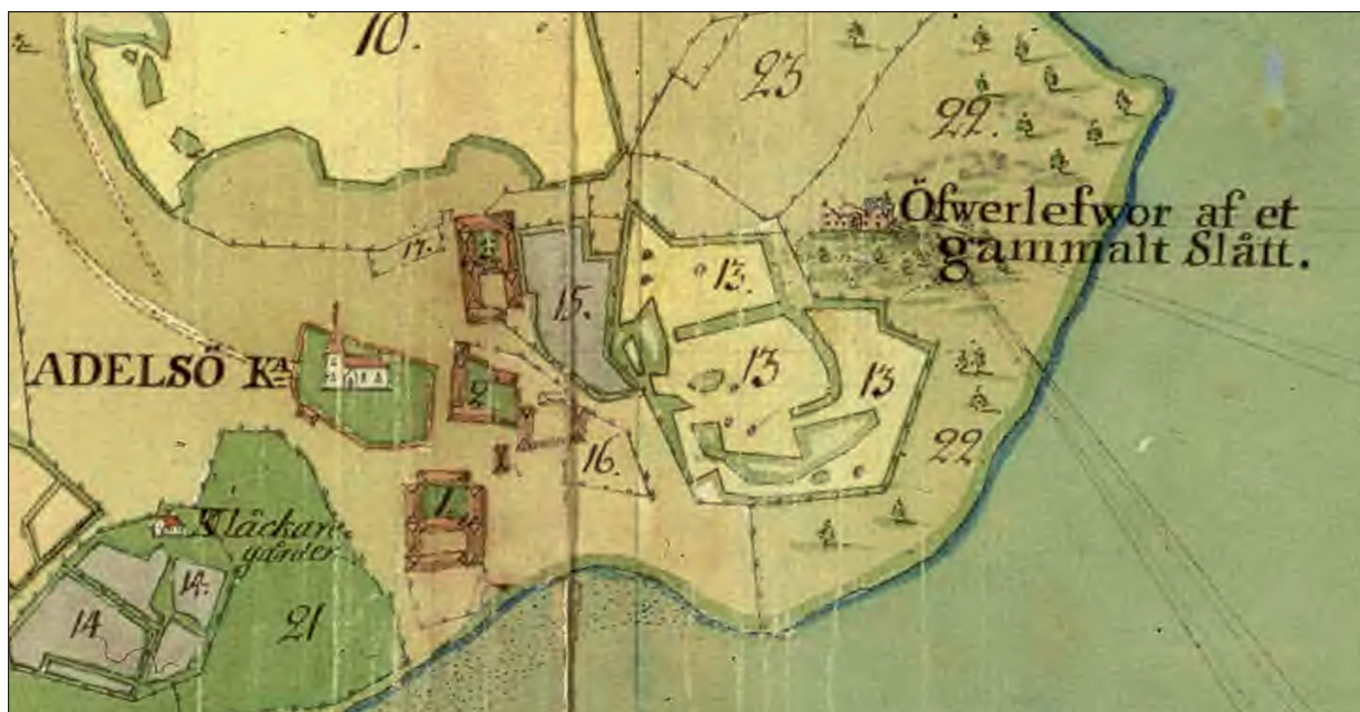
Fig. 7 Extract of the 1751 map of Adelsö. To the east the surveyor has noted "Remains of an old castle". To the west the parish church and the farms at Hovgården. File number A1-11:1, Lantmäteriet, surveyor Gabriel Boding.

The palace at Alsnö was a brick building, c. 30 m by 15 m in size. When excavated, the walls were preserved to a maximum height of 2 m. An illustration on a map dating to 1751 shows a ruined building with two rows of windows (fig. 7). The ground plan of the building, with small buttresses in the corners and in its middle, also indicates that it must have had at least two floors, and also that the upper floor had been vaulted. The building was built in monk bond on a foundation of fieldstones. The ground floor had two rooms – a larger western one and a smaller eastern one. The latter room had a fireplace and floor of brick tiles, partly ornate. Under the western room on the ground floor, a cellar had
